Hybrid 5z161 Traveler

June 15, 2000

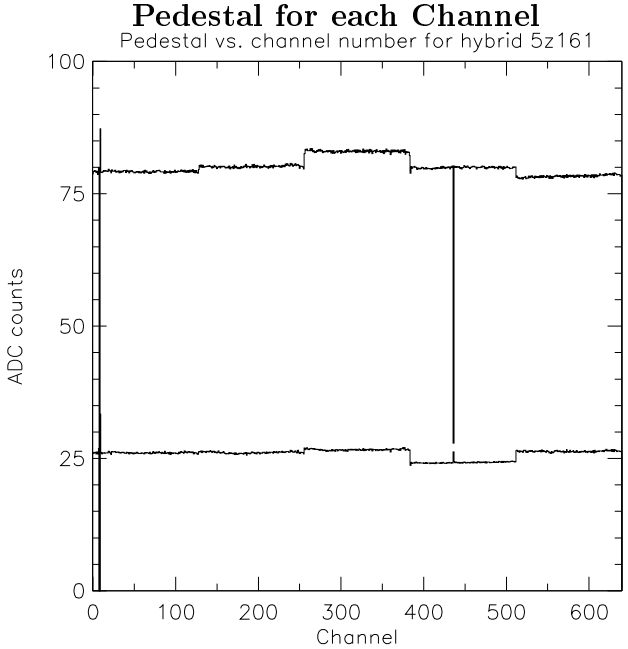
Pedestal for each Channel

The following plot shows the pedestals vs. channel number with and without charge injection:

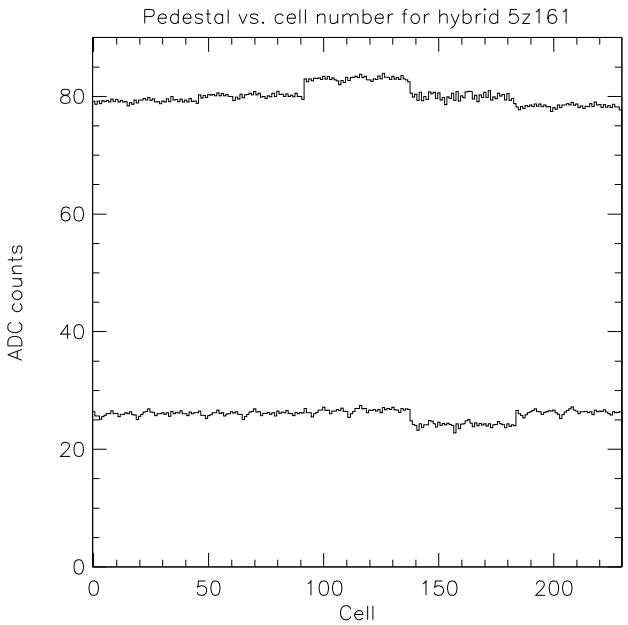
Pedestal vs. Pipeline Cell ID

The following plot shows the average pedestal vs. pipeline cell ID with and without charge injection. The x-axis is cell ID offset by 46 for each chip. Thus cell ID 5 for chip 1 is at x=5, chip 2 at x=51, chip 3 at x=97, etc.

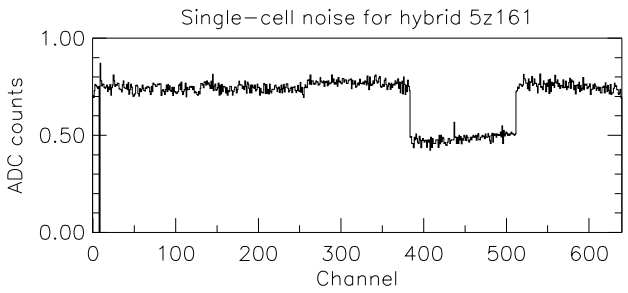
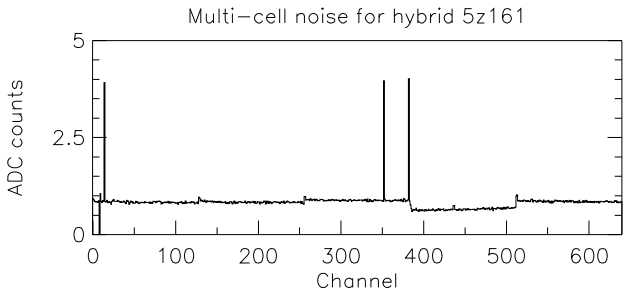
RMS Noise

The following plots show the single-cell and multi-cell RMS noise:

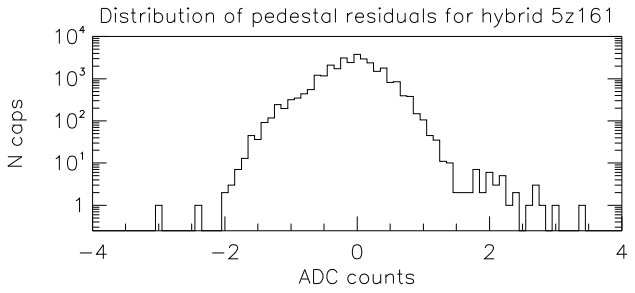
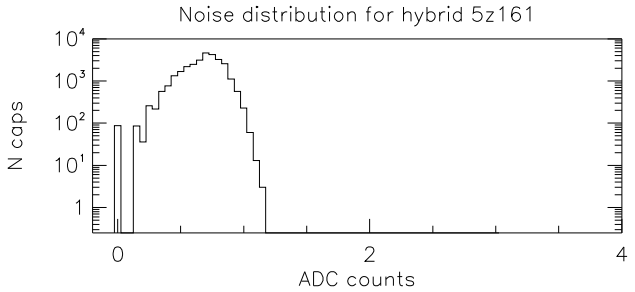
Distribution of Pedestals and Noise

The following are histograms of the pedestal of each pipeline capacitor relative to the chip average (top); and the RMS noise of each capacitor (bottom):

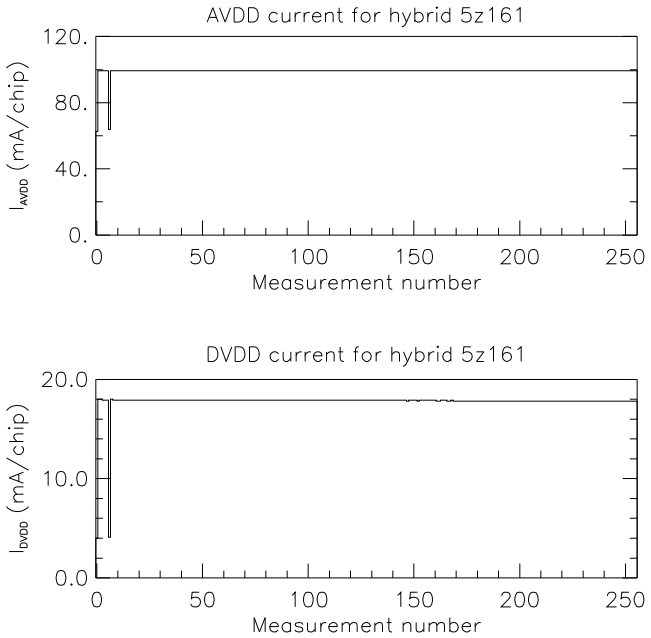
Supply Currents During Burn-in

The following plots show the supply currents per chip as a function of measurment number. Currents are measured approximately every 10 minutes:
