Hybrid 5z42 Traveler

April 27, 2000

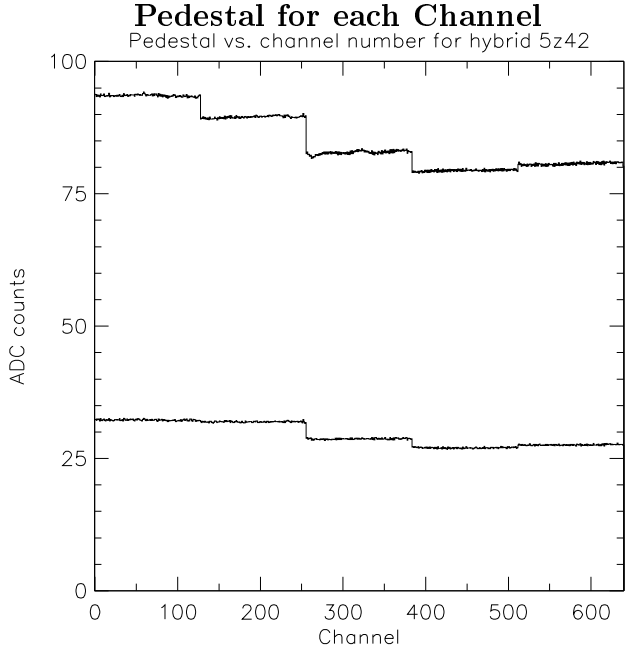
Pedestal for each Channel

The following plot shows the pedestals vs. channel number with and without charge injection:

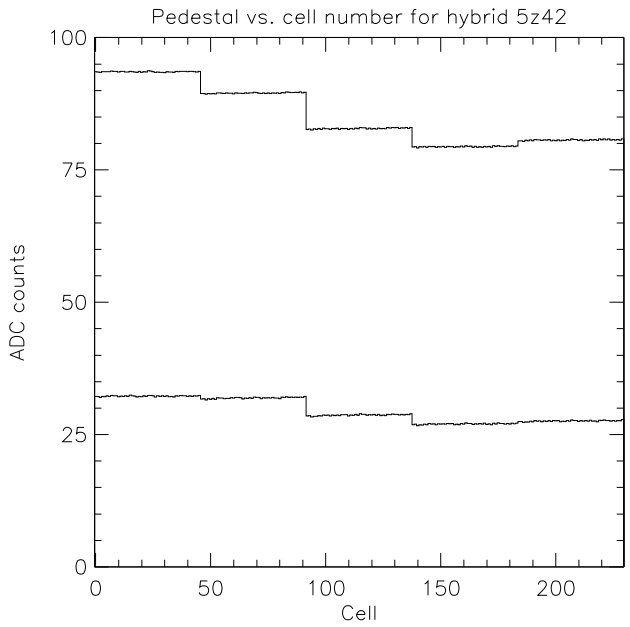
Pedestal vs. Pipeline Cell ID

The following plot shows the average pedestal vs. pipeline cell ID with and without charge injection. The x-axis is cell ID offset by 46 for each chip. Thus cell ID 5 for chip 1 is at x=5, chip 2 at x=51, chip 3 at x=97, etc.

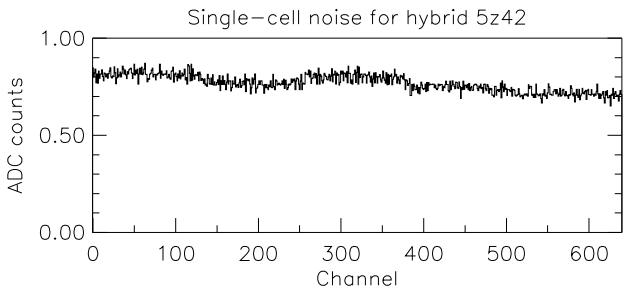
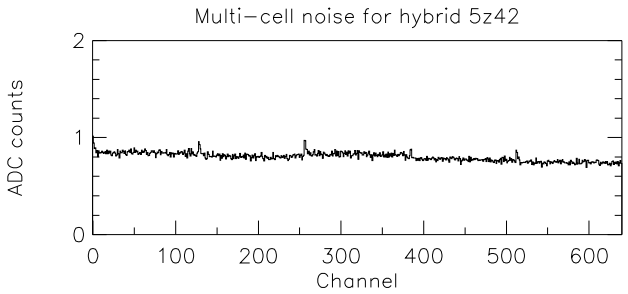
RMS Noise

The following plots show the single-cell and multi-cell RMS noise:

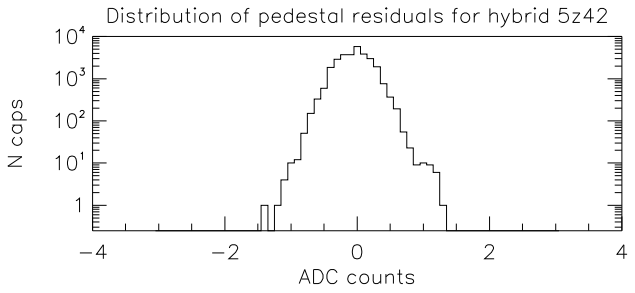
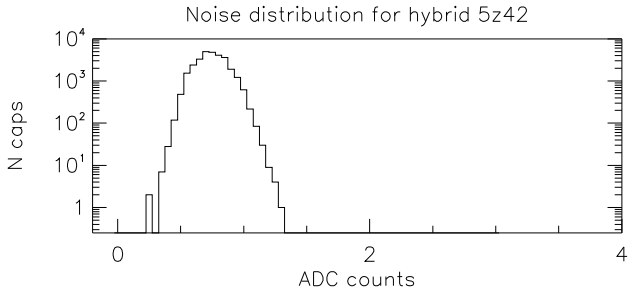
Distribution of Pedestals and Noise

The following are histograms of the pedestal of each pipeline capacitor relative to the chip average (top); and the RMS noise of each capacitor (bottom):

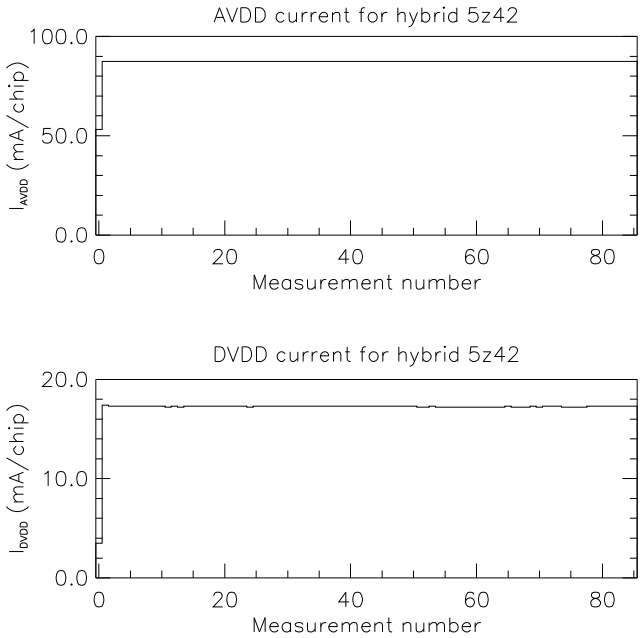
Supply Currents During Burn-in

The following plots show the supply currents per chip as a function of measurment number. Currents are measured approximately every 10 minutes:
