Hybrid 5z82 Traveler

March 7, 2000

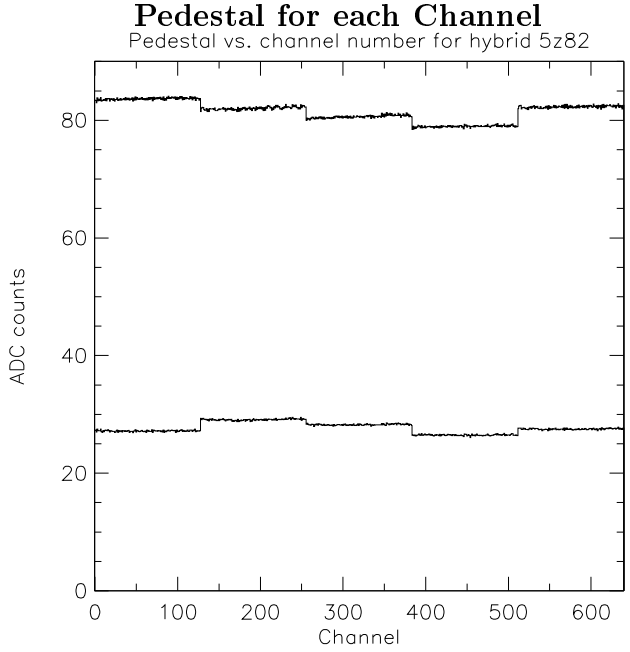
Pedestal for each Channel

Hybrid 5z82 quality: fair
Chip classification: good fair fair fair good
Bad channels (chip-channel): 2-44
Bad cells: none
Random bad capacitors (chip-cell-channel): 1-31-62 2-42-43 3-37-11
Channels at pedestal needed for DCMS: 37.6 36.7 34.7 33.5 35.6
```

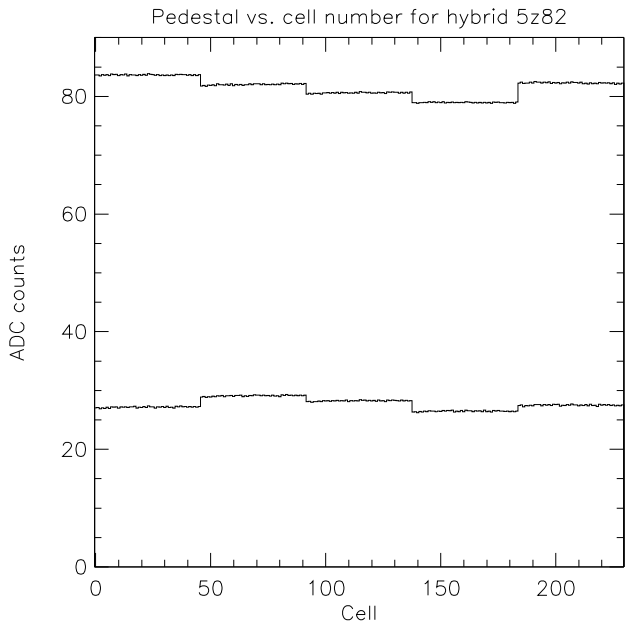
Pedestal vs. Pipeline Cell ID

The following plot shows the average pedestal vs. pipeline cell ID with and without charge injection. The x-axis is cell ID offset by 46 for each chip. Thus cell ID 5 for chip 1 is at x=5, chip 2 at x=51, chip 3 at x=97, etc.

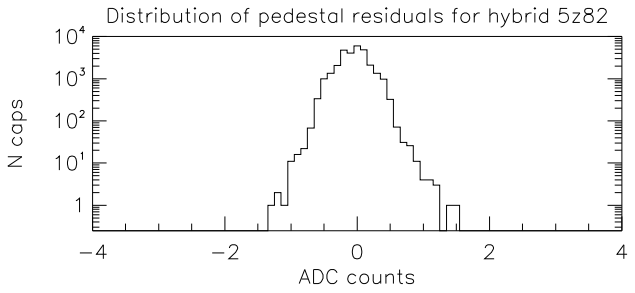
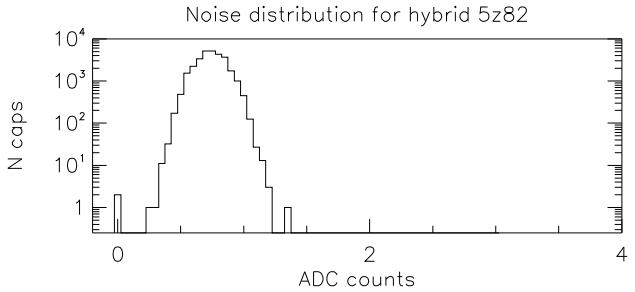
Distribution of Pedestals and Noise

The following are histograms of the pedestal of each pipeline capacitor relative to the chip average (top); and the RMS noise of each capacitor (bottom):

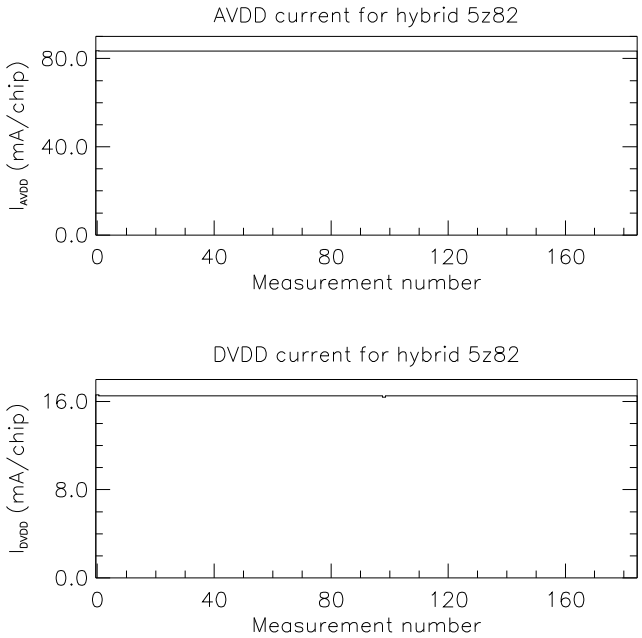
Supply Currents During Burn-in

The following plots show the supply currents per chip as a function of measurment number. Currents are measured approximately every 10 minutes:
