Hybrid 5z90 Traveler

April 19, 2000

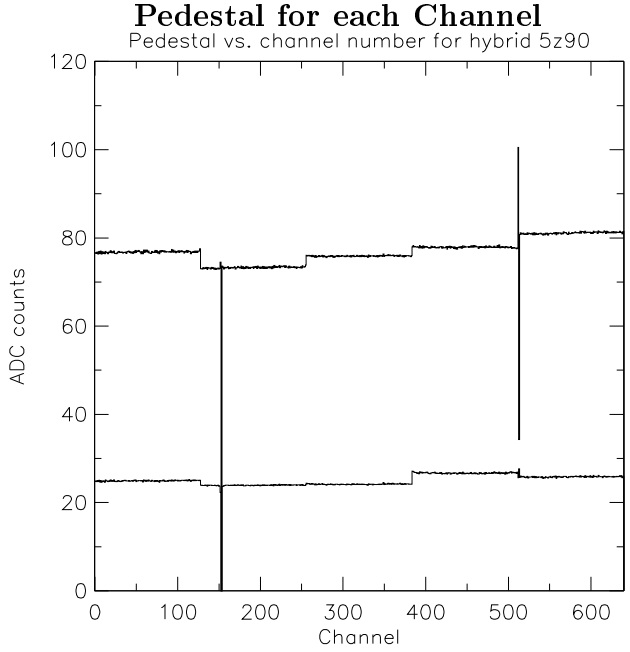
Pedestal for each Channel

The following plot shows the pedestals vs. channel number with and without charge injection:

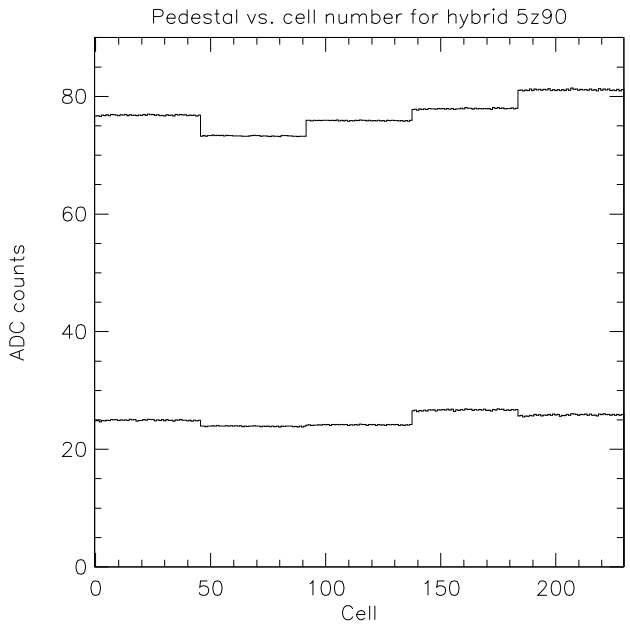
Pedestal vs. Pipeline Cell ID

The following plot shows the average pedestal vs. pipeline cell ID with and without charge injection. The x-axis is cell ID offset by 46 for each chip. Thus cell ID 5 for chip 1 is at x=5, chip 2 at x=51, chip 3 at x=97, etc.

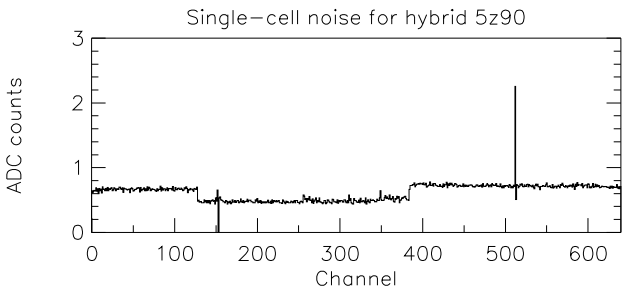
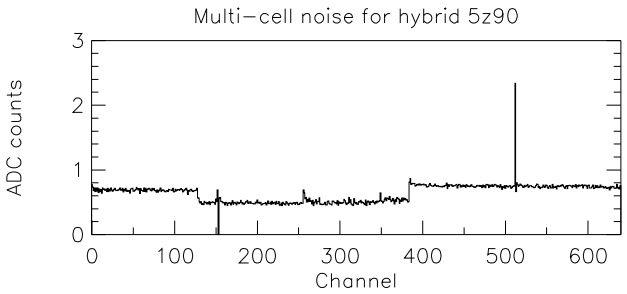
RMS Noise

The following plots show the single-cell and multi-cell RMS noise:

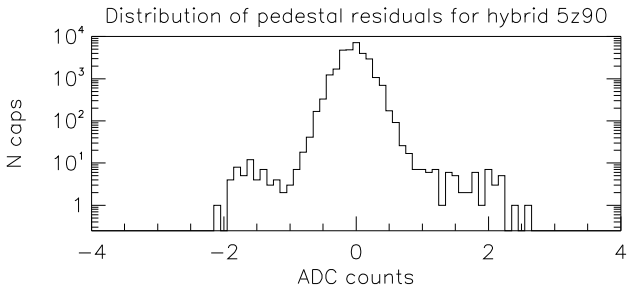
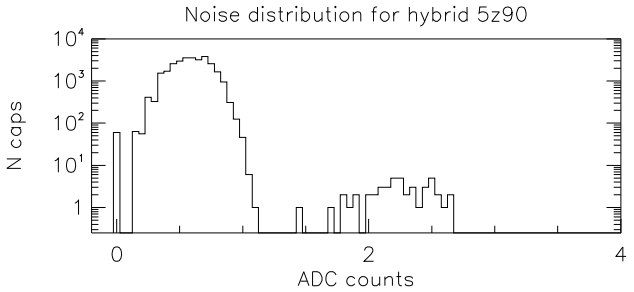
Distribution of Pedestals and Noise

The following are histograms of the pedestal of each pipeline capacitor relative to the chip average (top); and the RMS noise of each capacitor (bottom):

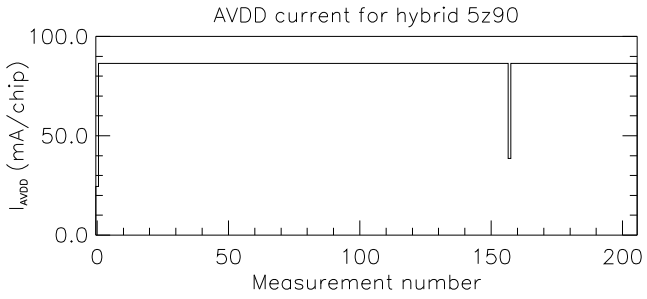
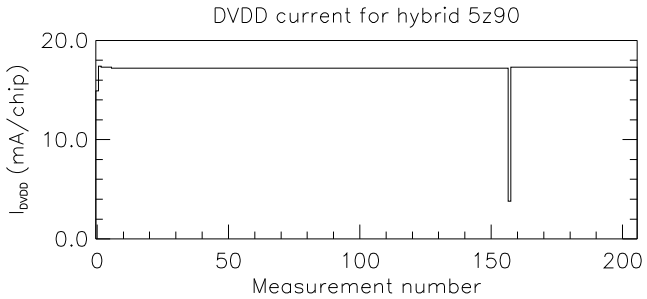
Supply Currents During Burn-in

The following plots show the supply currents per chip as a function of measurment number. Currents are measured approximately every 10 minutes:
