Hybrid 6p115 Traveler

January 11, 2000

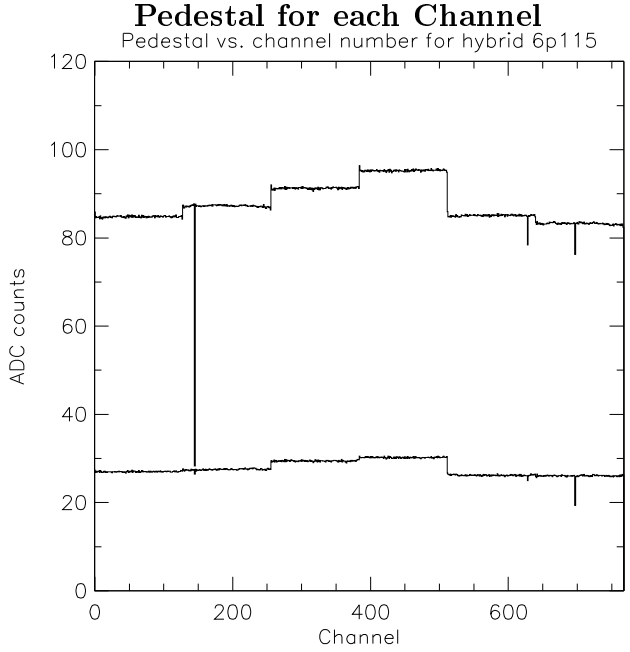
Pedestal for each Channel

The following plot shows the pedestals vs. channel number with and without charge injection:

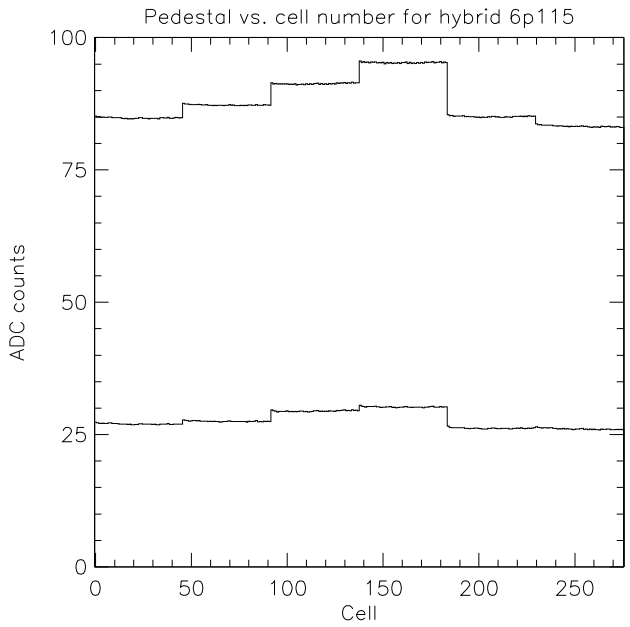
Pedestal vs. Pipeline Cell ID

The following plot shows the average pedestal vs. pipeline cell ID with and without charge injection. The x-axis is cell ID offset by 46 for each chip. Thus cell ID 5 for chip 1 is at x=5, chip 2 at x=51, chip 3 at x=97, etc.

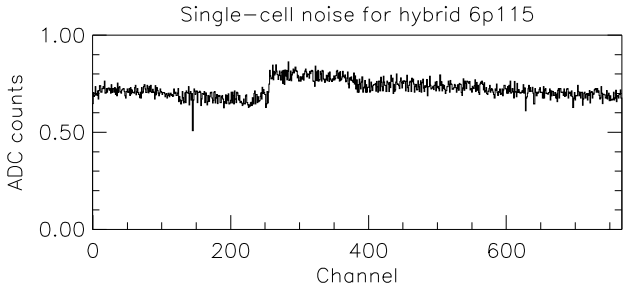
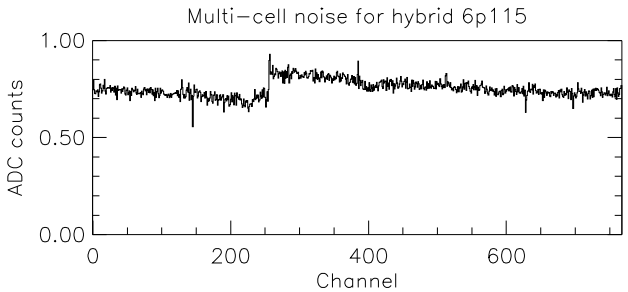
RMS Noise

The following plots show the single-cell and multi-cell RMS noise:

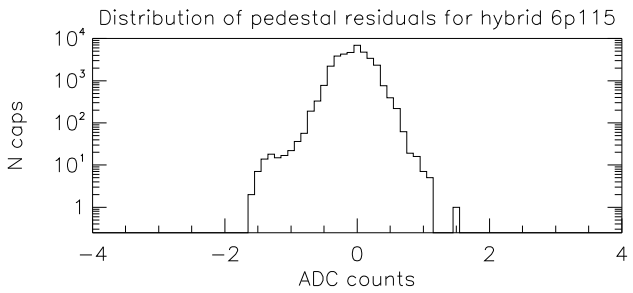
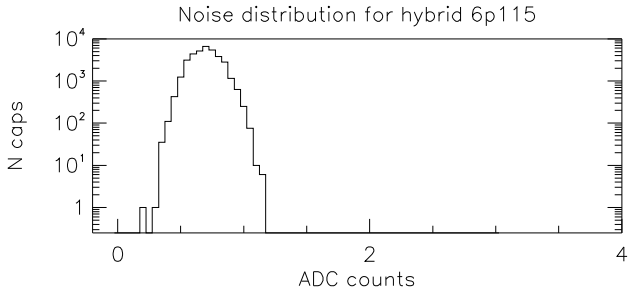
Distribution of Pedestals and Noise

The following are histograms of the pedestal of each pipeline capacitor relative to the chip average (top); and the RMS noise of each capacitor (bottom):

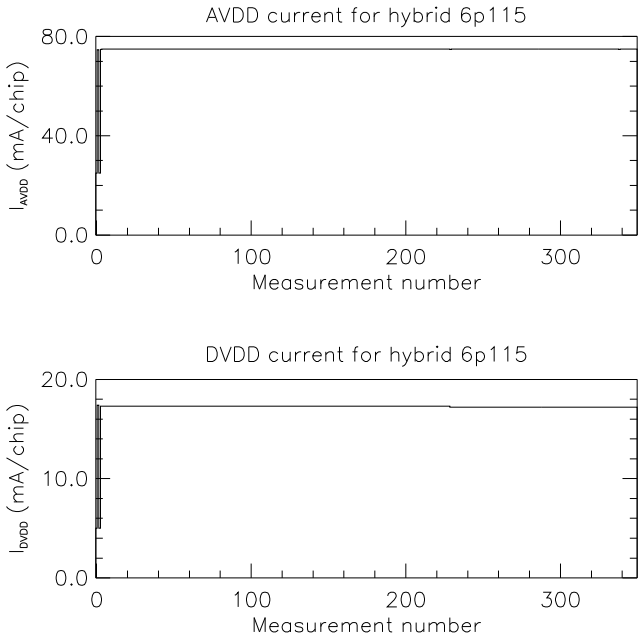
Supply Currents During Burn-in

The following plots show the supply currents per chip as a function of measurment number. Currents are measured approximately every 10 minutes:
