Hybrid 6p124 Traveler

February 10, 2000

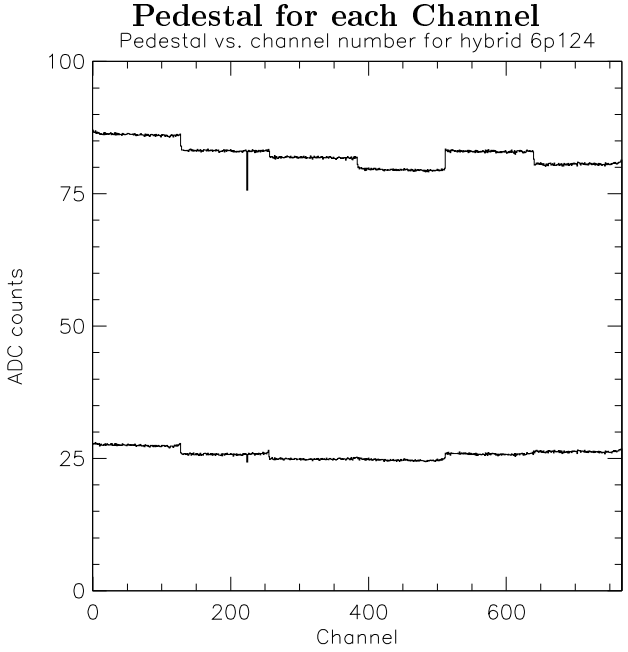
Pedestal for each Channel

The following plot shows the pedestals vs. channel number with and without charge injection:

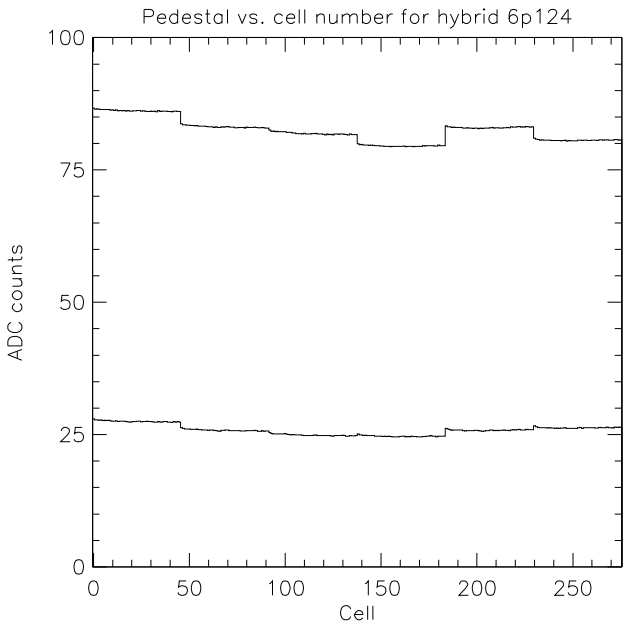
Pedestal vs. Pipeline Cell ID

The following plot shows the average pedestal vs. pipeline cell ID with and without charge injection. The x-axis is cell ID offset by 46 for each chip. Thus cell ID 5 for chip 1 is at x=5, chip 2 at x=51, chip 3 at x=97, etc.

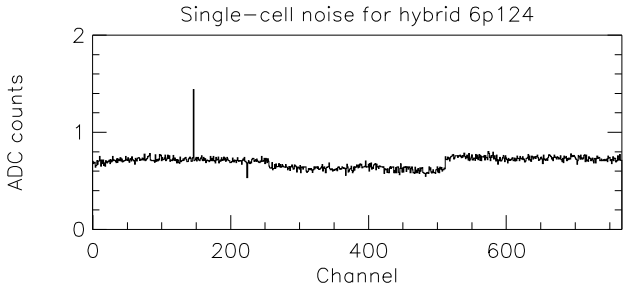
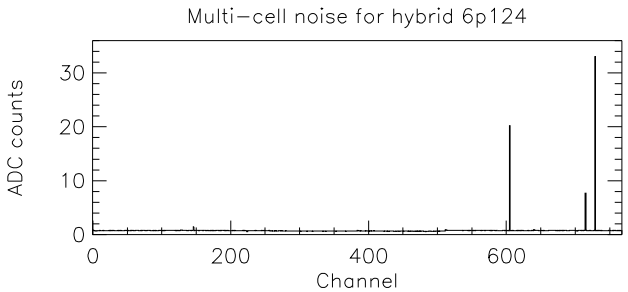
RMS Noise

The following plots show the single-cell and multi-cell RMS noise:

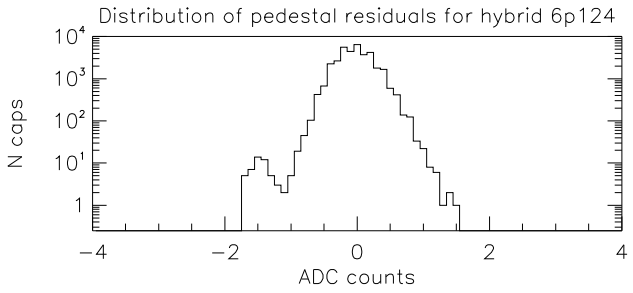
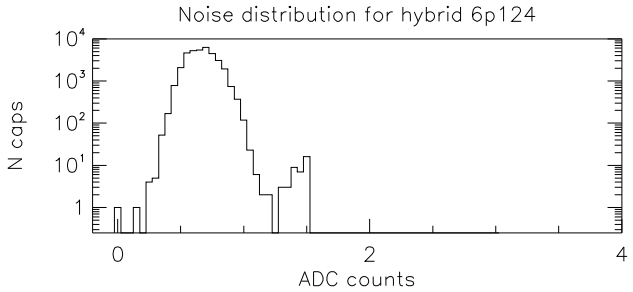
Distribution of Pedestals and Noise

The following are histograms of the pedestal of each pipeline capacitor relative to the chip average (top); and the RMS noise of each capacitor (bottom):

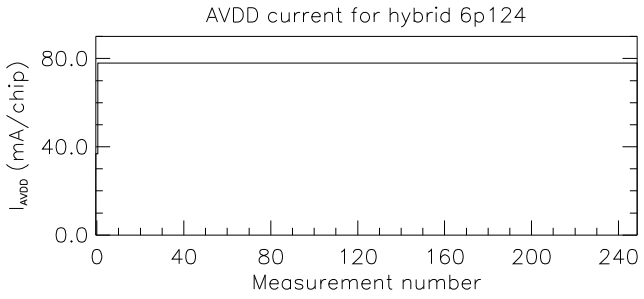
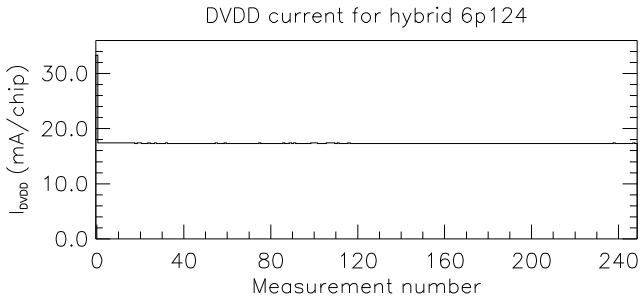
Supply Currents During Burn-in

The following plots show the supply currents per chip as a function of measurment number. Currents are measured approximately every 10 minutes:
