Hybrid 6p205 Traveler

May 31, 2000

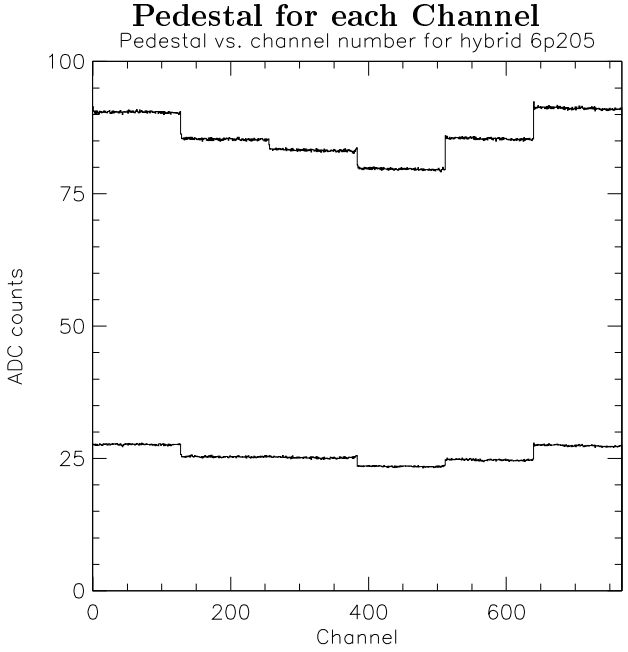
Pedestal for each Channel

The following plot shows the pedestals vs. channel number with and without charge injection:

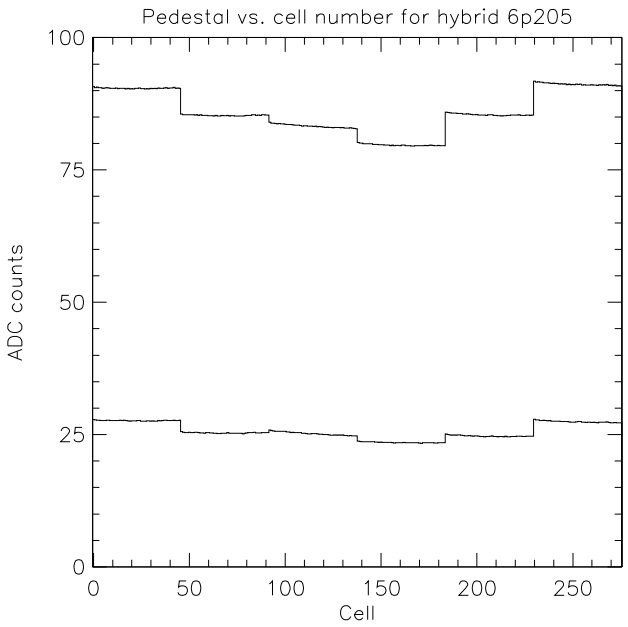
Pedestal vs. Pipeline Cell ID

The following plot shows the average pedestal vs. pipeline cell ID with and without charge injection. The x-axis is cell ID offset by 46 for each chip. Thus cell ID 5 for chip 1 is at x=5, chip 2 at x=51, chip 3 at x=97, etc.

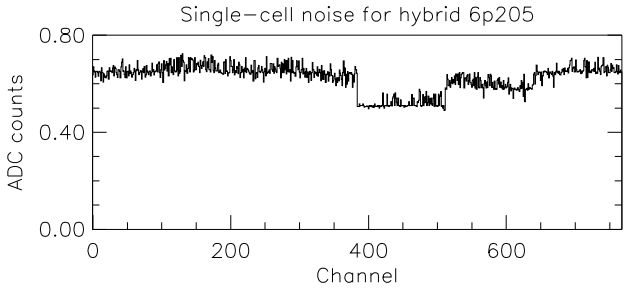
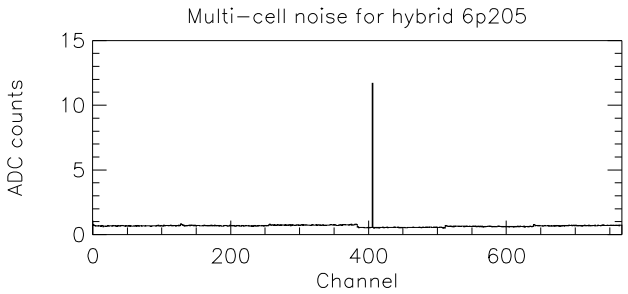
RMS Noise

The following plots show the single-cell and multi-cell RMS noise:

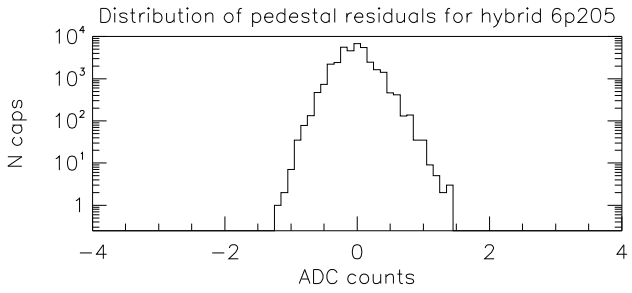
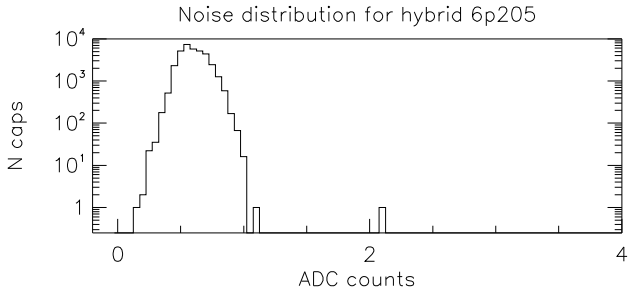
Distribution of Pedestals and Noise

The following are histograms of the pedestal of each pipeline capacitor relative to the chip average (top); and the RMS noise of each capacitor (bottom):

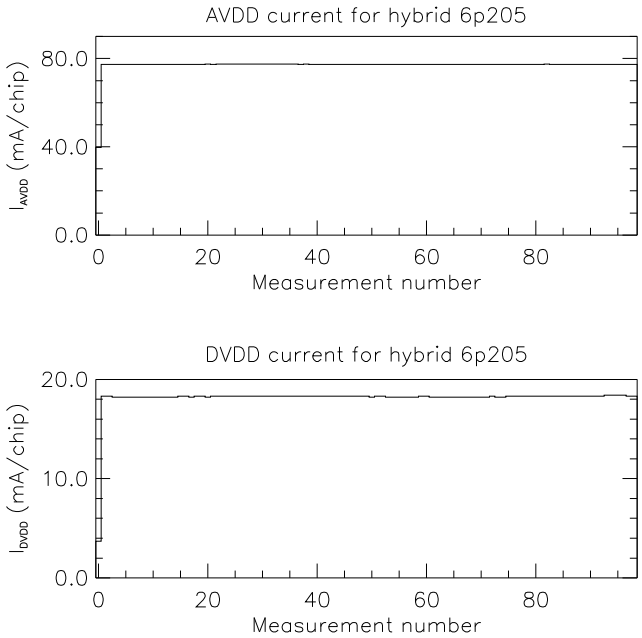
Supply Currents During Burn-in

The following plots show the supply currents per chip as a function of measurment number. Currents are measured approximately every 10 minutes:
