Hybrid 6p209 Traveler

May 15, 2000

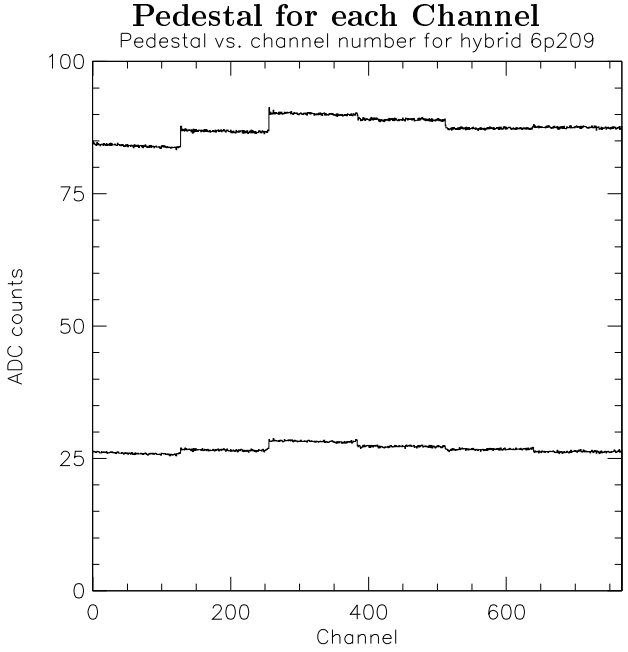
Pedestal for each Channel

The following plot shows the pedestals vs. channel number with and without charge injection:

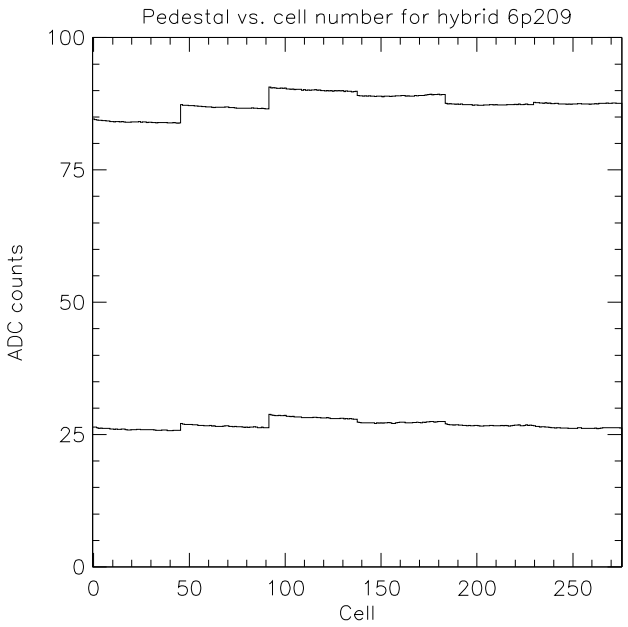
Pedestal vs. Pipeline Cell ID

The following plot shows the average pedestal vs. pipeline cell ID with and without charge injection. The x-axis is cell ID offset by 46 for each chip. Thus cell ID 5 for chip 1 is at x=5, chip 2 at x=51, chip 3 at x=97, etc.

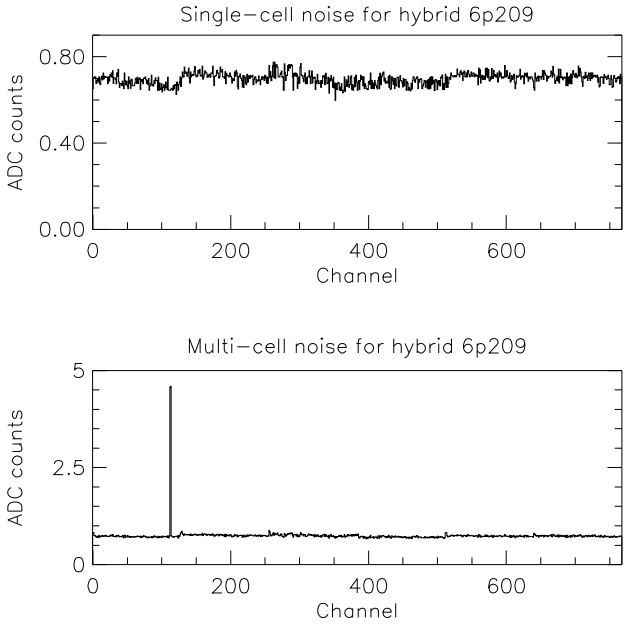
RMS Noise

The following plots show the single-cell and multi-cell RMS noise:

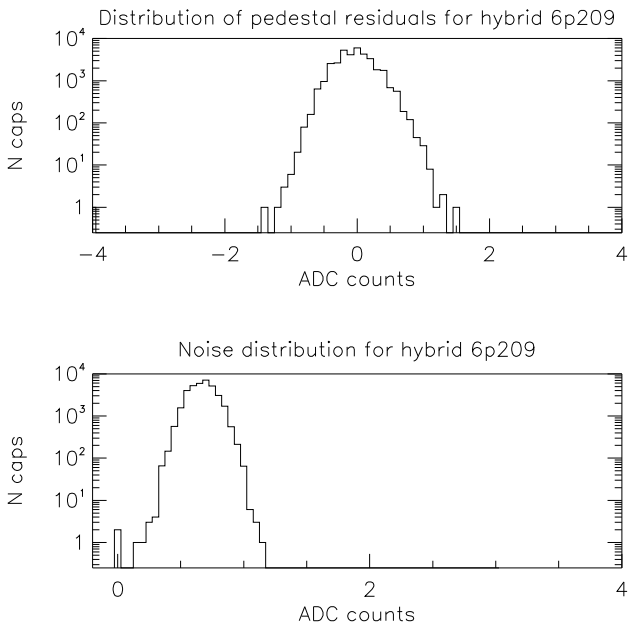
Distribution of Pedestals and Noise

The following are histograms of the pedestal of each pipeline capacitor relative to the chip average (top); and the RMS noise of each capacitor (bottom):

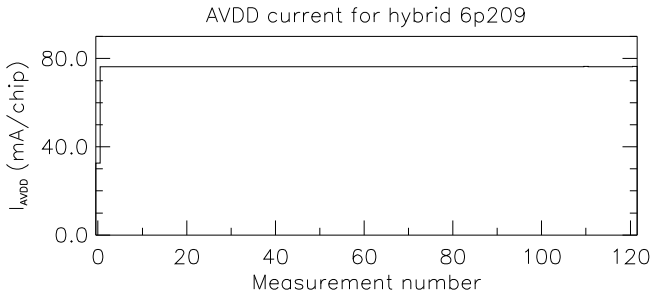
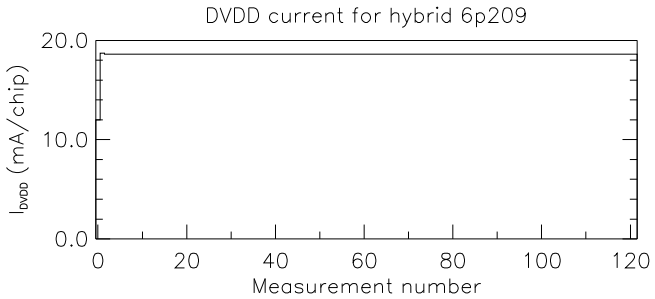
Supply Currents During Burn-in

The following plots show the supply currents per chip as a function of measurment number. Currents are measured approximately every 10 minutes:
