# Hybrid 6p219 Traveler

March 2, 2000

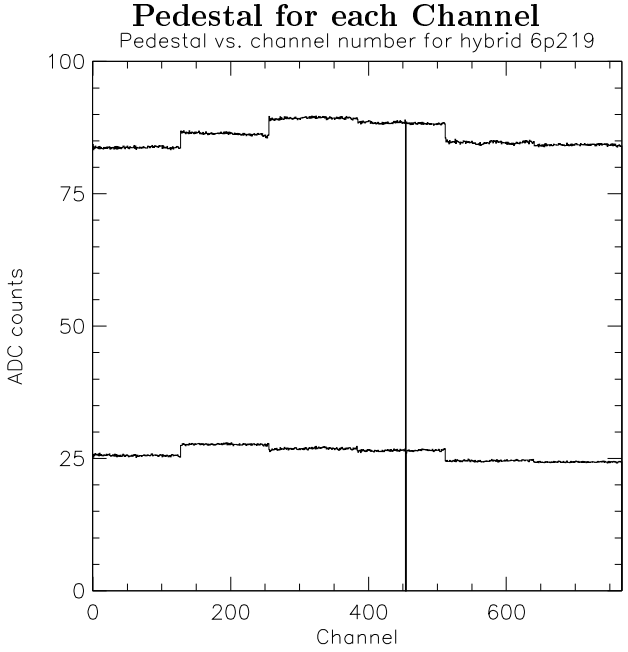
**Pedestal for each Channel**

The following plot shows the pedestals vs. channel number with and without charge injection:

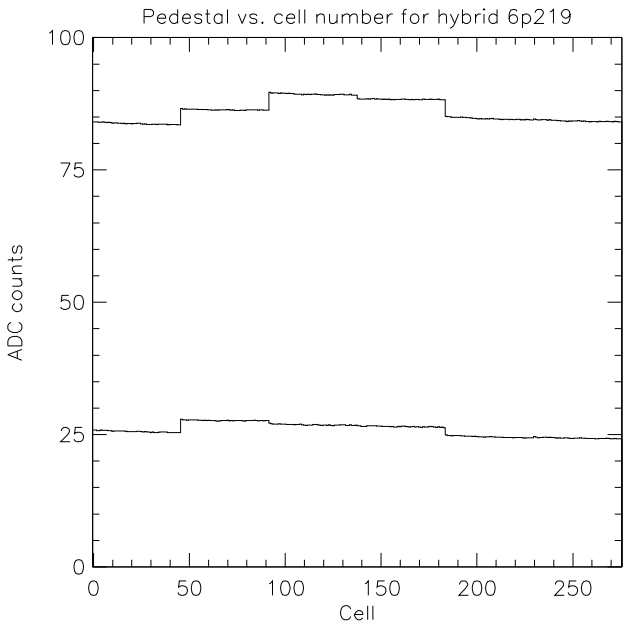
**Pedestal vs. Pipeline Cell ID**

The following plot shows the average pedestal vs. pipeline cell ID with and without charge injection. The x-axis is cell ID offset by 46 for each chip. Thus cell ID 5 for chip 1 is at x=5, chip 2 at x=51, chip 3 at x=97, etc.

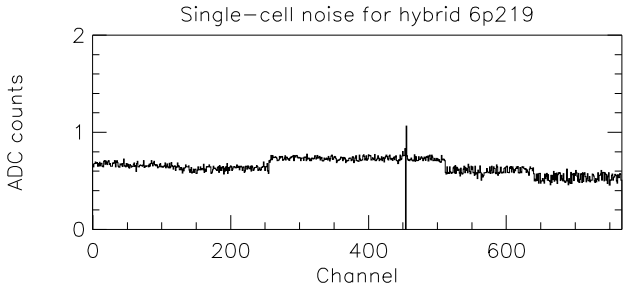
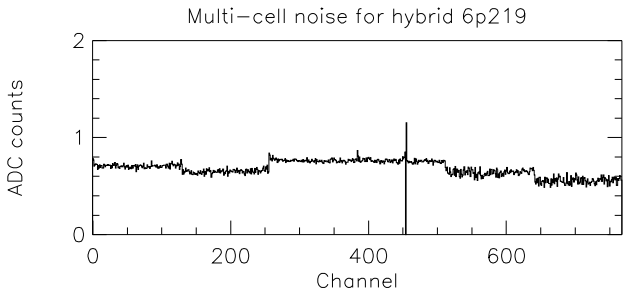
**RMS Noise**

The following plots show the single-cell and multi-cell RMS noise:

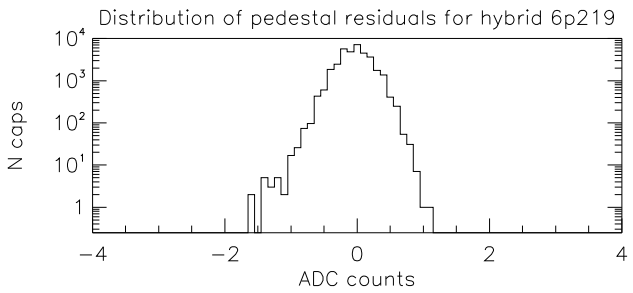
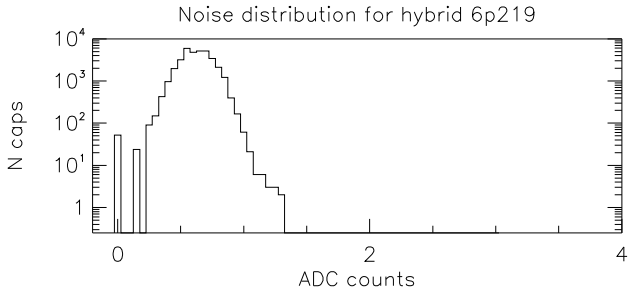
**Distribution of Pedestals and Noise**

The following are histograms of the pedestal of each pipeline capacitor relative to the chip average (top); and the RMS noise of each capacitor (bottom):

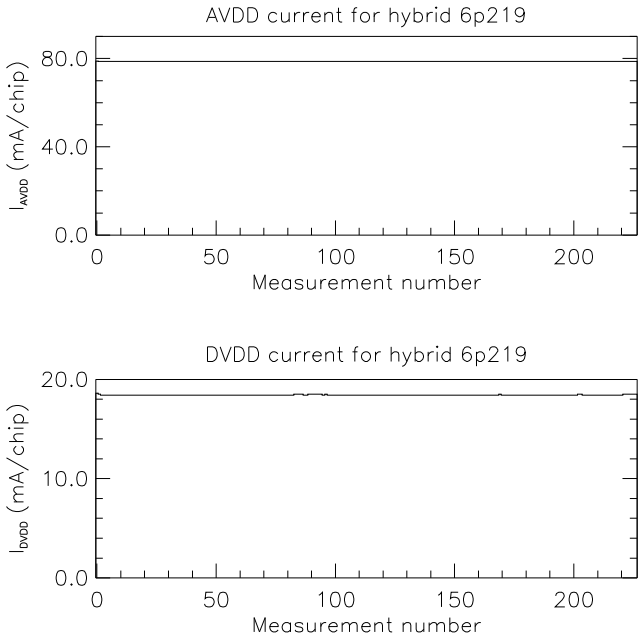
**Supply Currents During Burn-in**

The following plots show the supply currents per chip as a function of measurment number. Currents are measured approximately every 10 minutes:
