Hybrid 6p229 Traveler

February 17, 2000

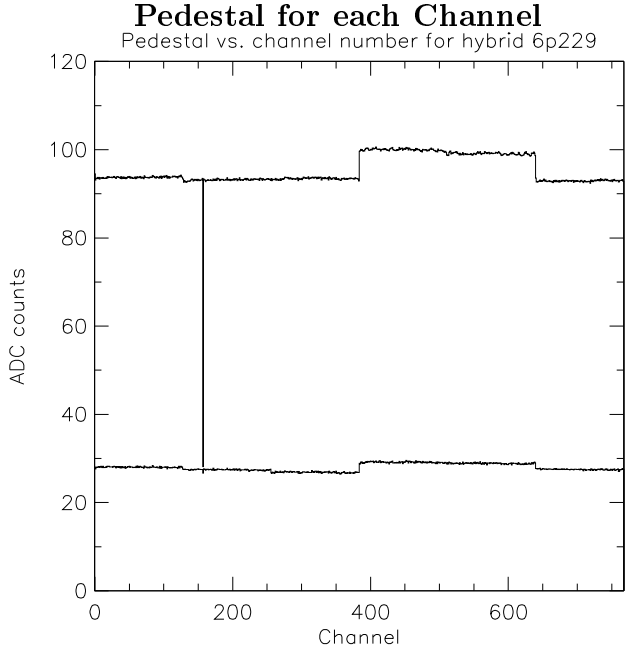
Pedestal for each Channel

The following plot shows the pedestals vs. channel number with and without charge injection:

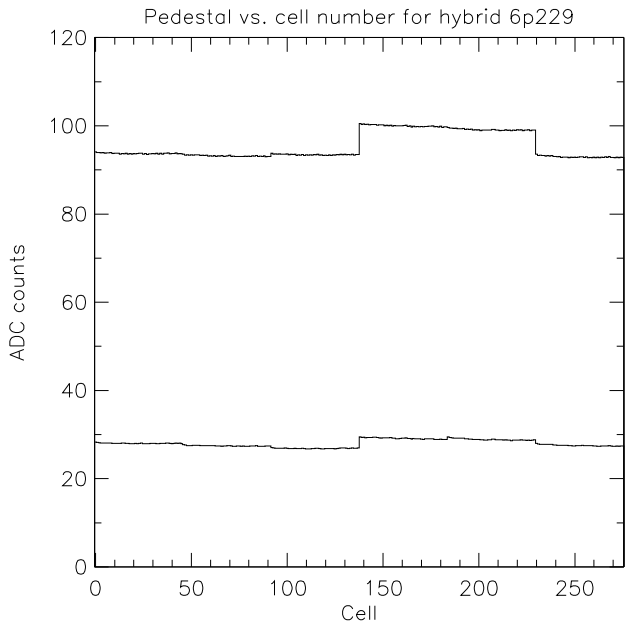
Pedestal vs. Pipeline Cell ID

The following plot shows the average pedestal vs. pipeline cell ID with and without charge injection. The x-axis is cell ID offset by 46 for each chip. Thus cell ID 5 for chip 1 is at x=5, chip 2 at x=51, chip 3 at x=97, etc.

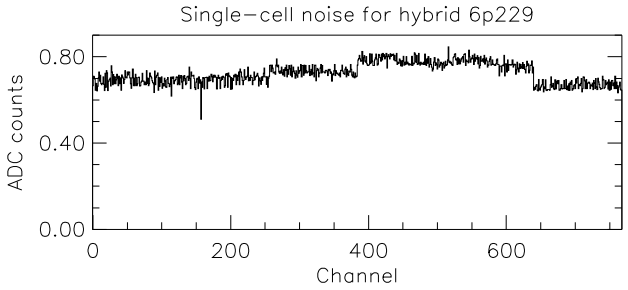
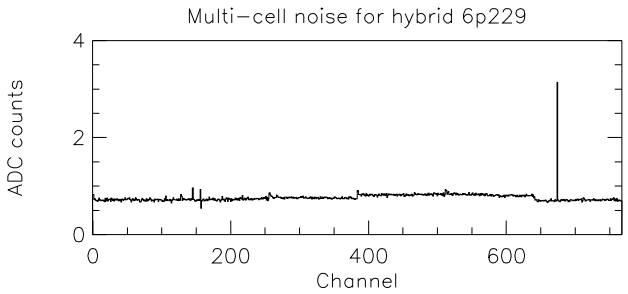
RMS Noise

The following plots show the single-cell and multi-cell RMS noise:

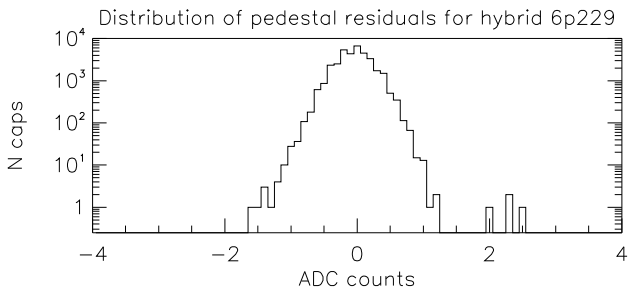
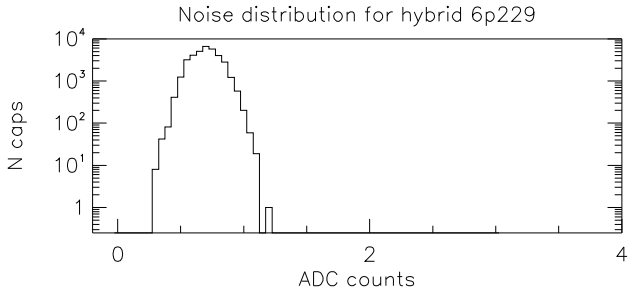
Distribution of Pedestals and Noise

The following are histograms of the pedestal of each pipeline capacitor relative to the chip average (top); and the RMS noise of each capacitor (bottom):

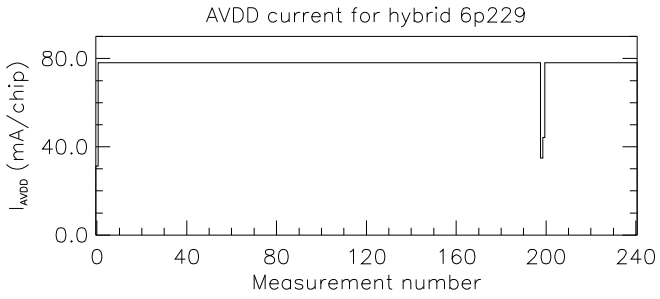
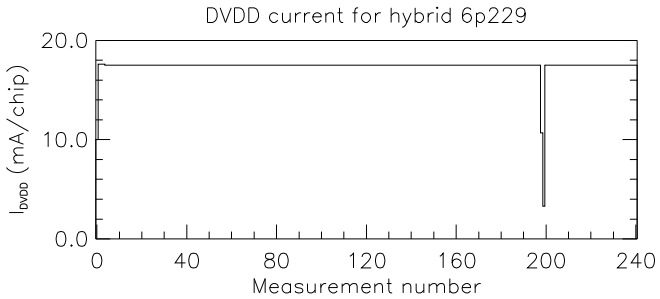
Supply Currents During Burn-in

The following plots show the supply currents per chip as a function of measurment number. Currents are measured approximately every 10 minutes:
