Hybrid 6p232 Traveler

June 8, 2000

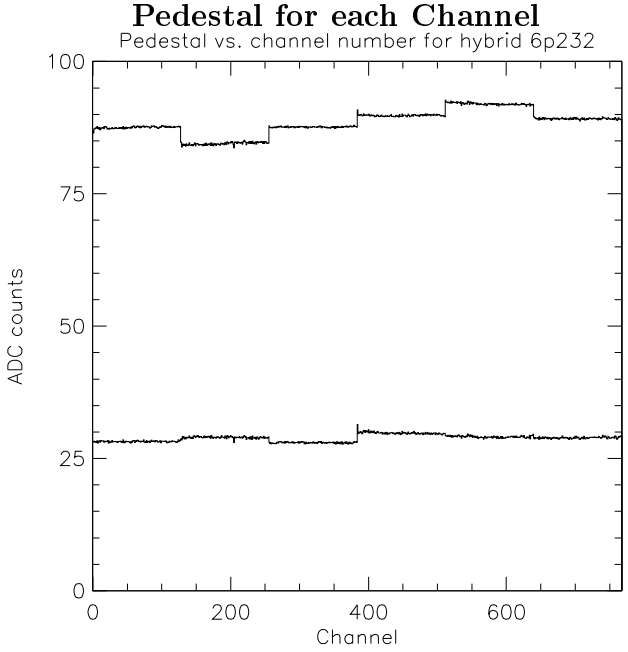
Pedestal for each Channel

The following plot shows the pedestals vs. channel number with and without charge injection:

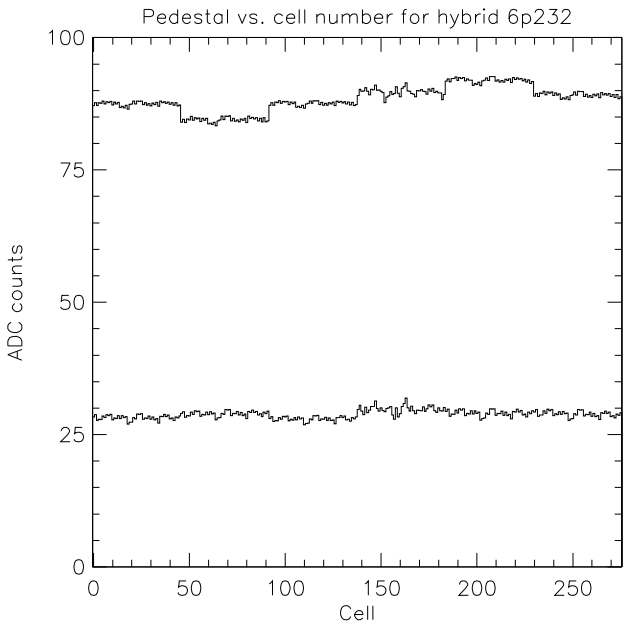
Pedestal vs. Pipeline Cell ID

The following plot shows the average pedestal vs. pipeline cell ID with and without charge injection. The x-axis is cell ID offset by 46 for each chip. Thus cell ID 5 for chip 1 is at x=5, chip 2 at x=51, chip 3 at x=97, etc.

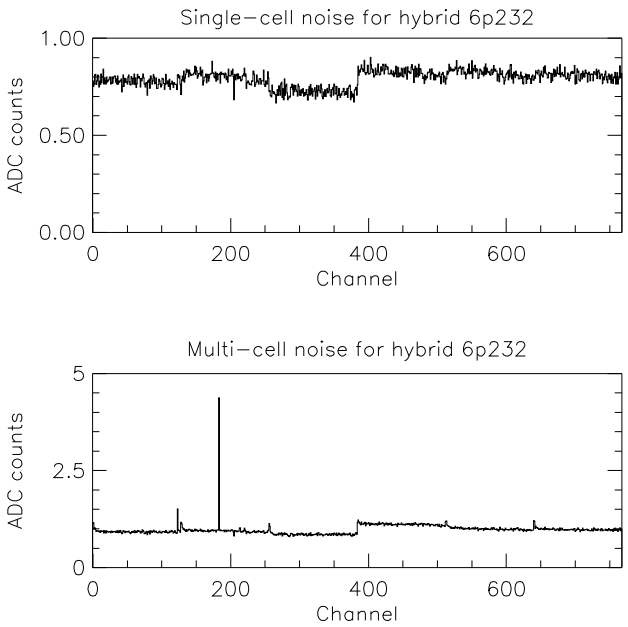
RMS Noise

The following plots show the single-cell and multi-cell RMS noise:

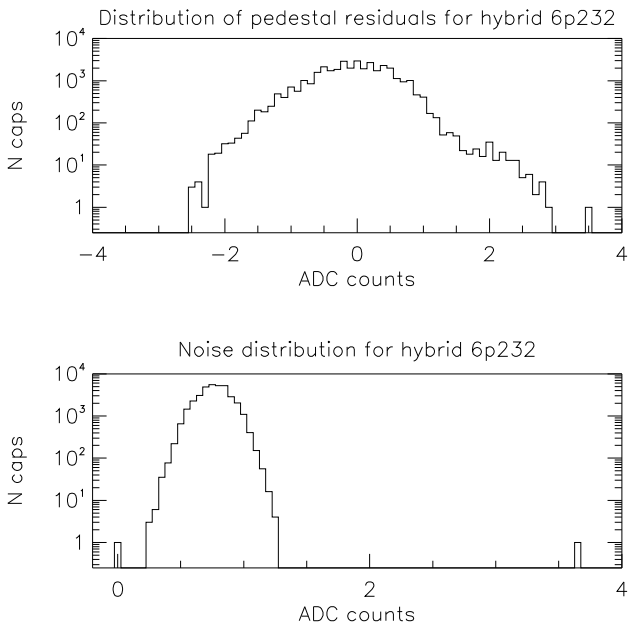
Distribution of Pedestals and Noise

The following are histograms of the pedestal of each pipeline capacitor relative to the chip average (top); and the RMS noise of each capacitor (bottom):

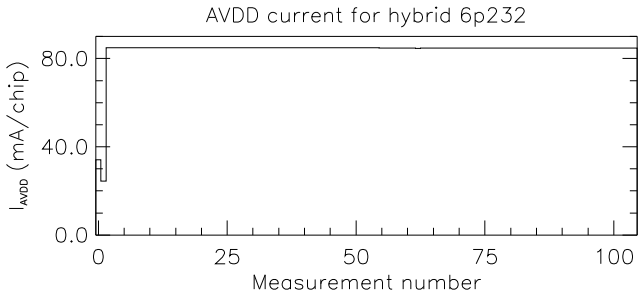
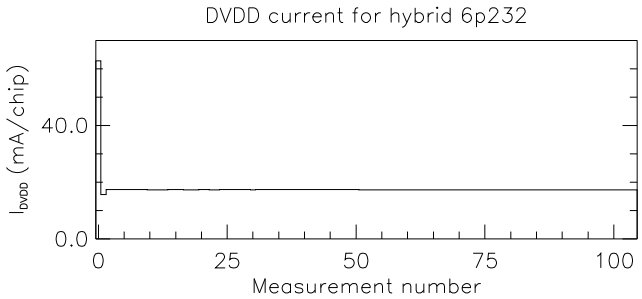
Supply Currents During Burn-in

The following plots show the supply currents per chip as a function of measurment number. Currents are measured approximately every 10 minutes:
