Hybrid 6p76 Traveler

September 27, 1999

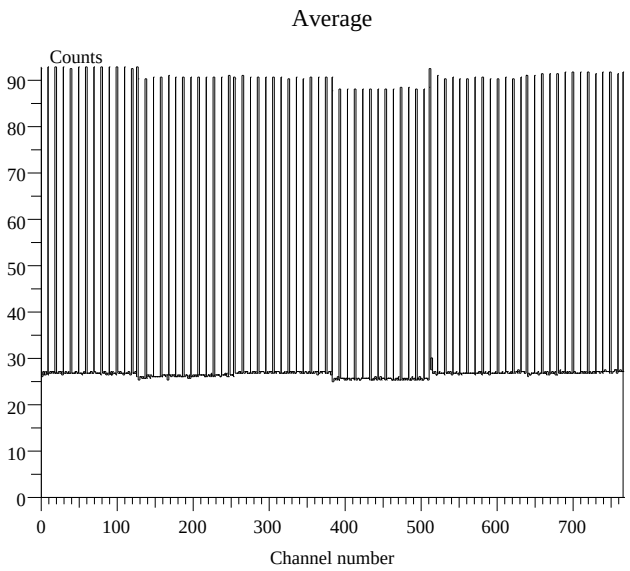
Pedestal

The following plot shows the pedestals vs. channel number

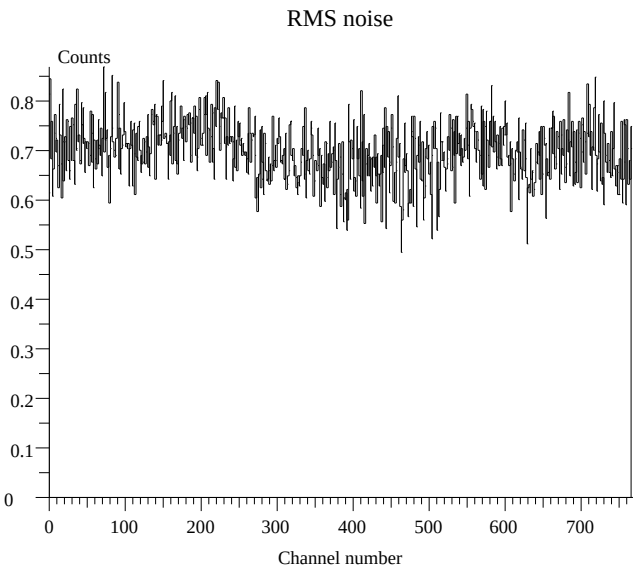
RMS Noise

The following plot shows the single cell RMS noise:

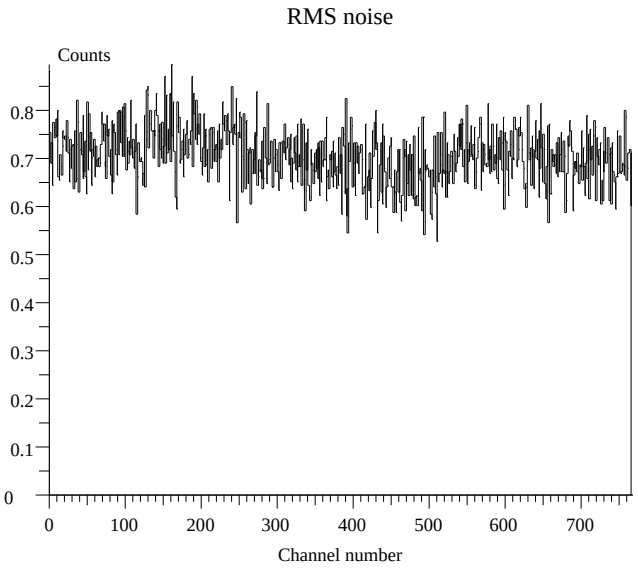
Multi-Cell Noise

The following plot show the multi-cell RMS noise:

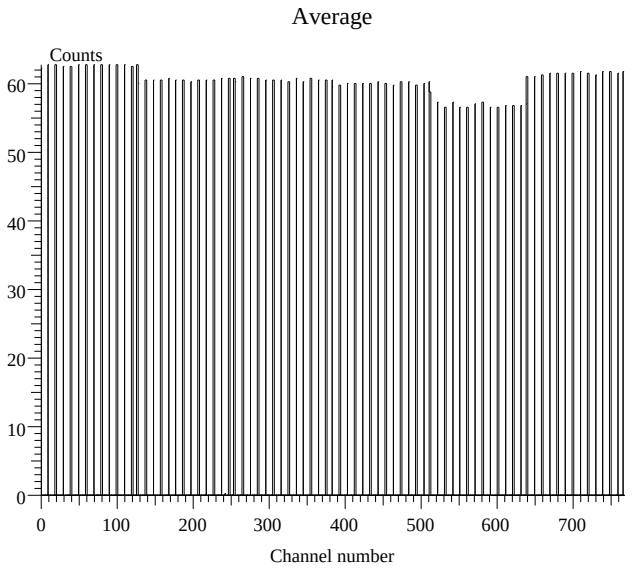
Dynamic Threshold Subtraction

The following plot shows the readout of channels with charge injection with the dynamic threshold subtraction turned on:
