Hybrid 6p82 Traveler

January 18, 2000

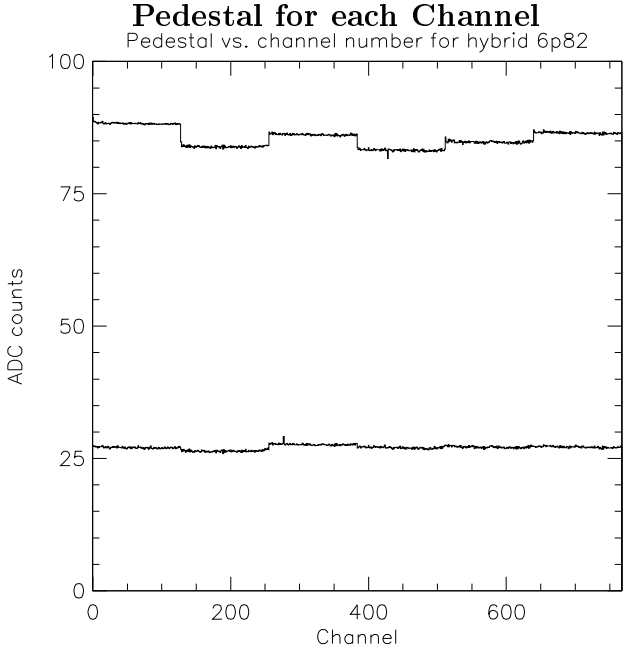
Pedestal for each Channel

Hybrid 6p82 quality: fair
Chip classification: good good fair good good good
Bad channels (chip-channel): 2-21
Bad cells: none
Random bad capacitors: none
Channels at pedestal needed for DCMS: 33.6 34.7 31.8 33.6 34.7 35.6
```
