Hybrid 6p88 Traveler

January 11, 2000

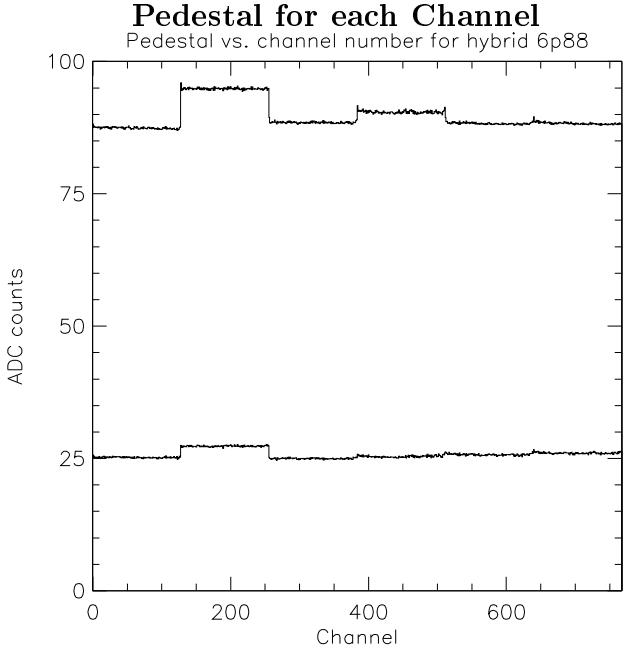
Pedestal for each Channel

The following plot shows the pedestals vs. channel number with and without charge injection:

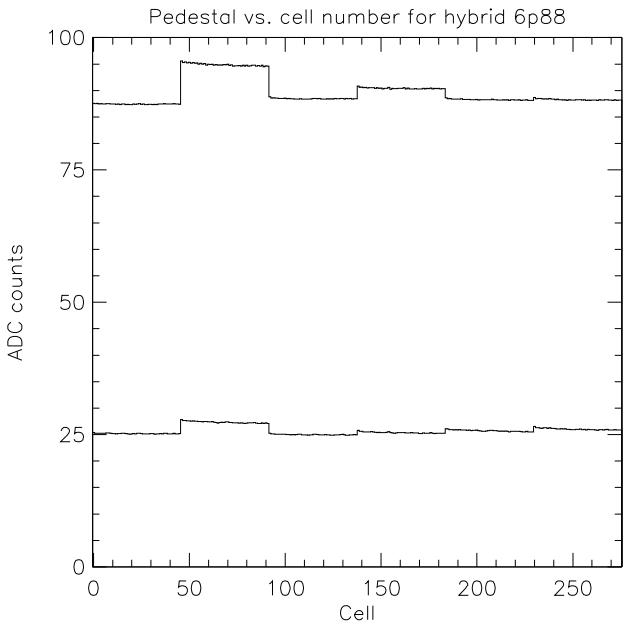
Pedestal vs. Pipeline Cell ID

The following plot shows the average pedestal vs. pipeline cell ID with and without charge injection. The x-axis is cell ID offset by 46 for each chip. Thus cell ID 5 for chip 1 is at x=5, chip 2 at x=51, chip 3 at x=97, etc.

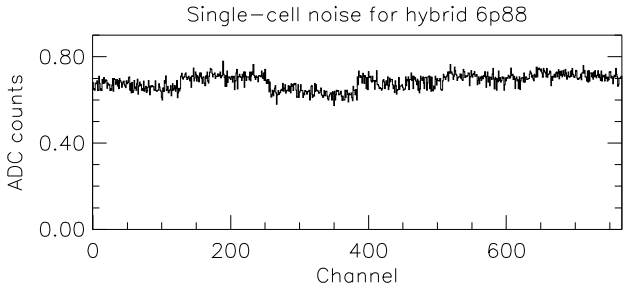
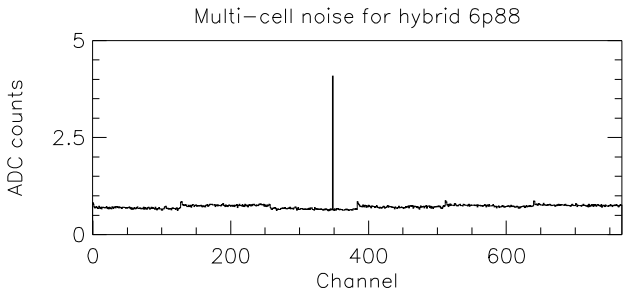
RMS Noise

The following plots show the single-cell and multi-cell RMS noise:

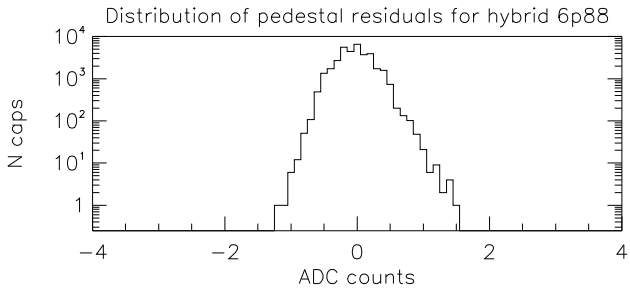
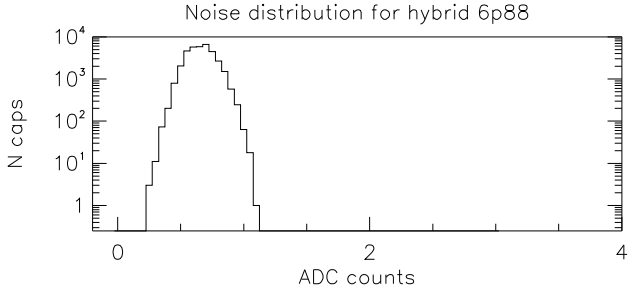
Distribution of Pedestals and Noise

The following are histograms of the pedestal of each pipeline capacitor relative to the chip average (top); and the RMS noise of each capacitor (bottom):

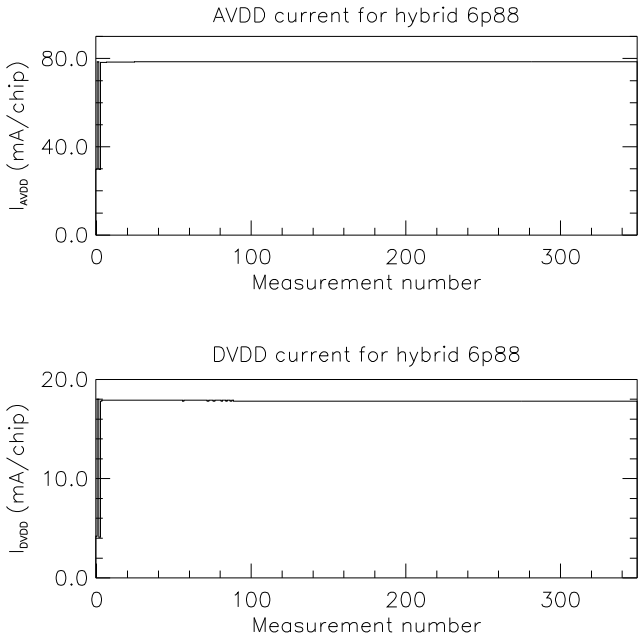
Supply Currents During Burn-in

The following plots show the supply currents per chip as a function of measurment number. Currents are measured approximately every 10 minutes:
