Hybrid 6p96 Traveler

January 7, 2000

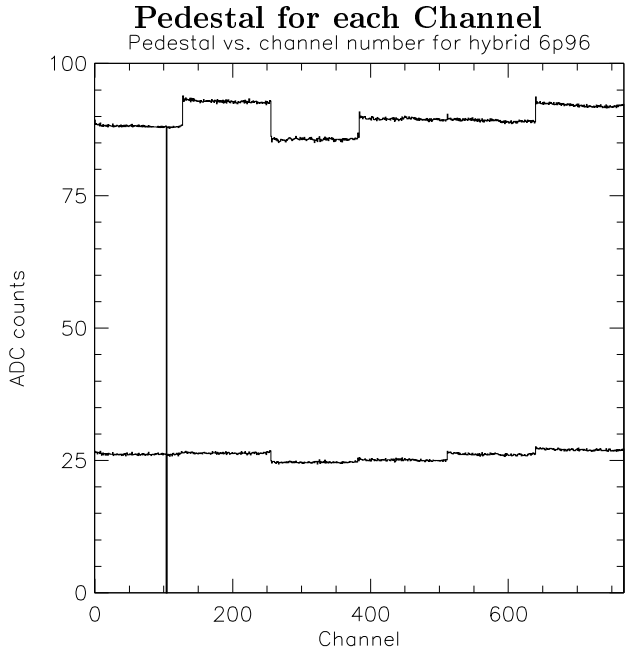
The following plot shows the pedestals vs. channel number with and without charge injection:

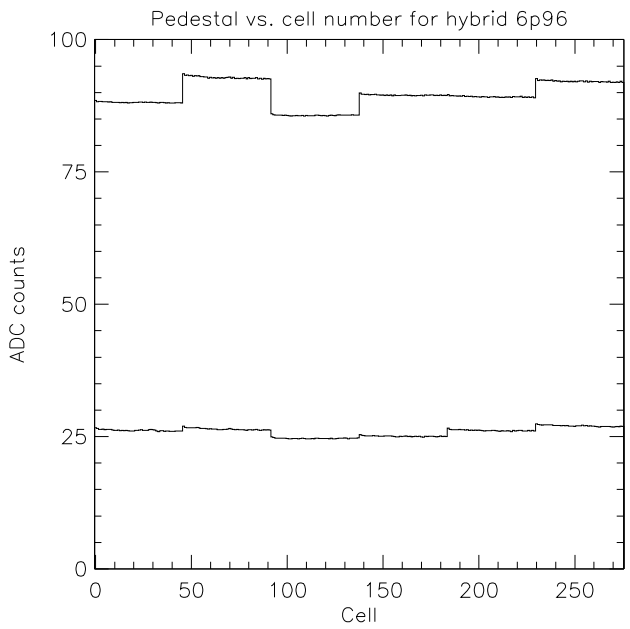
The following plot shows the average pedestal vs. pipeline cell ID with and without charge injection. The x-axis is cell ID offset by 46 for each chip. Thus cell ID 5 for chip 1 is at x=5, chip 2 at x=51, chip 3 at x=97, etc.

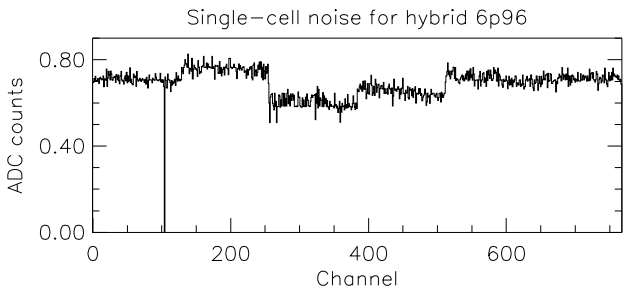
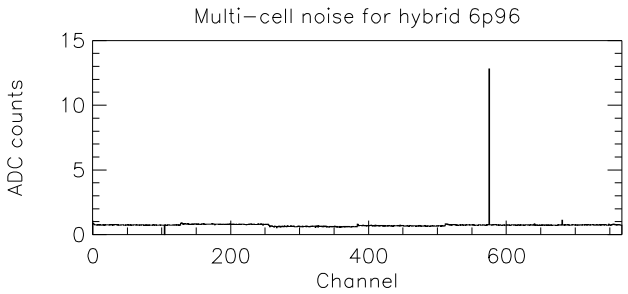
RMS Noise

The following plots show the single-cell and multi-cell RMS noise:

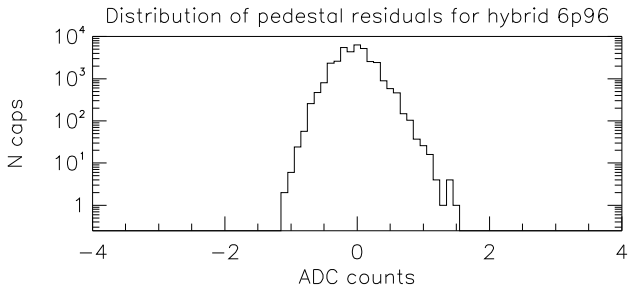
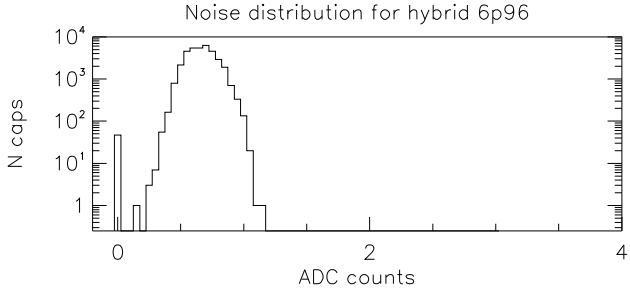
Distribution of Pedestals and Noise

The following are histograms of the pedestal of each pipeline capacitor relative to the chip average (top); and the RMS noise of each capacitor (bottom):

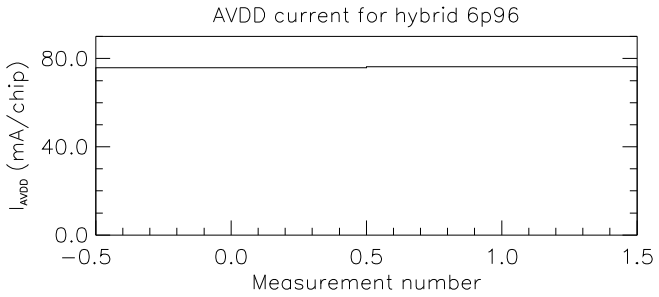
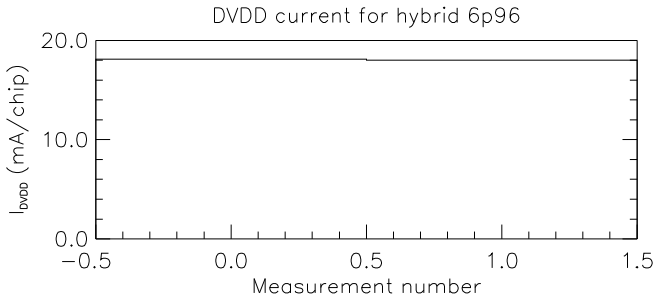
Supply Currents During Burn-in

The following plots show the supply currents per chip as a function of measurment number. Currents are measured approximately every 10 minutes:
