Hybrid 7p131 Traveler

May 30, 2000

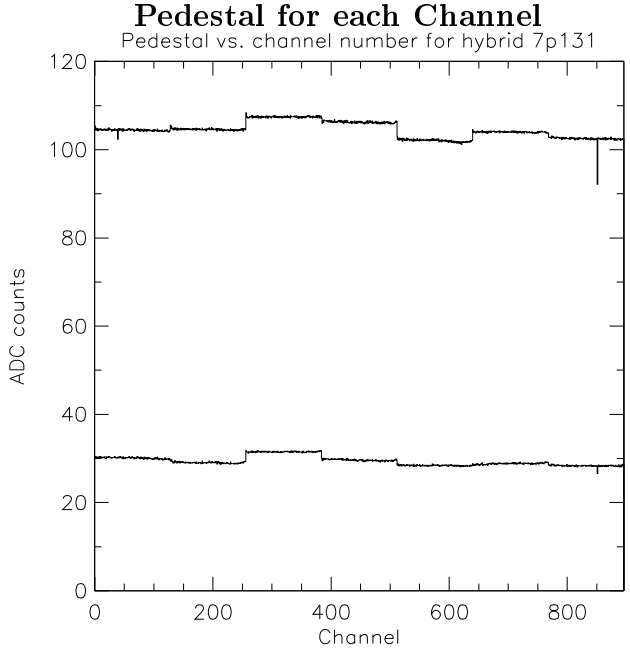
Pedestal for each Channel

Hybrid 7p131 quality: fair*
Chip classification: fair fair fair good good good fair*
Bad channels (chip-channel): 0-47 2-4 6-5 6-67 6-83
Bad cells: none
Random bad capacitors (chip-cell-channel): 1-29-20
Channels at pedestal needed for DCMS: 29.7 30.6 31.6 30.7 29.5 30.5 31.4
```

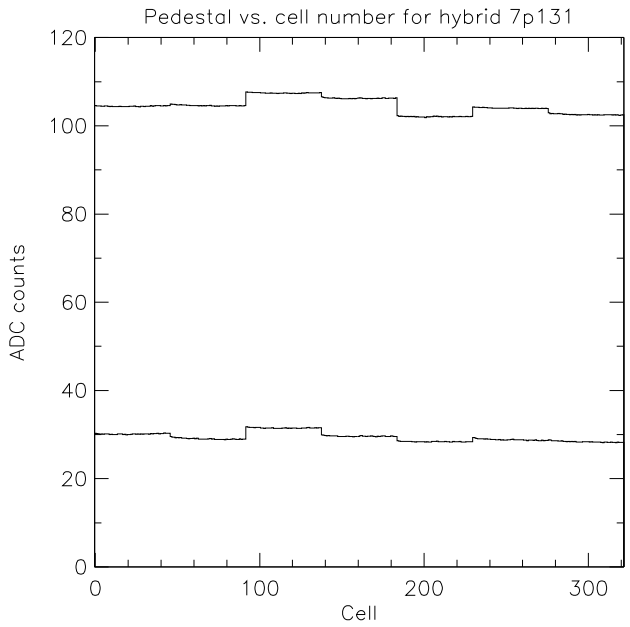
Pedestal vs. Pipeline Cell ID

The following plot shows the average pedestal vs. pipeline cell ID with and without charge injection. The x-axis is cell ID offset by 46 for each chip. Thus cell ID 5 for chip 1 is at x=5, chip 2 at x=51, chip 3 at x=97, etc.

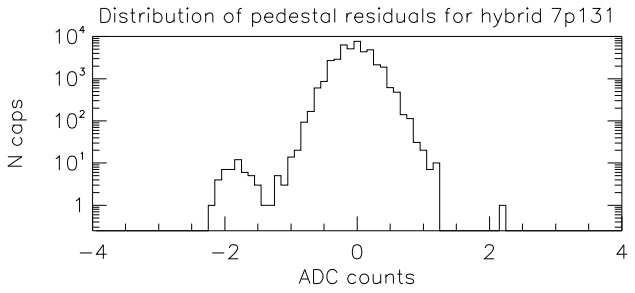
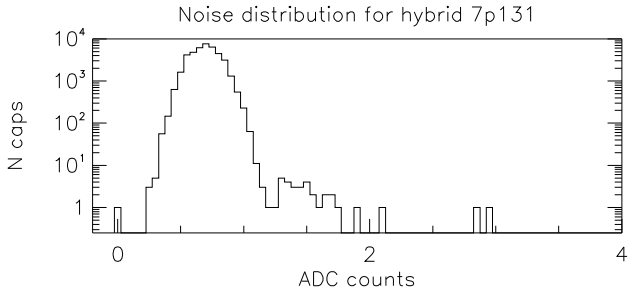
Distribution of Pedestals and Noise

The following are histograms of the pedestal of each pipeline capacitor relative to the chip average (top); and the RMS noise of each capacitor (bottom):

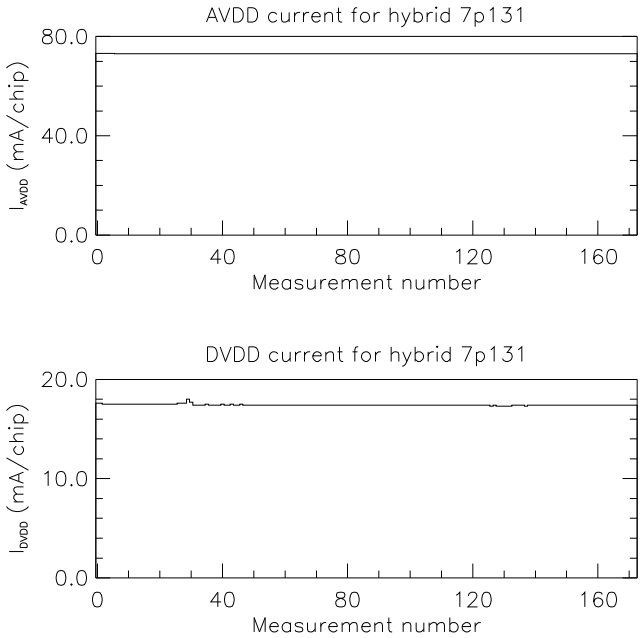
Supply Currents During Burn-in

The following plots show the supply currents per chip as a function of measurment number. Currents are measured approximately every 10 minutes:
