Hybrid 7p141 Traveler

May 24, 2000

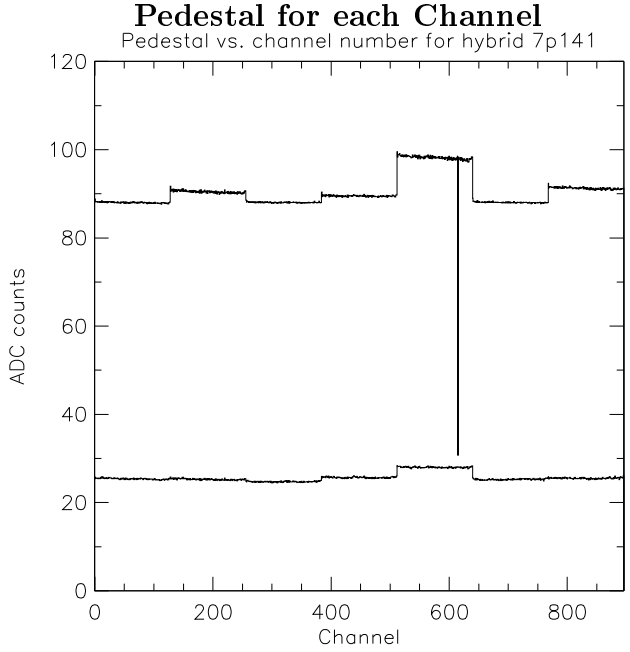
Pedestal for each Channel

The following plot shows the pedestals vs. channel number with and without charge injection:

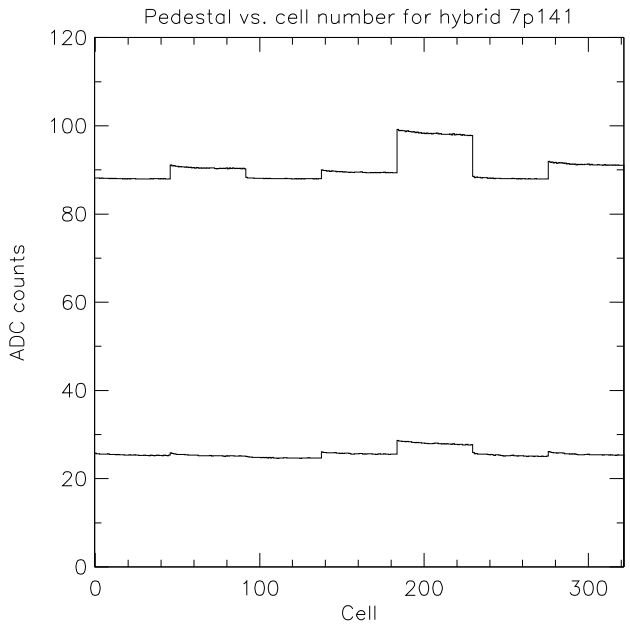
Pedestal vs. Pipeline Cell ID

The following plot shows the average pedestal vs. pipeline cell ID with and without charge injection. The x-axis is cell ID offset by 46 for each chip. Thus cell ID 5 for chip 1 is at x=5, chip 2 at x=51, chip 3 at x=97, etc.

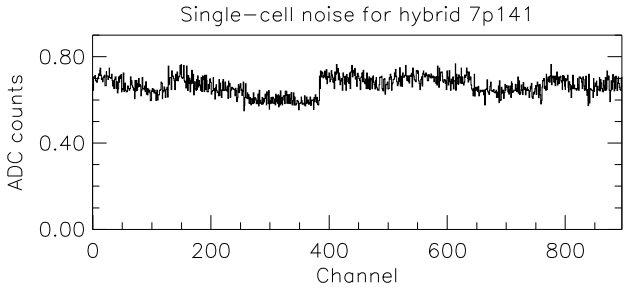
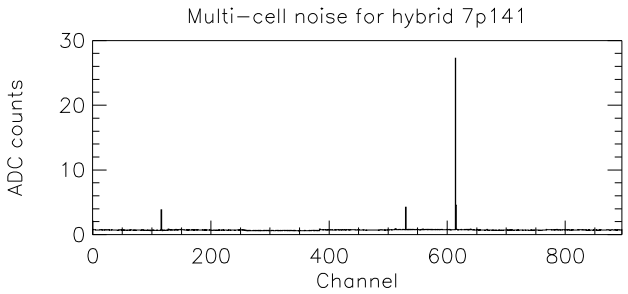
RMS Noise

The following plots show the single-cell and multi-cell RMS noise:

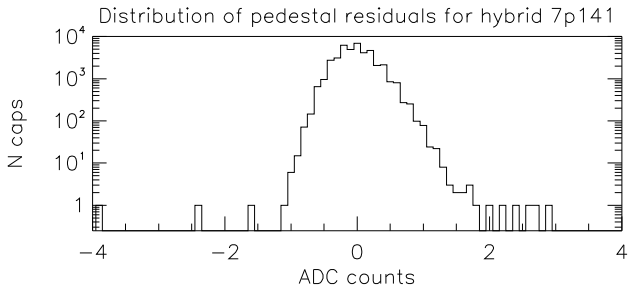
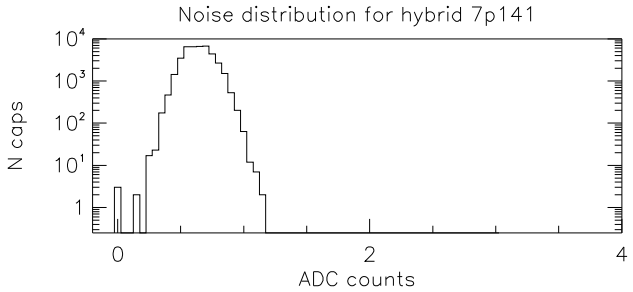
Distribution of Pedestals and Noise

The following are histograms of the pedestal of each pipeline capacitor relative to the chip average (top); and the RMS noise of each capacitor (bottom):

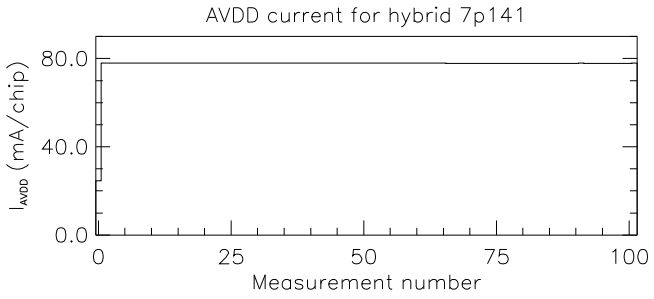
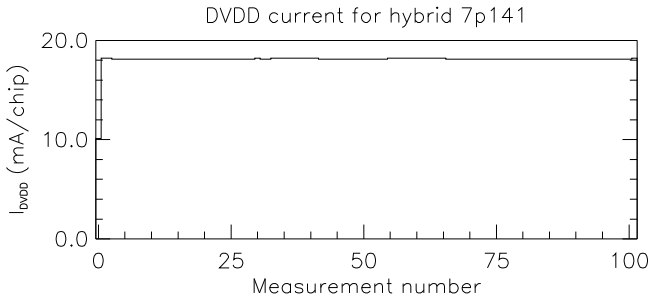
Supply Currents During Burn-in

The following plots show the supply currents per chip as a function of measurment number. Currents are measured approximately every 10 minutes:
