Hybrid 7p142 Traveler

April 14, 2000

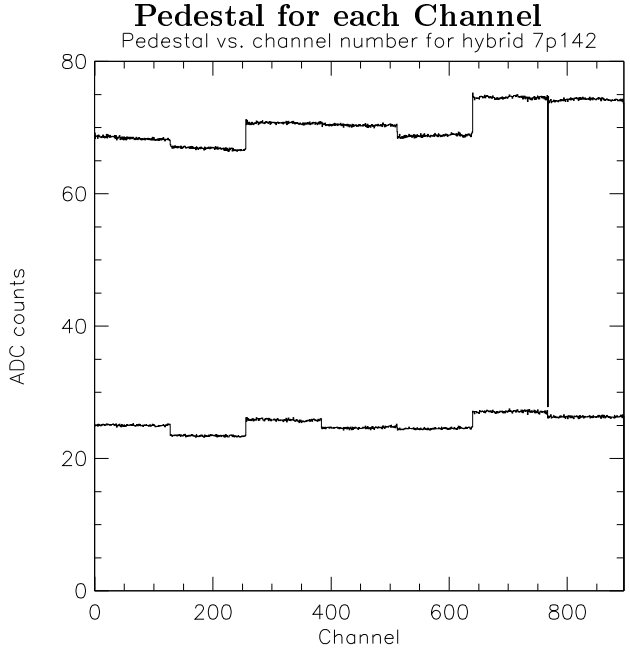
Pedestal for each Channel

The following plot shows the pedestals vs. channel number with and without charge injection:

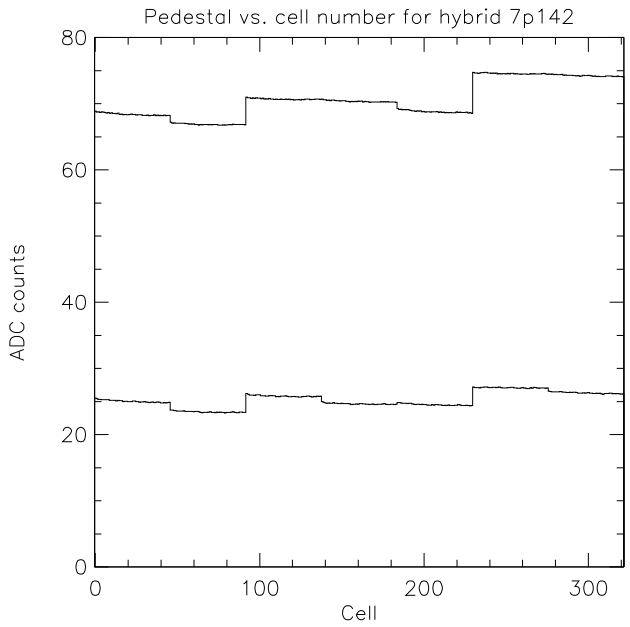
Pedestal vs. Pipeline Cell ID

The following plot shows the average pedestal vs. pipeline cell ID with and without charge injection. The x-axis is cell ID offset by 46 for each chip. Thus cell ID 5 for chip 1 is at x=5, chip 2 at x=51, chip 3 at x=97, etc.

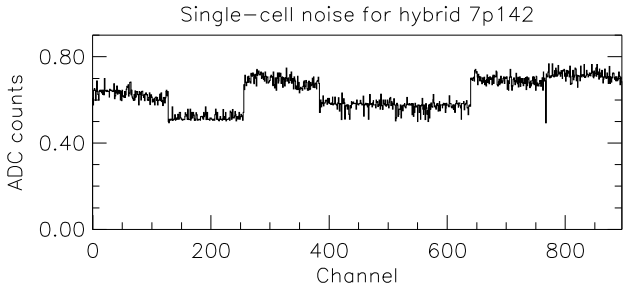
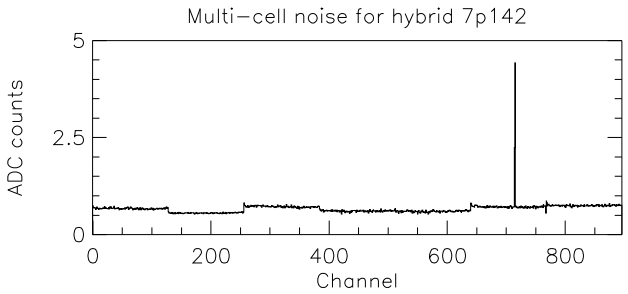
RMS Noise

The following plots show the single-cell and multi-cell RMS noise:

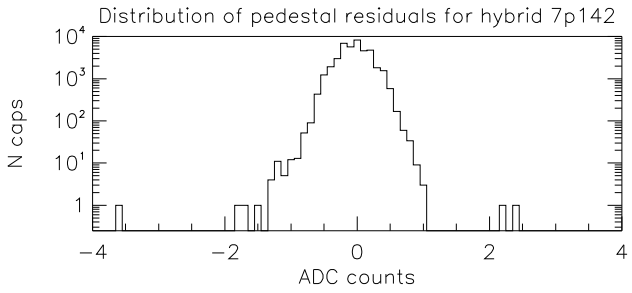
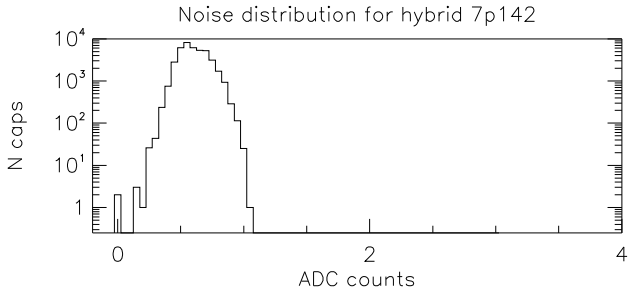
Distribution of Pedestals and Noise

The following are histograms of the pedestal of each pipeline capacitor relative to the chip average (top); and the RMS noise of each capacitor (bottom):

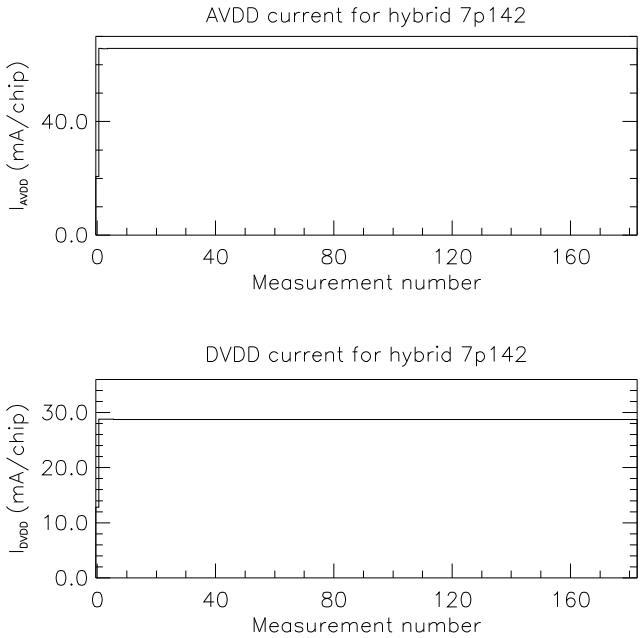
Supply Currents During Burn-in

The following plots show the supply currents per chip as a function of measurment number. Currents are measured approximately every 10 minutes:
