Hybrid 7p165 Traveler

February 10, 2000

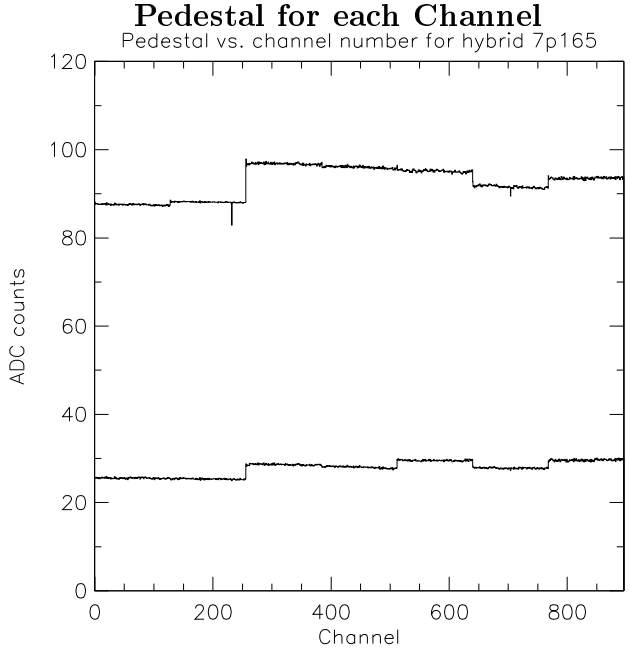
Pedestal for each Channel

The following plot shows the pedestals vs. channel number with and without charge injection:

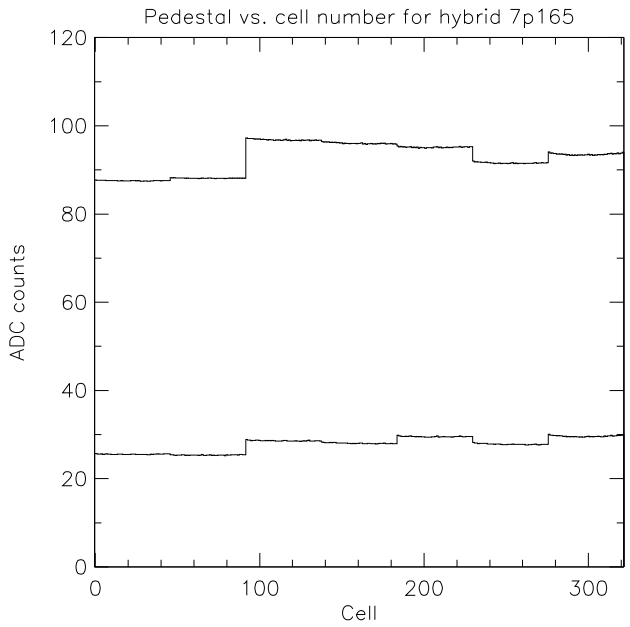
Pedestal vs. Pipeline Cell ID

The following plot shows the average pedestal vs. pipeline cell ID with and without charge injection. The x-axis is cell ID offset by 46 for each chip. Thus cell ID 5 for chip 1 is at x=5, chip 2 at x=51, chip 3 at x=97, etc.

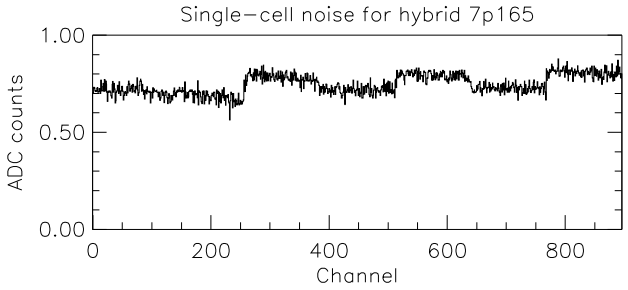
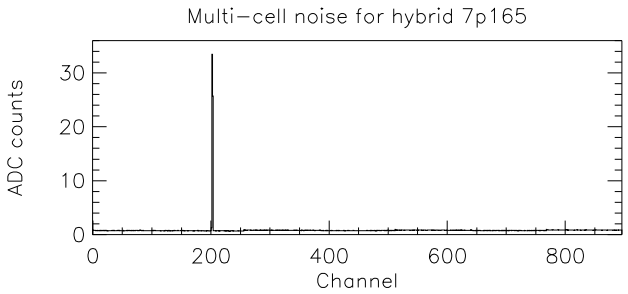
RMS Noise

The following plots show the single-cell and multi-cell RMS noise:

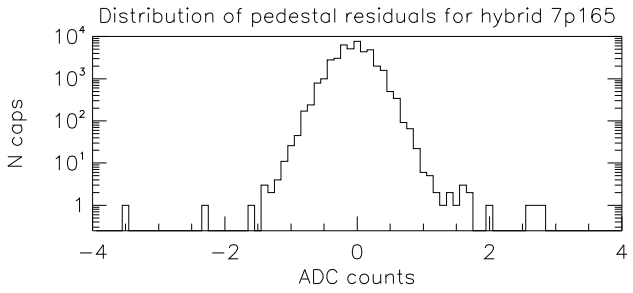
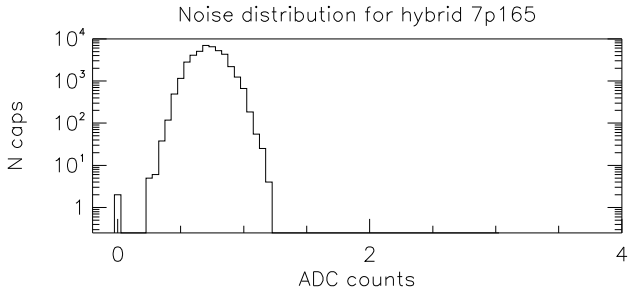
Distribution of Pedestals and Noise

The following are histograms of the pedestal of each pipeline capacitor relative to the chip average (top); and the RMS noise of each capacitor (bottom):

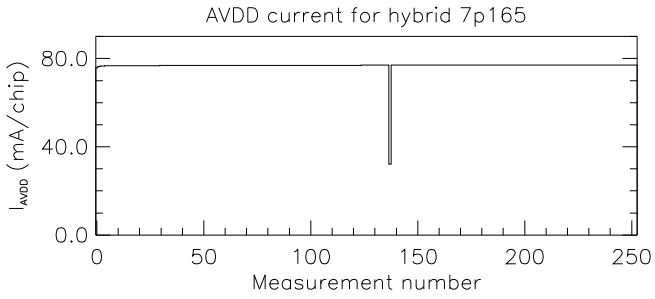
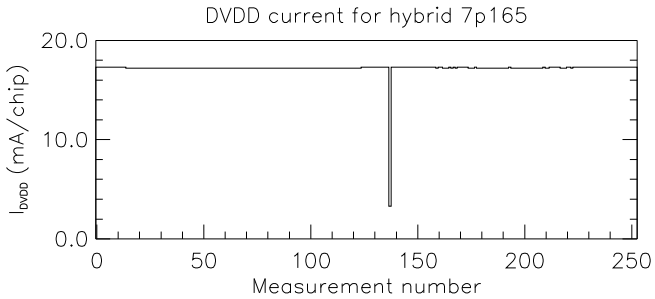
Supply Currents During Burn-in

The following plots show the supply currents per chip as a function of measurment number. Currents are measured approximately every 10 minutes:
