Hybrid 7p179 Traveler

February 9, 2000

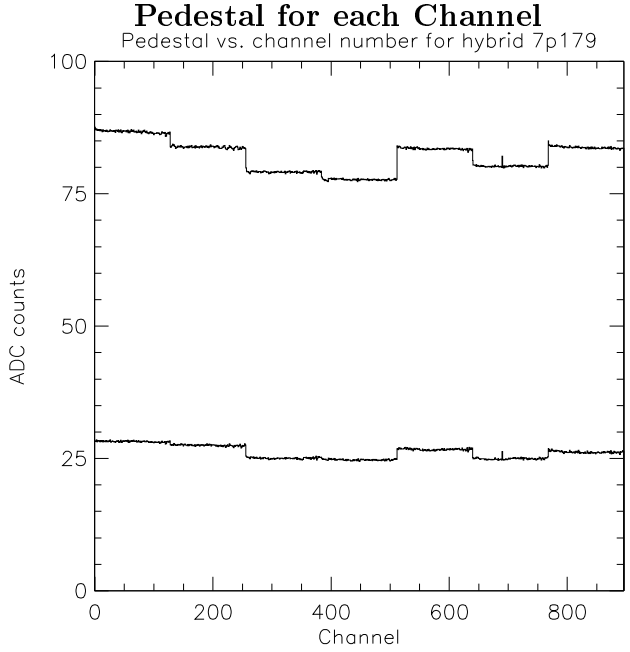
Pedestal for each Channel

Hybrid 7p179 quality: fair
Chip classification: good good good good good fair good
Bad channels (chip-channel): 5-50
Bad cells: none
Random bad capacitors (chip-cell-channel): 5-35-50 5-40-50 5-41-50
   5-42-50 5-43-50 5-44-50
Channels at pedestal needed for DCMS: 31.7 31.7 31.6 33.6 31.5 31.7 29.6
```

The following plot shows the pedestals vs. channel number with and without charge injection:

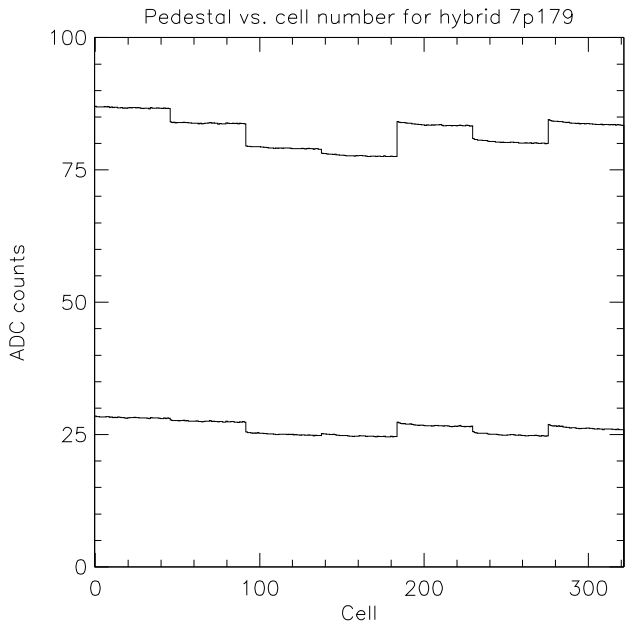
Pedestal vs. Pipeline Cell ID

The following plot shows the average pedestal vs. pipeline cell ID with and without charge injection. The x-axis is cell ID offset by 46 for each chip. Thus cell ID 5 for chip 1 is at x=5, chip 2 at x=51, chip 3 at x=97, etc.

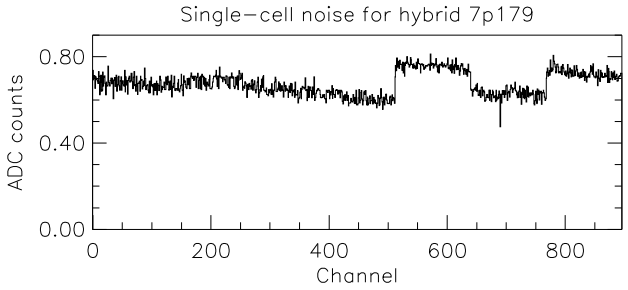
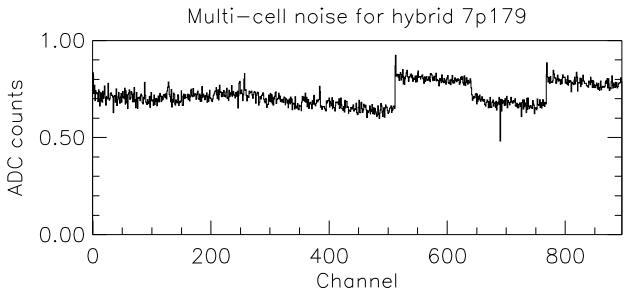
RMS Noise

The following plots show the single-cell and multi-cell RMS noise:

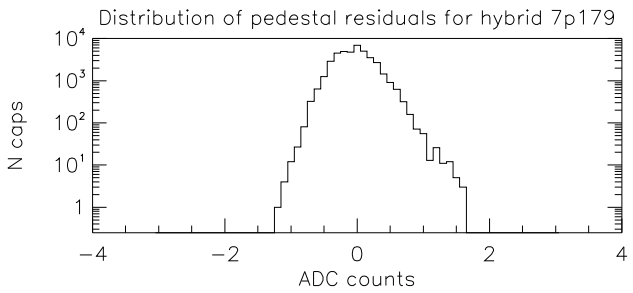
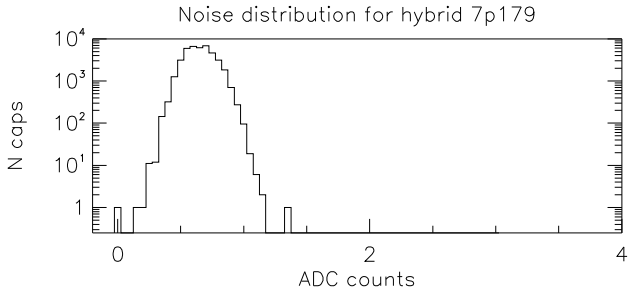
Distribution of Pedestals and Noise

The following are histograms of the pedestal of each pipeline capacitor relative to the chip average (top); and the RMS noise of each capacitor (bottom):

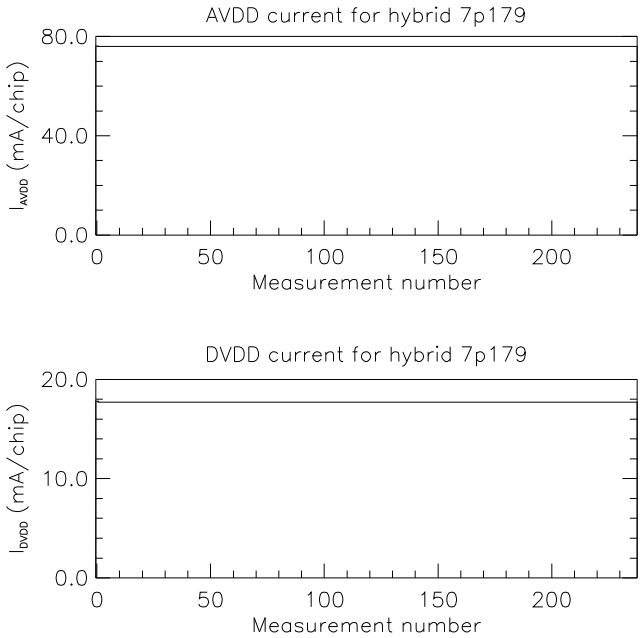
Supply Currents During Burn-in

The following plots show the supply currents per chip as a function of measurment number. Currents are measured approximately every 10 minutes:
