Hybrid 7p29 Traveler

June 27, 2000

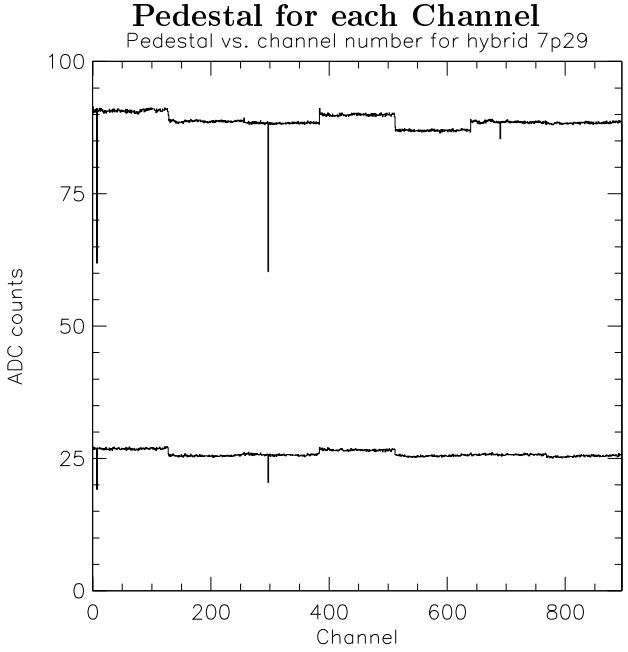
Pedestal for each Channel

The following plot shows the pedestals vs. channel number with and without charge injection:

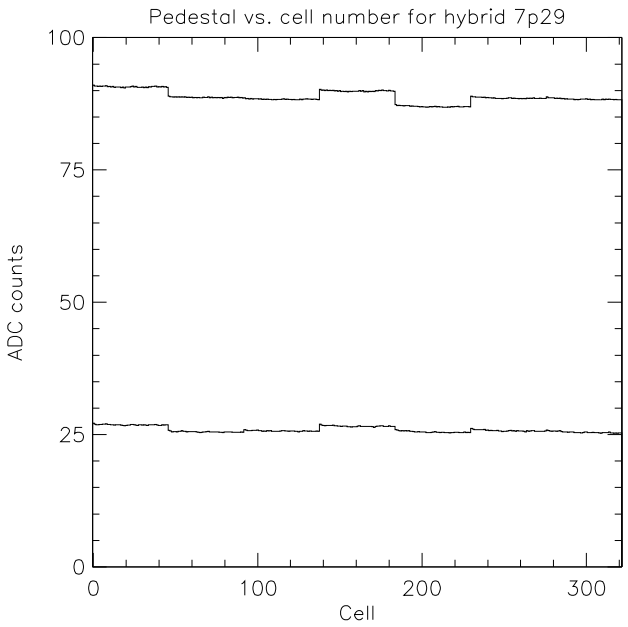
Pedestal vs. Pipeline Cell ID

The following plot shows the average pedestal vs. pipeline cell ID with and without charge injection. The x-axis is cell ID offset by 46 for each chip. Thus cell ID 5 for chip 1 is at x=5, chip 2 at x=51, chip 3 at x=97, etc.

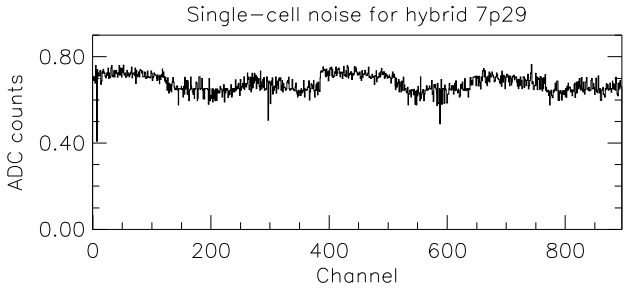
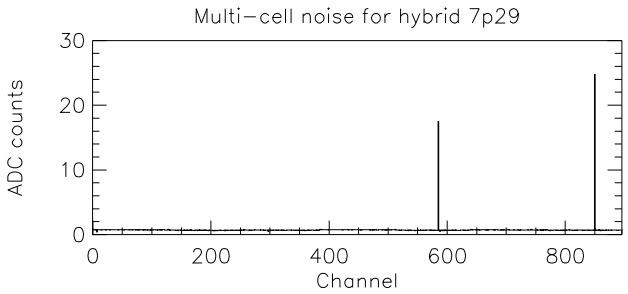
RMS Noise

The following plots show the single-cell and multi-cell RMS noise:

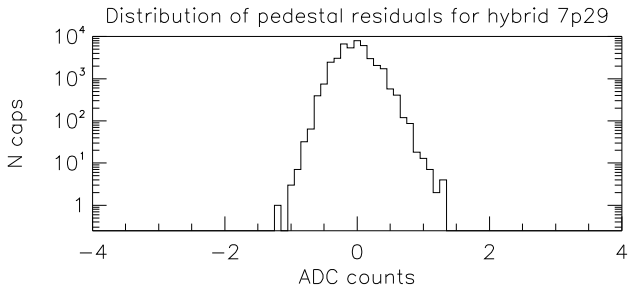
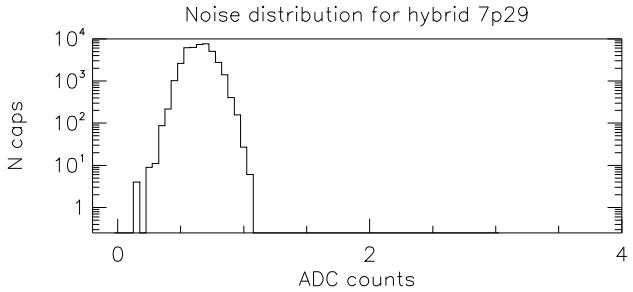
Distribution of Pedestals and Noise

The following are histograms of the pedestal of each pipeline capacitor relative to the chip average (top); and the RMS noise of each capacitor (bottom):

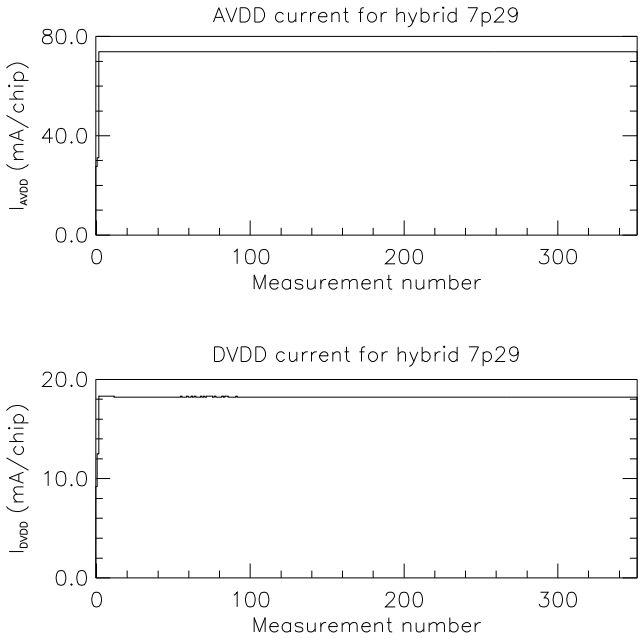
Supply Currents During Burn-in

The following plots show the supply currents per chip as a function of measurment number. Currents are measured approximately every 10 minutes:
