Hybrid 7p70 Traveler

June 19, 2000

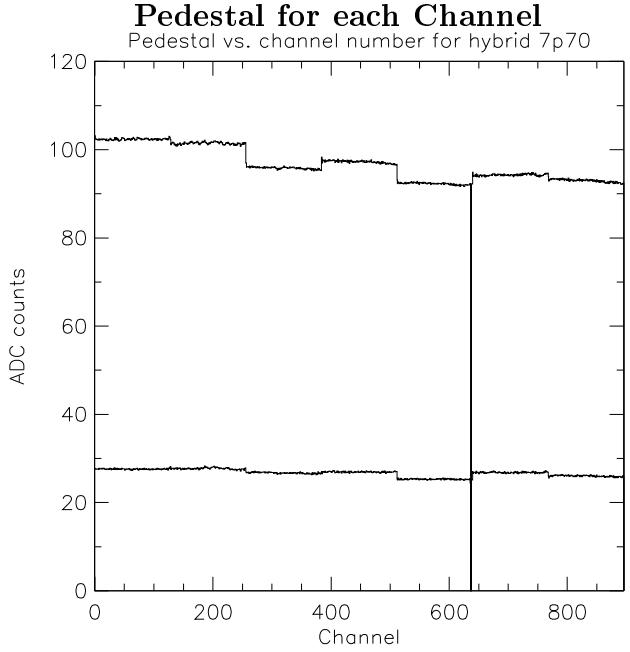
Pedestal for each Channel

Hybrid 7p70 quality: fair
Chip classification: good good good good fair good good
Bad channels (chip-channel): 4-125
Bad cells: none
Random bad capacitors (chip-cell-channel): 4-13-52 4-13-53 4-14-53
Channels at pedestal needed for DCMS: 31.6 32.7 34.6 31.6 32.6 32.6 33.8
```
