Hybrid 7p75 Traveler

June 15, 2000

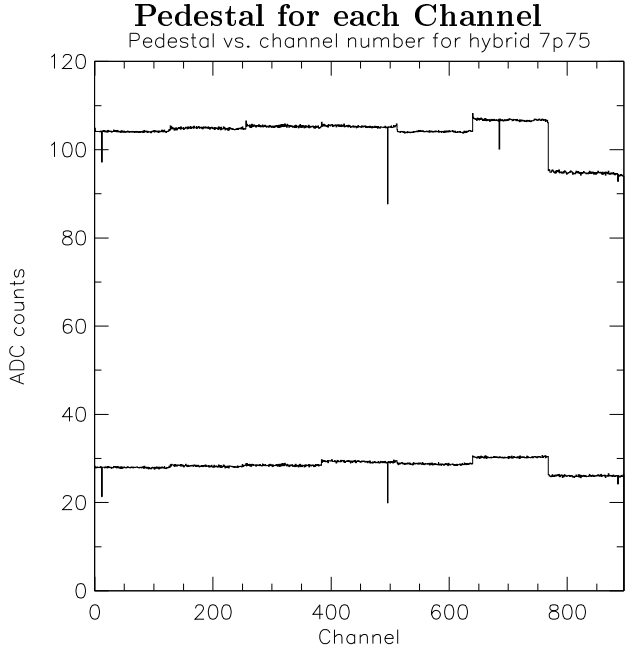
Pedestal for each Channel

The following plot shows the pedestals vs. channel number with and without charge injection:

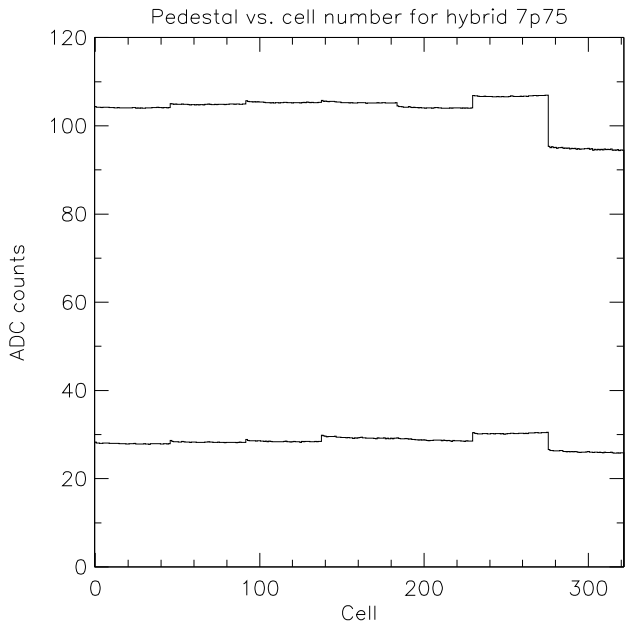
Pedestal vs. Pipeline Cell ID

The following plot shows the average pedestal vs. pipeline cell ID with and without charge injection. The x-axis is cell ID offset by 46 for each chip. Thus cell ID 5 for chip 1 is at x=5, chip 2 at x=51, chip 3 at x=97, etc.

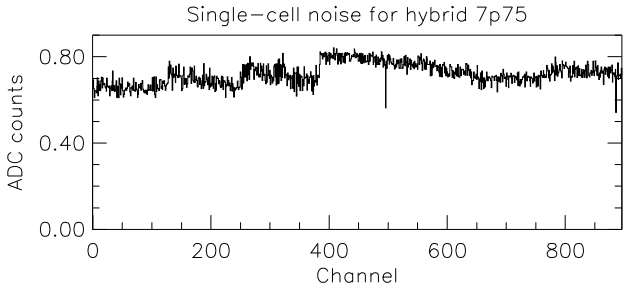
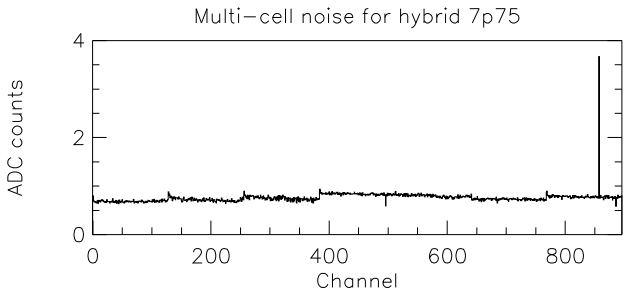
RMS Noise

The following plots show the single-cell and multi-cell RMS noise:

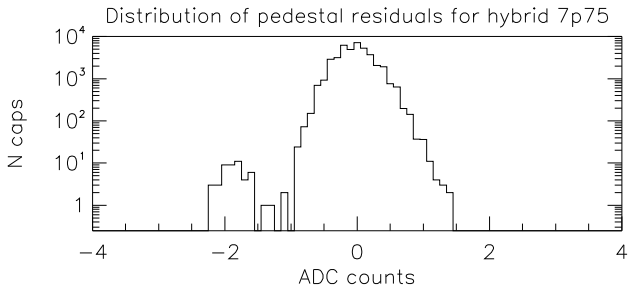
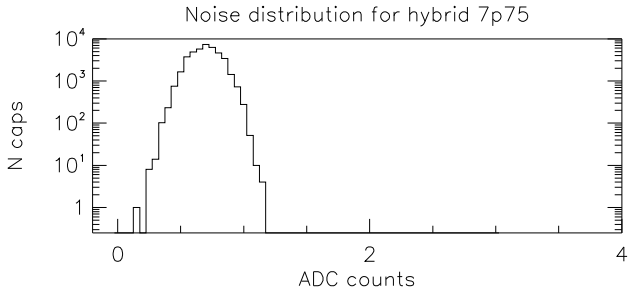
Distribution of Pedestals and Noise

The following are histograms of the pedestal of each pipeline capacitor relative to the chip average (top); and the RMS noise of each capacitor (bottom):

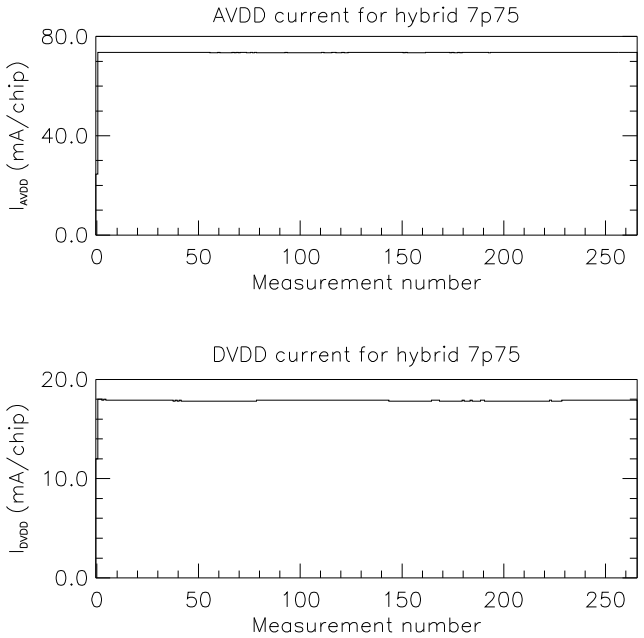
Supply Currents During Burn-in

The following plots show the supply currents per chip as a function of measurment number. Currents are measured approximately every 10 minutes:
