# Hybrid 7p80 Traveler

June 8, 2000

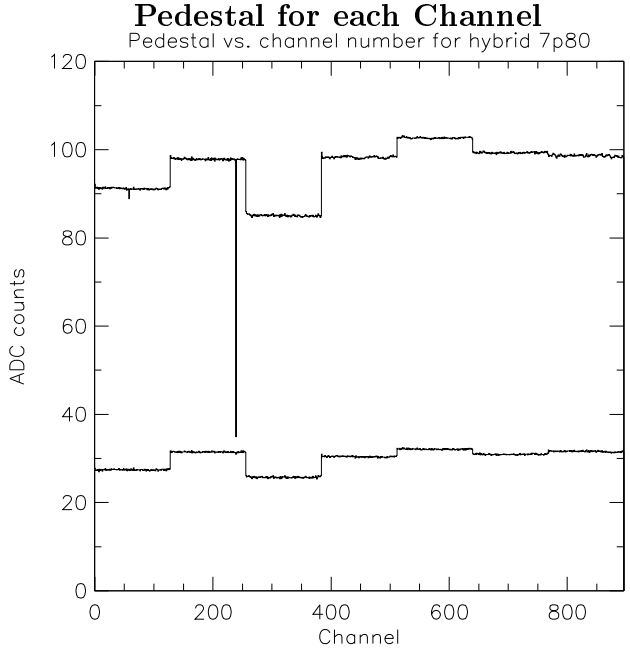
**Pedestal for each Channel**

The following plot shows the pedestals vs. channel number with and without charge injection:

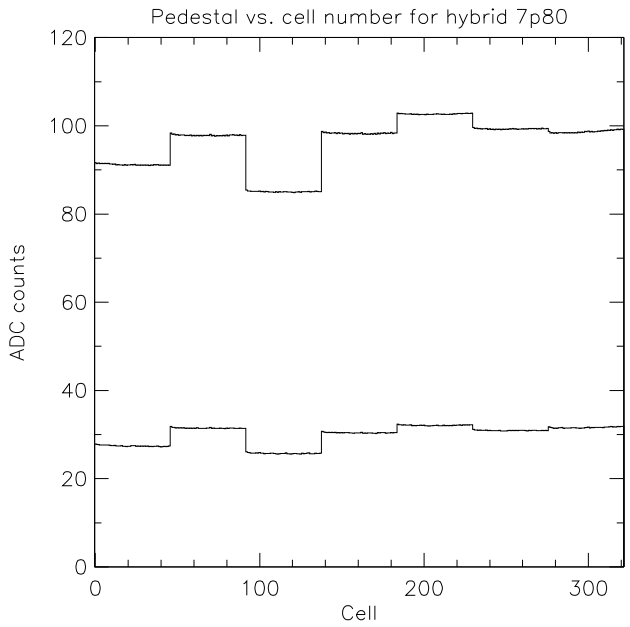
**Pedestal vs. Pipeline Cell ID**

The following plot shows the average pedestal vs. pipeline cell ID with and without charge injection. The x-axis is cell ID offset by 46 for each chip. Thus cell ID 5 for chip 1 is at x=5, chip 2 at x=51, chip 3 at x=97, etc.

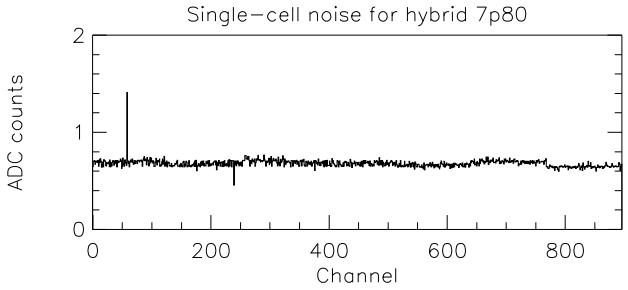
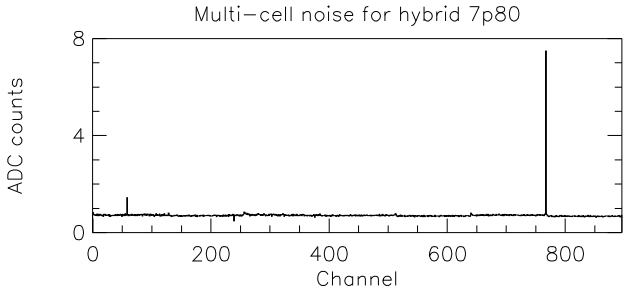
**RMS Noise**

The following plots show the single-cell and multi-cell RMS noise:

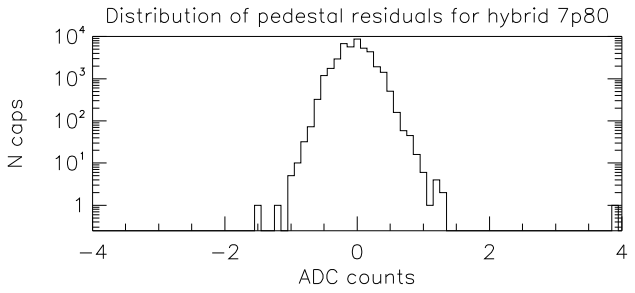
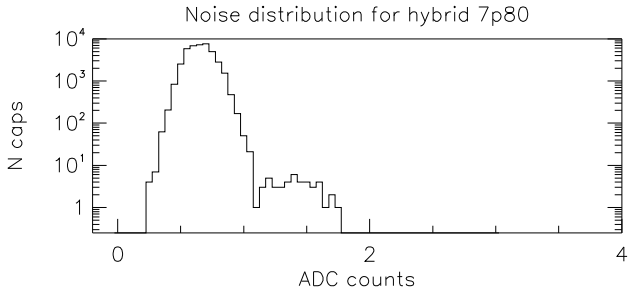
**Distribution of Pedestals and Noise**

The following are histograms of the pedestal of each pipeline capacitor relative to the chip average (top); and the RMS noise of each capacitor (bottom):

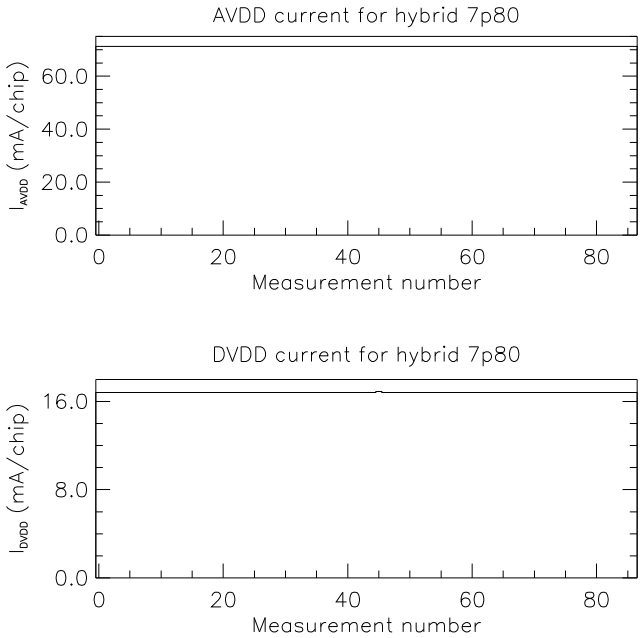
**Supply Currents During Burn-in**

The following plots show the supply currents per chip as a function of measurment number. Currents are measured approximately every 10 minutes:
