Hybrid 7p98 Traveler

June 5, 2000

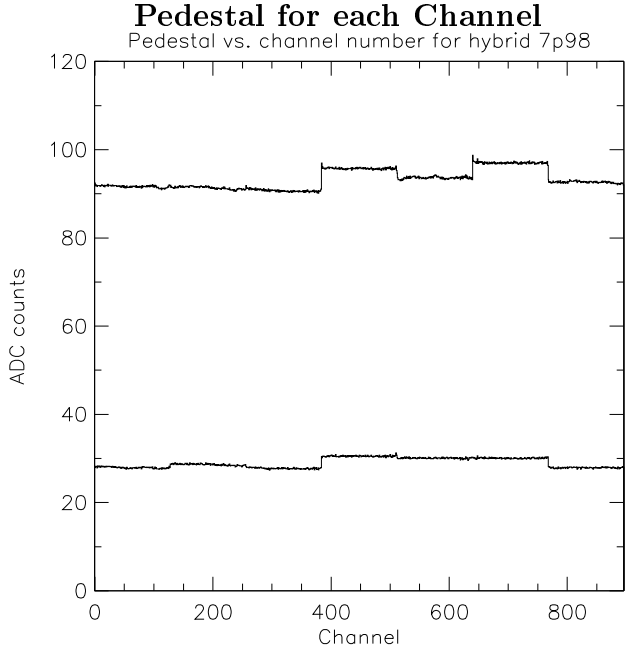
Pedestal for each Channel

The following plot shows the pedestals vs. channel number with and without charge injection:

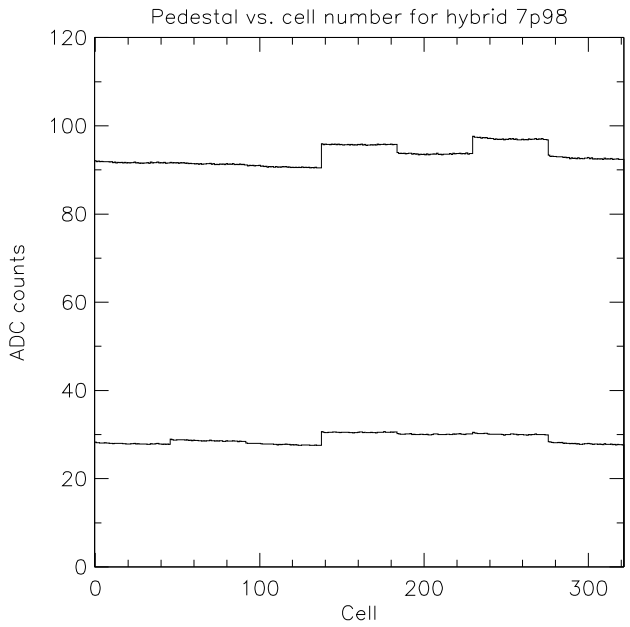
Pedestal vs. Pipeline Cell ID

The following plot shows the average pedestal vs. pipeline cell ID with and without charge injection. The x-axis is cell ID offset by 46 for each chip. Thus cell ID 5 for chip 1 is at x=5, chip 2 at x=51, chip 3 at x=97, etc.

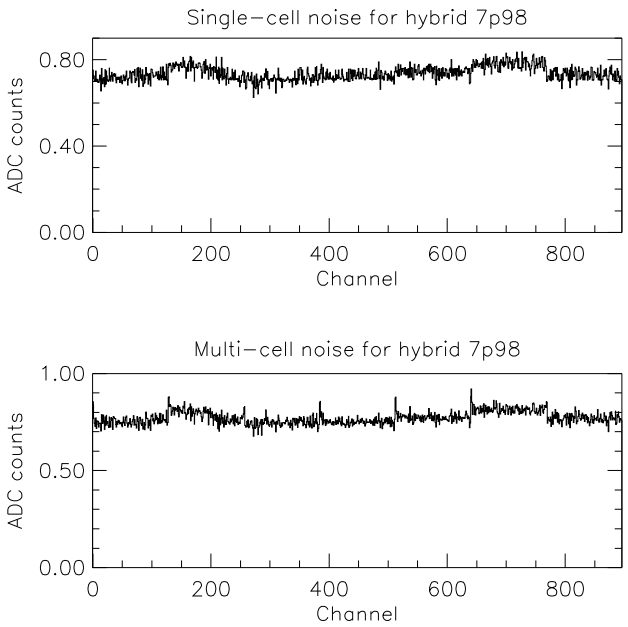
RMS Noise

The following plots show the single-cell and multi-cell RMS noise:

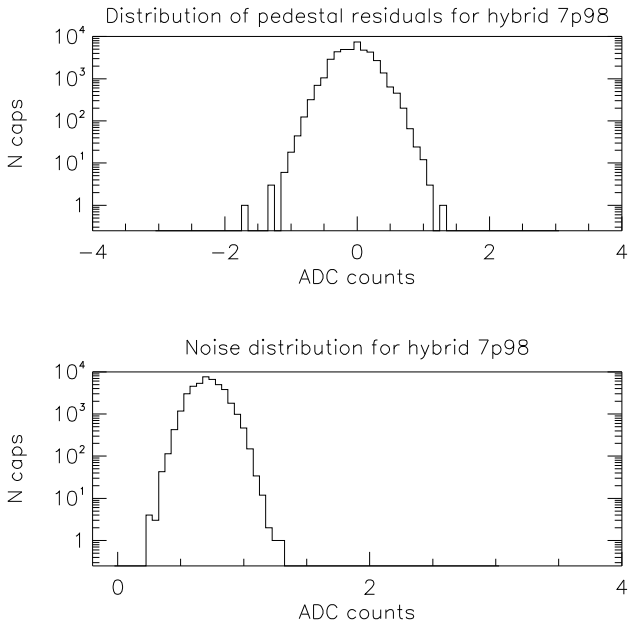
Distribution of Pedestals and Noise

The following are histograms of the pedestal of each pipeline capacitor relative to the chip average (top); and the RMS noise of each capacitor (bottom):

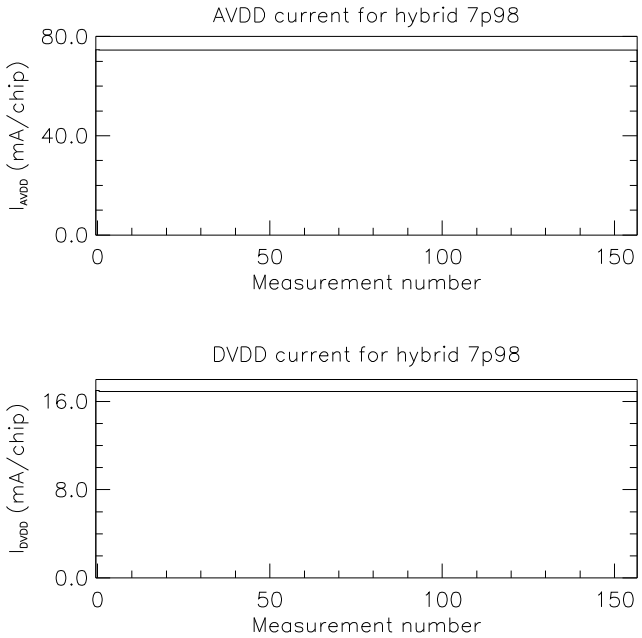
Supply Currents During Burn-in

The following plots show the supply currents per chip as a function of measurment number. Currents are measured approximately every 10 minutes:
