Hybrid 7z117 Traveler

May 24, 2000

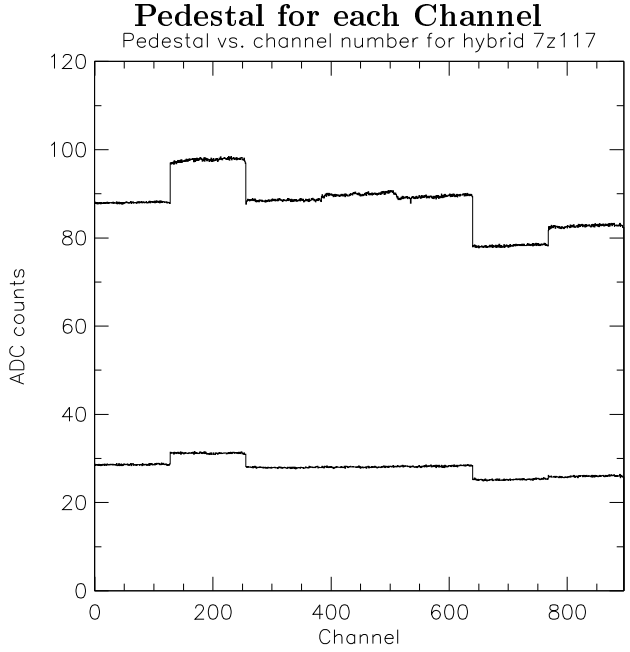
Pedestal for each Channel

Hybrid 7z117 quality: fair
Chip classification: good good good good fair good good
Bad channels (chip-channel): 4-23
Bad cells: none
Random bad capacitors: none
Channels at pedestal needed for DCMS: 34.7 31.7 32.6 34.3 34.7 36.6 33.7
```
