Hybrid 7z123 Traveler

July 19, 2000

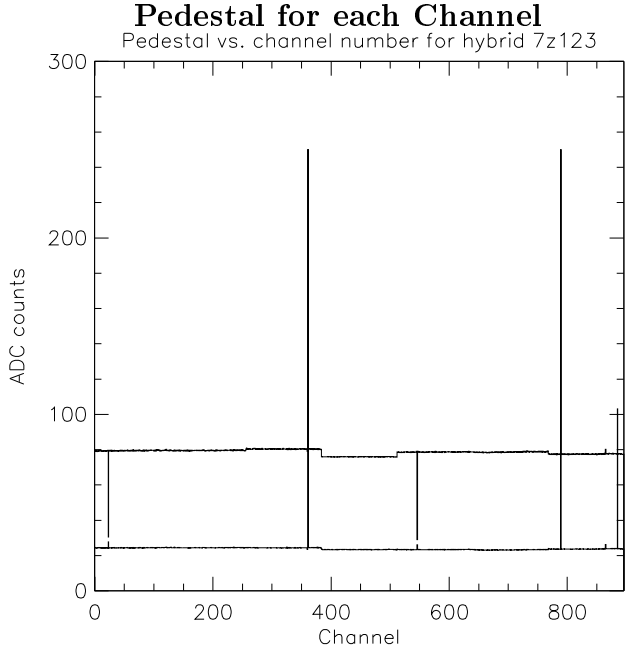
Pedestal for each Channel

The following plot shows the pedestals vs. channel number with and without charge injection:

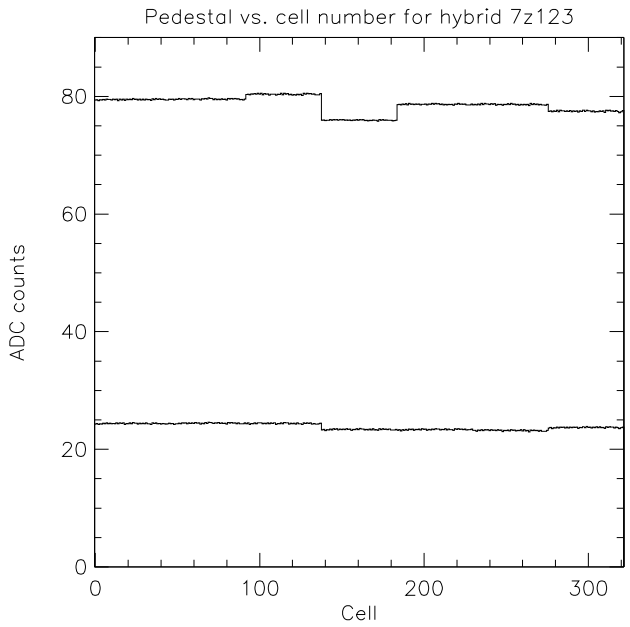
Pedestal vs. Pipeline Cell ID

The following plot shows the average pedestal vs. pipeline cell ID with and without charge injection. The x-axis is cell ID offset by 46 for each chip. Thus cell ID 5 for chip 1 is at x=5, chip 2 at x=51, chip 3 at x=97, etc.

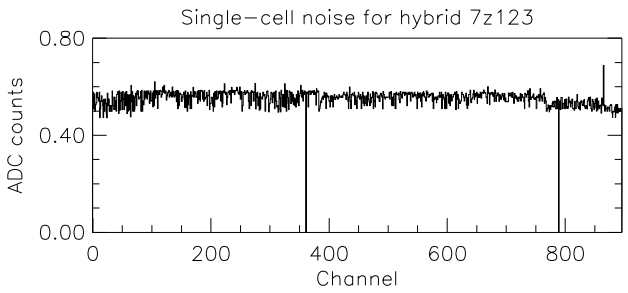
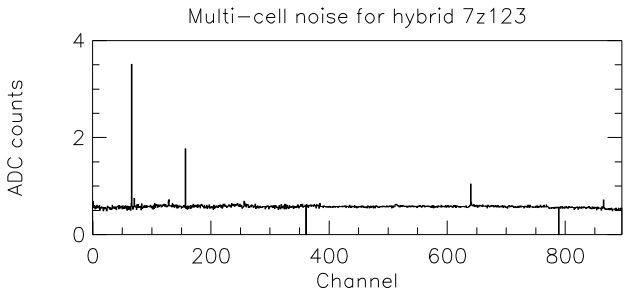
RMS Noise

The following plots show the single-cell and multi-cell RMS noise:

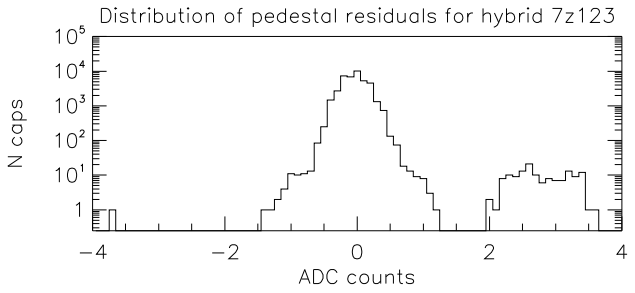
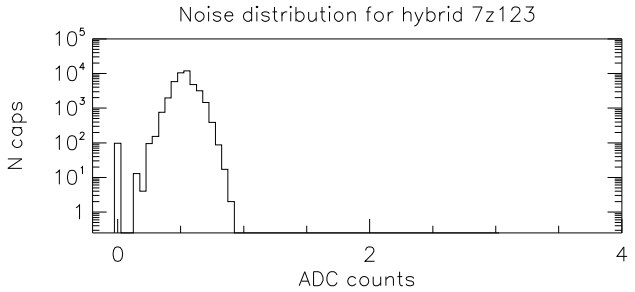
Distribution of Pedestals and Noise

The following are histograms of the pedestal of each pipeline capacitor relative to the chip average (top); and the RMS noise of each capacitor (bottom):

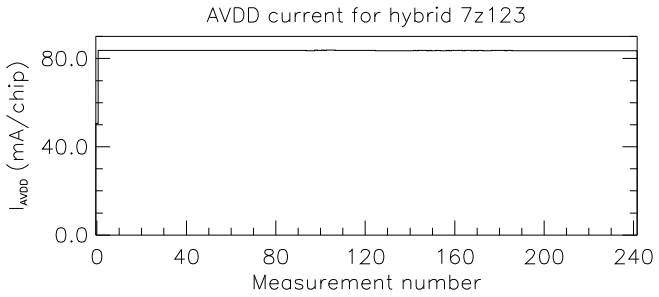
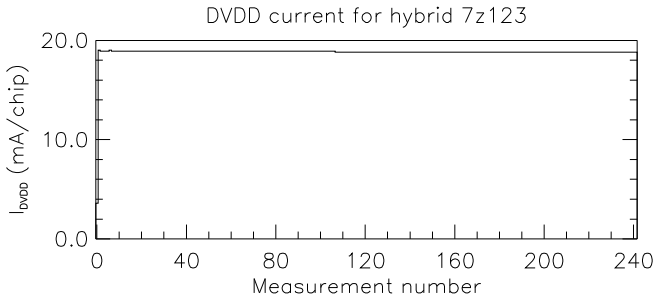
Supply Currents During Burn-in

The following plots show the supply currents per chip as a function of measurment number. Currents are measured approximately every 10 minutes:
