Hybrid 7z142 Traveler

April 10, 2000

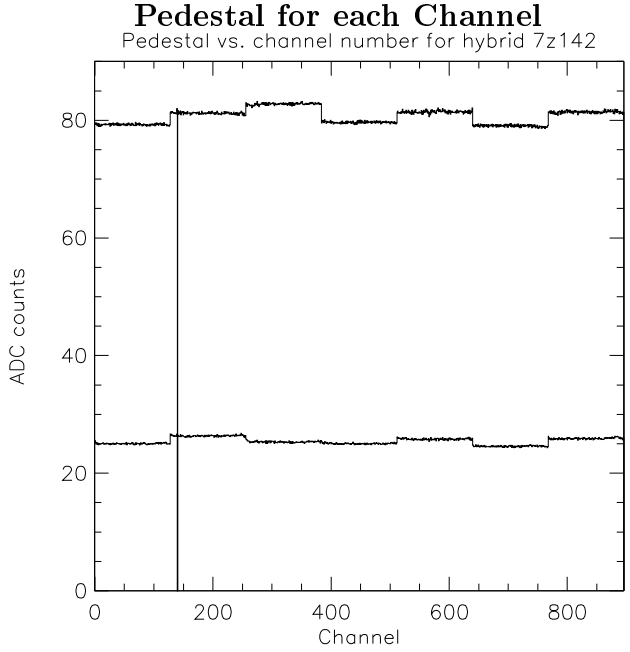
Pedestal for each Channel

The following plot shows the pedestals vs. channel number with and without charge injection:

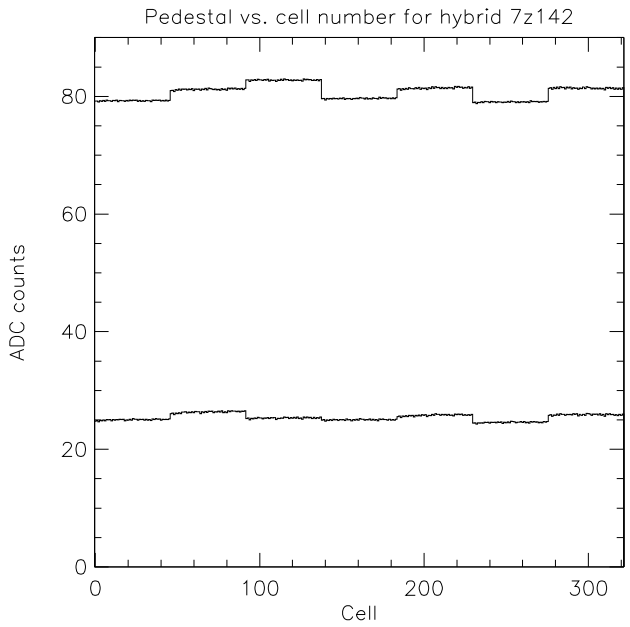
Pedestal vs. Pipeline Cell ID

The following plot shows the average pedestal vs. pipeline cell ID with and without charge injection. The x-axis is cell ID offset by 46 for each chip. Thus cell ID 5 for chip 1 is at x=5, chip 2 at x=51, chip 3 at x=97, etc.

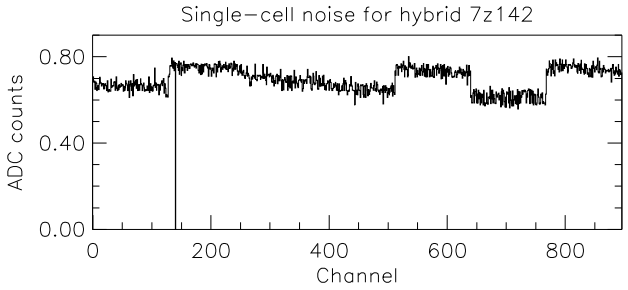
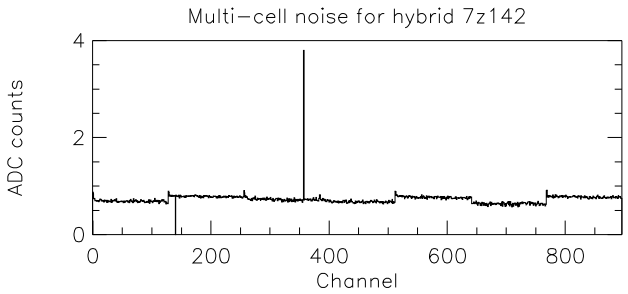
RMS Noise

The following plots show the single-cell and multi-cell RMS noise:

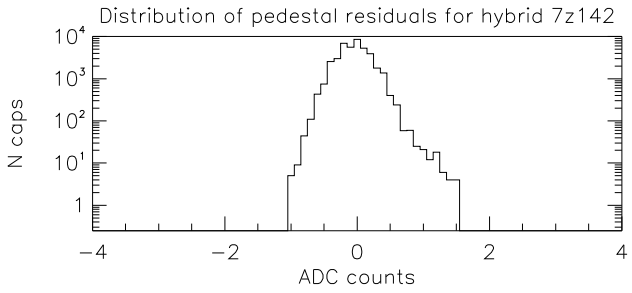
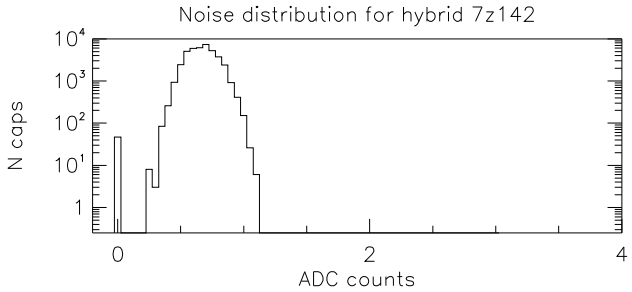
Distribution of Pedestals and Noise

The following are histograms of the pedestal of each pipeline capacitor relative to the chip average (top); and the RMS noise of each capacitor (bottom):

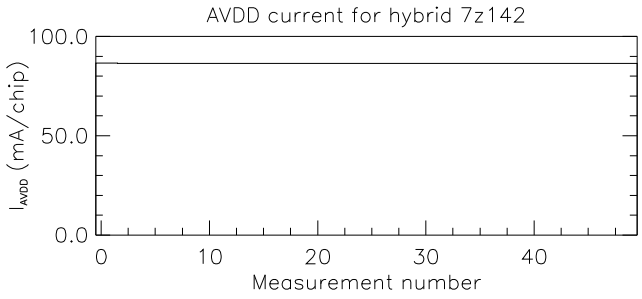
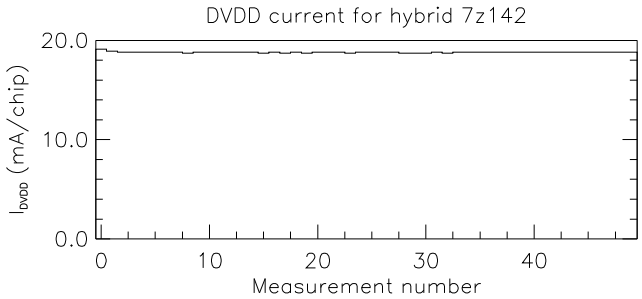
Supply Currents During Burn-in

The following plots show the supply currents per chip as a function of measurment number. Currents are measured approximately every 10 minutes:
