Hybrid 7z173 Traveler

February 8, 2000

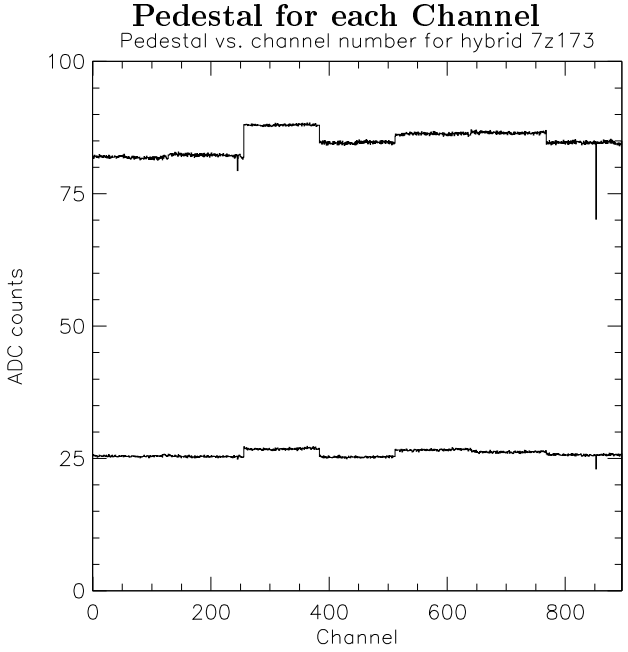
Pedestal for each Channel

The following plot shows the pedestals vs. channel number with and without charge injection:

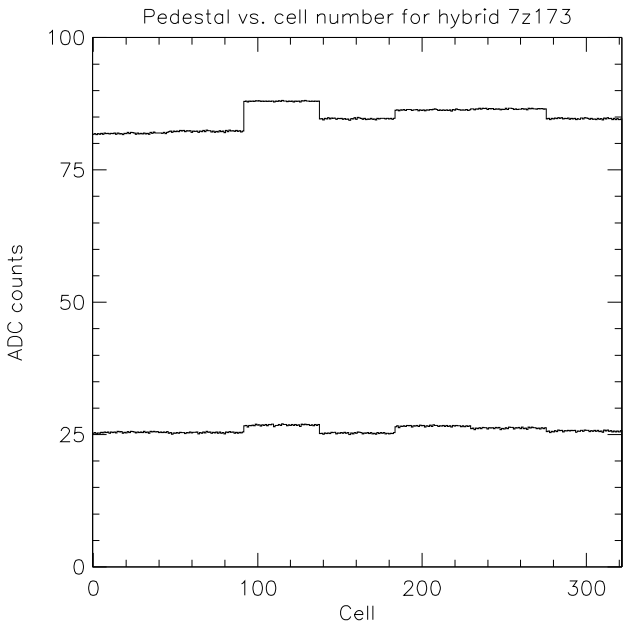
Pedestal vs. Pipeline Cell ID

The following plot shows the average pedestal vs. pipeline cell ID with and without charge injection. The x-axis is cell ID offset by 46 for each chip. Thus cell ID 5 for chip 1 is at x=5, chip 2 at x=51, chip 3 at x=97, etc.

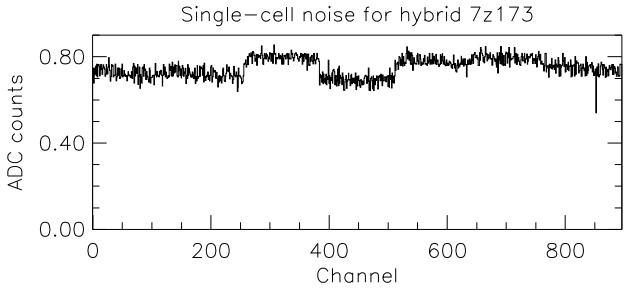
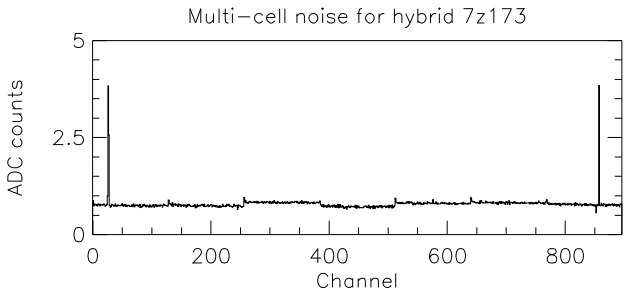
RMS Noise

The following plots show the single-cell and multi-cell RMS noise:

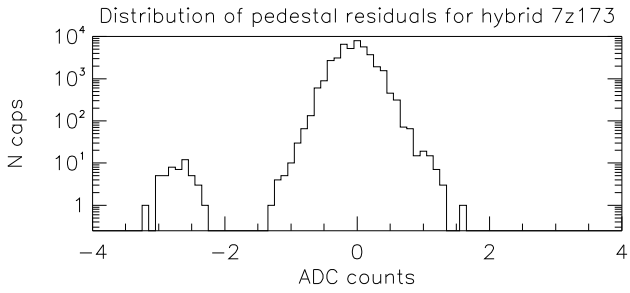
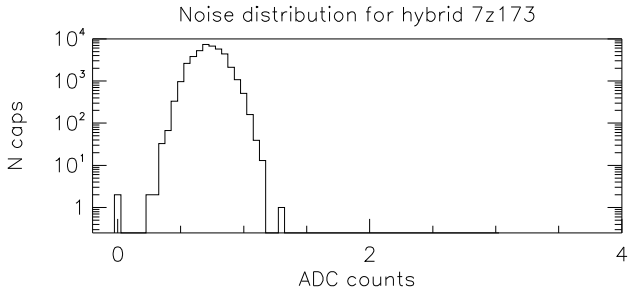
Distribution of Pedestals and Noise

The following are histograms of the pedestal of each pipeline capacitor relative to the chip average (top); and the RMS noise of each capacitor (bottom):

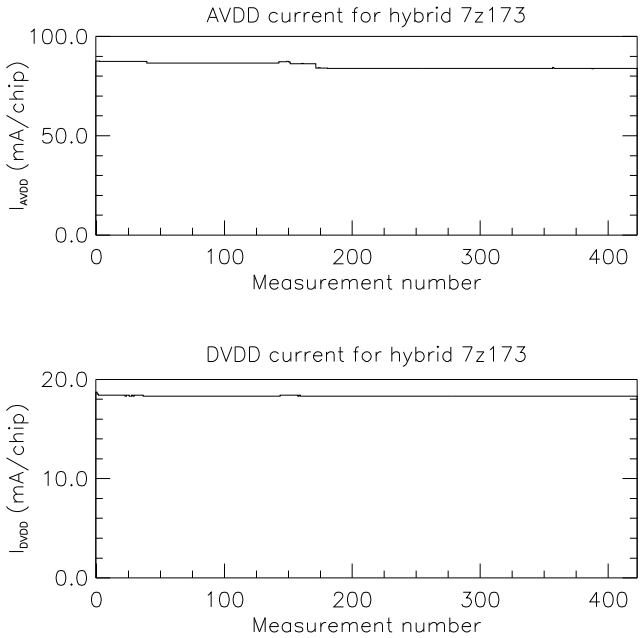
Supply Currents During Burn-in

The following plots show the supply currents per chip as a function of measurment number. Currents are measured approximately every 10 minutes:
