Hybrid 7z79 Traveler

May 22, 2000

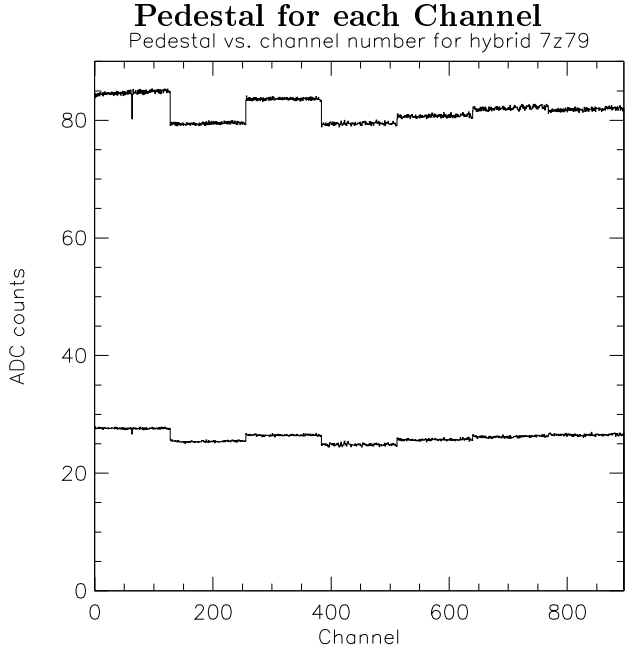
Pedestal for each Channel

The following plot shows the pedestals vs. channel number with and without charge injection:

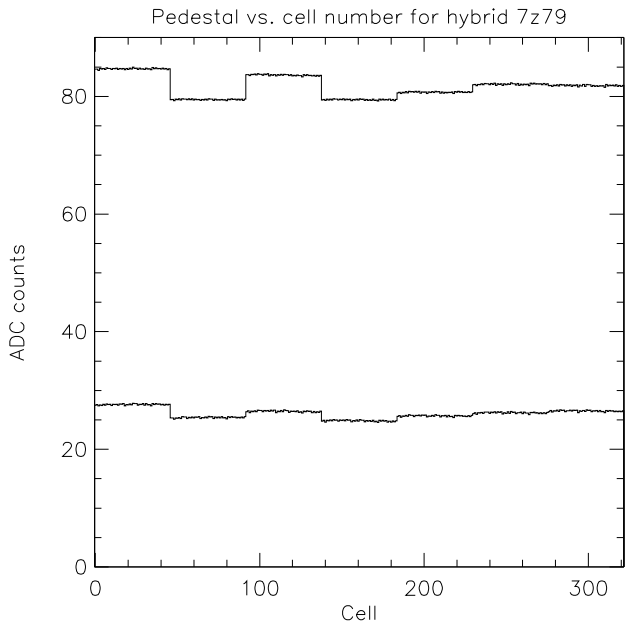
Pedestal vs. Pipeline Cell ID

The following plot shows the average pedestal vs. pipeline cell ID with and without charge injection. The x-axis is cell ID offset by 46 for each chip. Thus cell ID 5 for chip 1 is at x=5, chip 2 at x=51, chip 3 at x=97, etc.

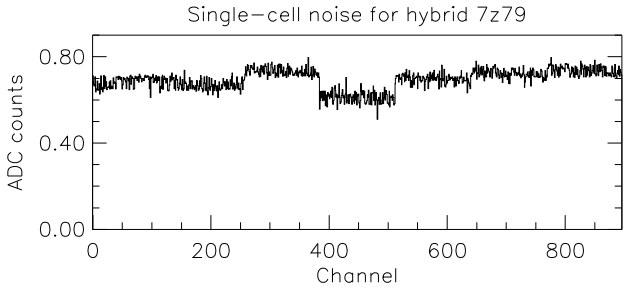
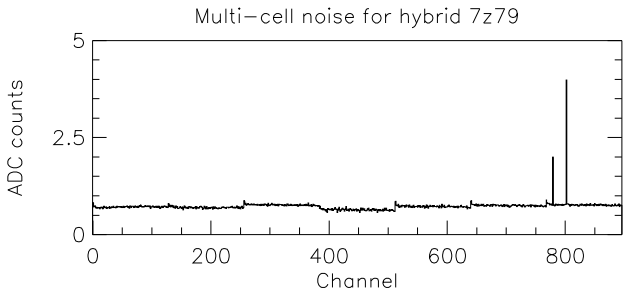
RMS Noise

The following plots show the single-cell and multi-cell RMS noise:

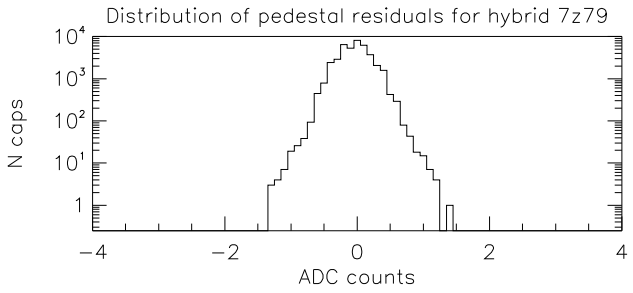
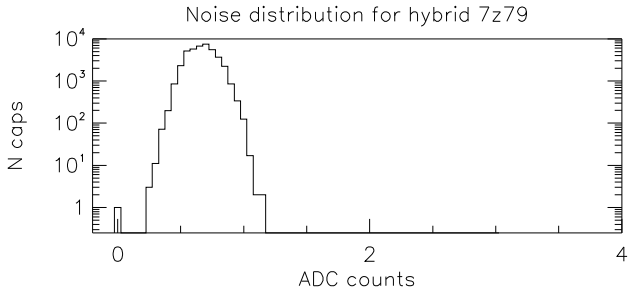
Distribution of Pedestals and Noise

The following are histograms of the pedestal of each pipeline capacitor relative to the chip average (top); and the RMS noise of each capacitor (bottom):

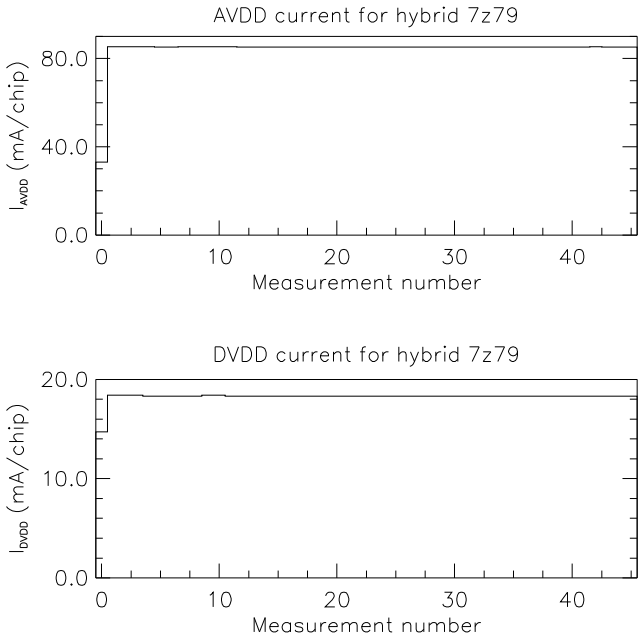
Supply Currents During Burn-in

The following plots show the supply currents per chip as a function of measurment number. Currents are measured approximately every 10 minutes:
