Hybrid 7z82 Traveler

June 30, 2000

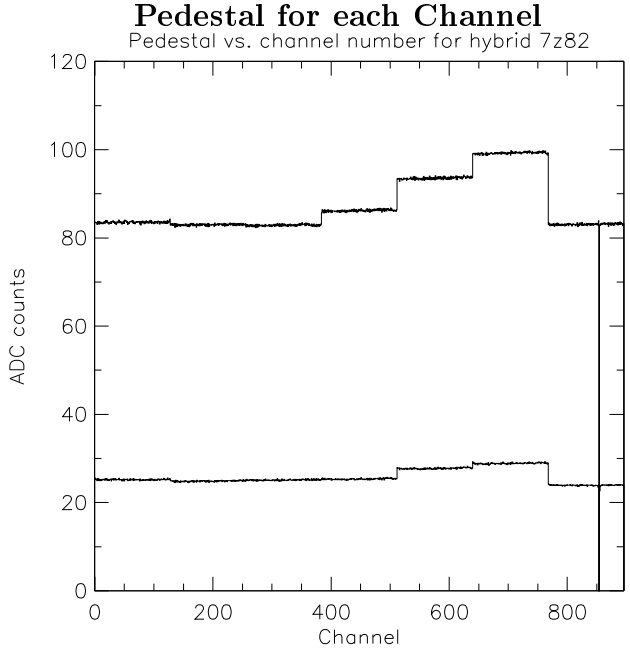
Pedestal for each Channel

The following plot shows the pedestals vs. channel number with and without charge injection:

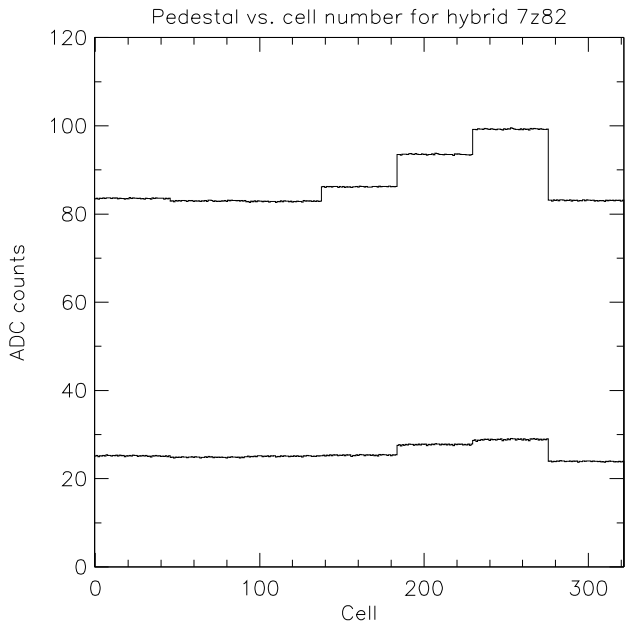
Pedestal vs. Pipeline Cell ID

The following plot shows the average pedestal vs. pipeline cell ID with and without charge injection. The x-axis is cell ID offset by 46 for each chip. Thus cell ID 5 for chip 1 is at x=5, chip 2 at x=51, chip 3 at x=97, etc.

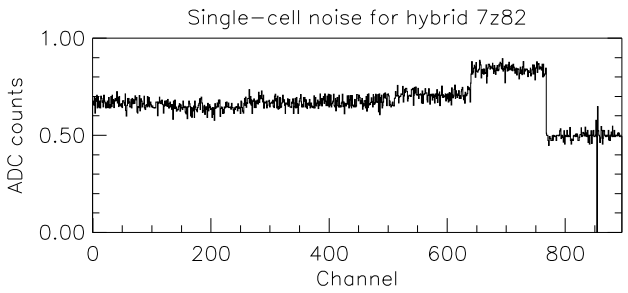
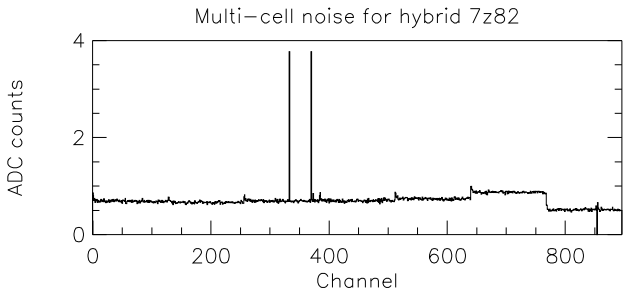
RMS Noise

The following plots show the single-cell and multi-cell RMS noise:

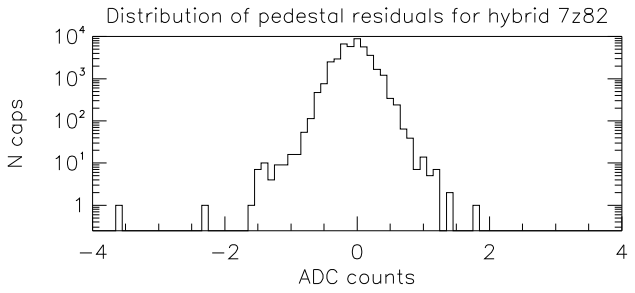
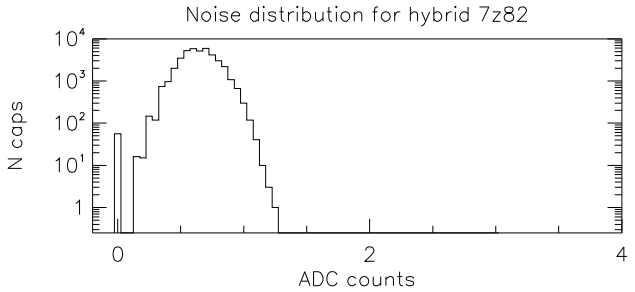
Distribution of Pedestals and Noise

The following are histograms of the pedestal of each pipeline capacitor relative to the chip average (top); and the RMS noise of each capacitor (bottom):

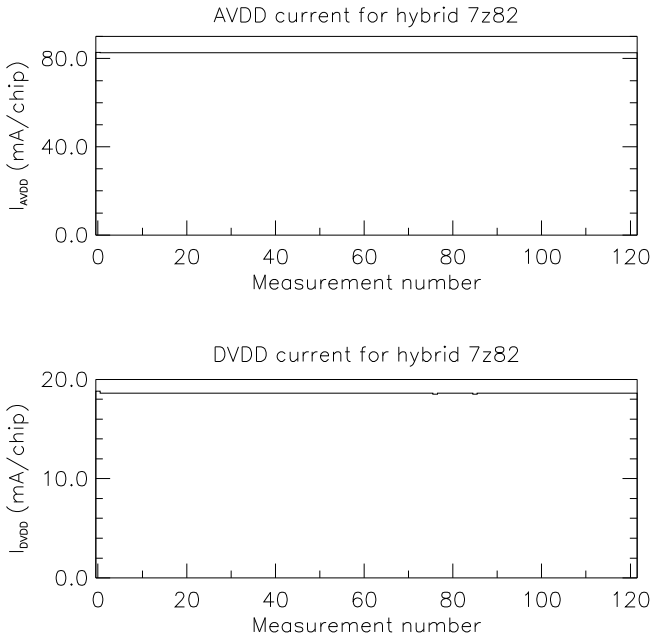
Supply Currents During Burn-in

The following plots show the supply currents per chip as a function of measurment number. Currents are measured approximately every 10 minutes:
