Hybrid 7z97 Traveler

February 8, 2000

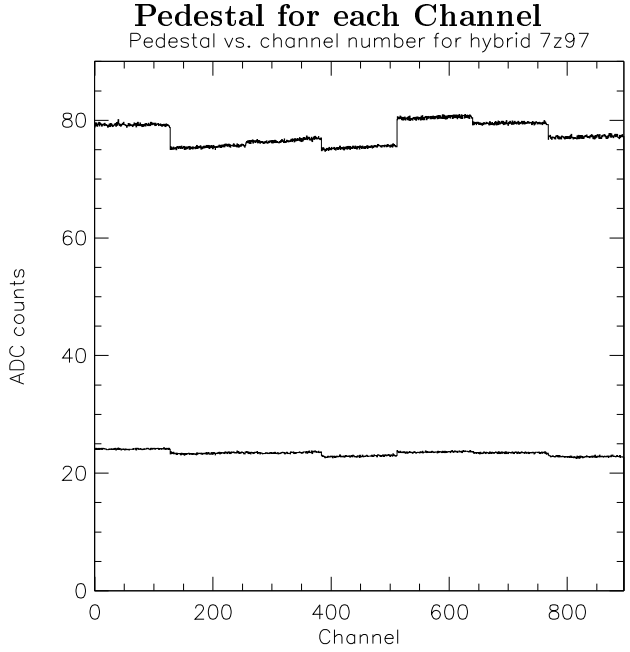
Pedestal for each Channel

The following plot shows the pedestals vs. channel number with and without charge injection:

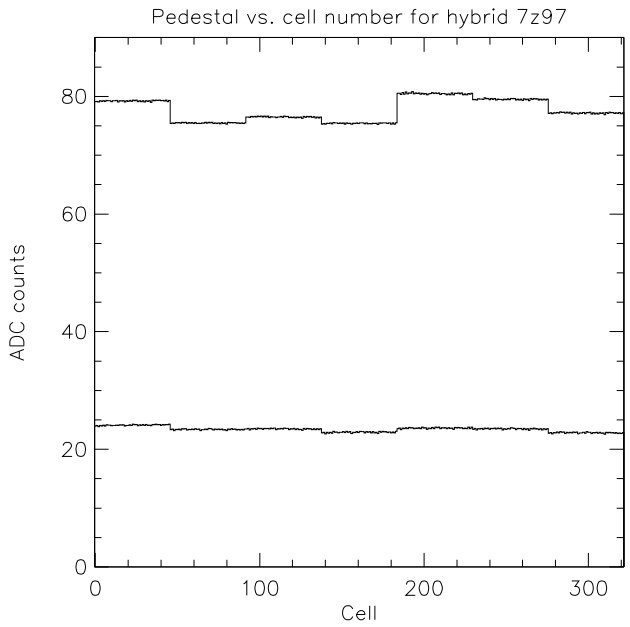
Pedestal vs. Pipeline Cell ID

The following plot shows the average pedestal vs. pipeline cell ID with and without charge injection. The x-axis is cell ID offset by 46 for each chip. Thus cell ID 5 for chip 1 is at x=5, chip 2 at x=51, chip 3 at x=97, etc.

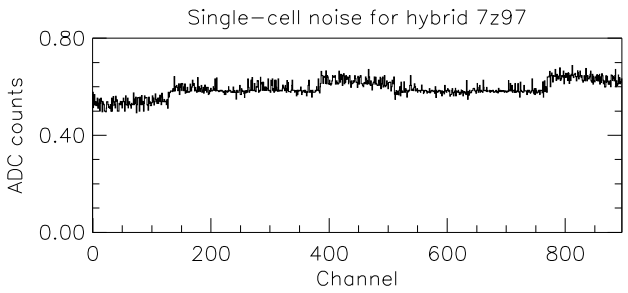
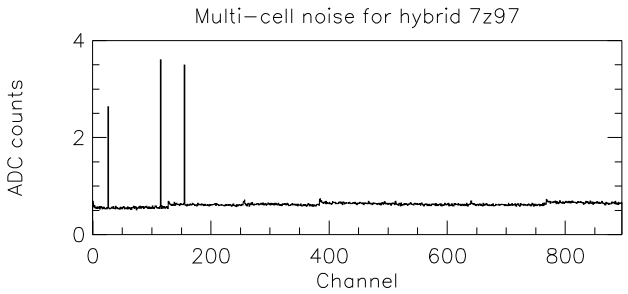
RMS Noise

The following plots show the single-cell and multi-cell RMS noise:

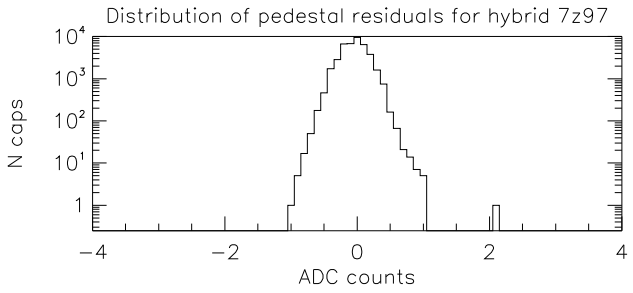
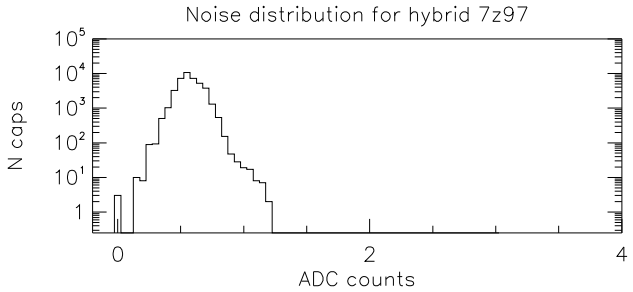
Distribution of Pedestals and Noise

The following are histograms of the pedestal of each pipeline capacitor relative to the chip average (top); and the RMS noise of each capacitor (bottom):

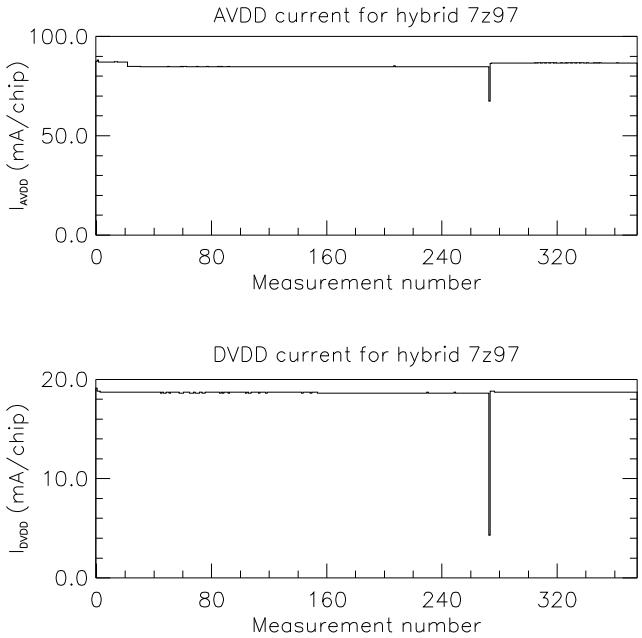
Supply Currents During Burn-in

The following plots show the supply currents per chip as a function of measurment number. Currents are measured approximately every 10 minutes:
