Hybrid 7z98 Traveler

February 3, 2000

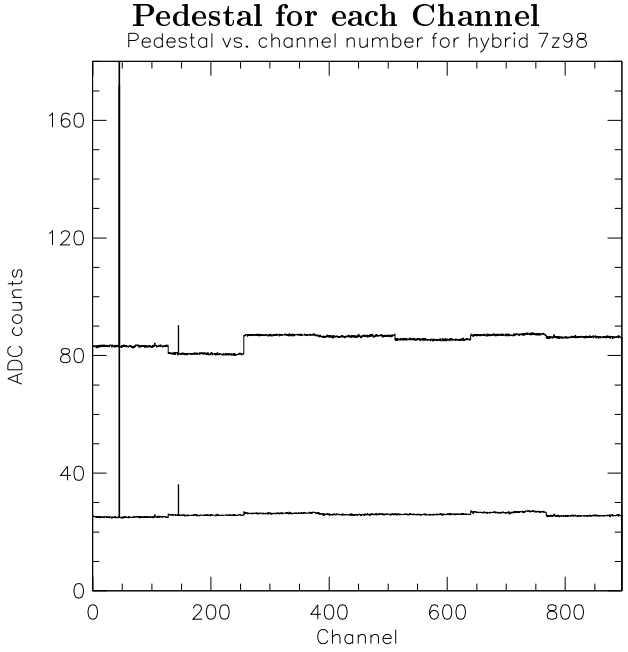
Pedestal for each Channel

Hybrid 7z98 quality: fair
Chip classification: fair fair good fair fair good fair
Bad channels (chip-channel): 0-45 1-17 6-13
Bad cells: none
Random bad capacitors (chip-cell-channel): 0-32-108 3-16-91 4-7-82
Channels at pedestal needed for DCMS: 32.6 32.8 32.6 35.6 32.7 32.6 34.7
```
