Hybrid 8j107 Traveler

December 8, 1999

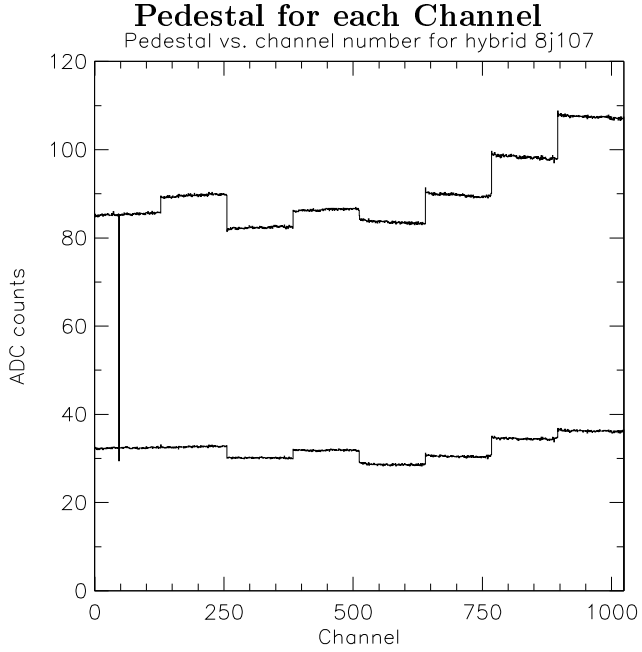
Pedestal for each Channel

The following plot shows the pedestals vs. channel number with and without charge injection:

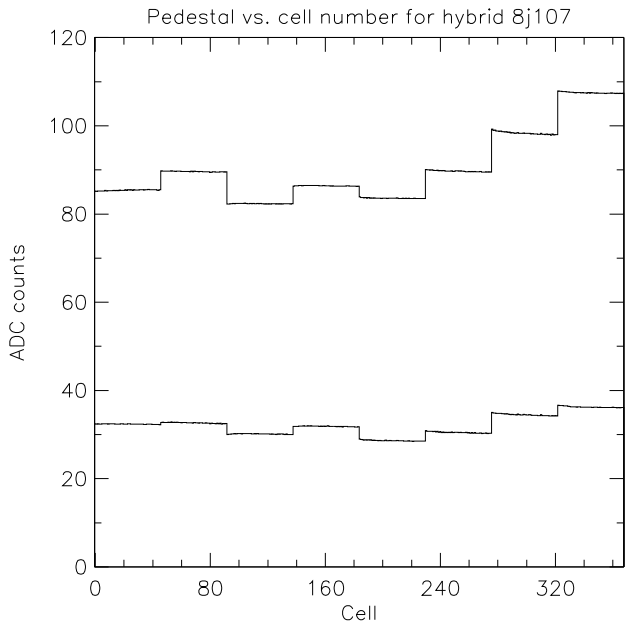
Pedestal vs. Pipeline Cell ID

The following plot shows the average pedestal vs. pipeline cell ID with and without charge injection. The x-axis is cell ID offset by 46 for each chip. Thus cell ID 5 for chip 1 is at x=5, chip 2 at x=51, chip 3 at x=97, etc.

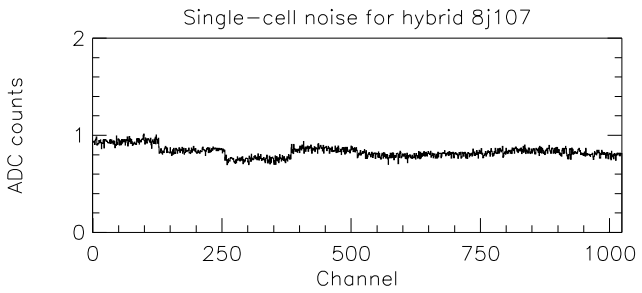
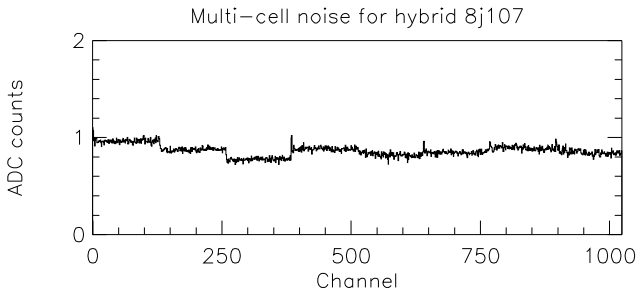
RMS Noise

The following plots show the single-cell and multi-cell RMS noise:

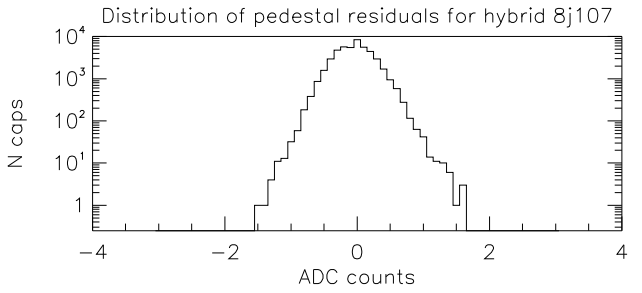
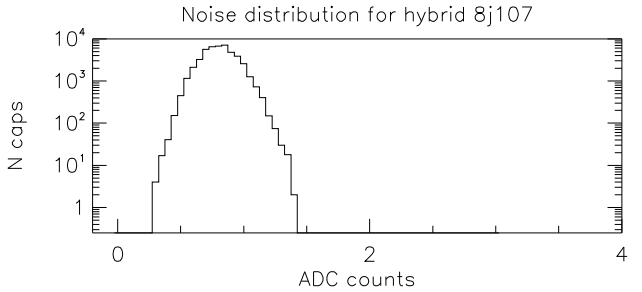
Distribution of Pedestals and Noise

The following are histograms of the pedestal of each pipeline capacitor relative to the chip average (top); and the RMS noise of each capacitor (bottom):

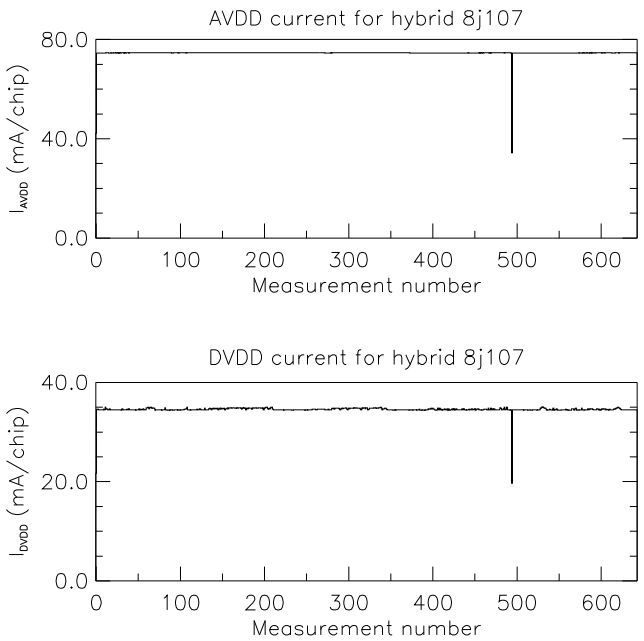
Supply Currents During Burn-in

The following plots show the supply currents per chip as a function of measurment number. Currents are measured approximately every 10 minutes:
