Hybrid 8j120 Traveler

December 8, 1999

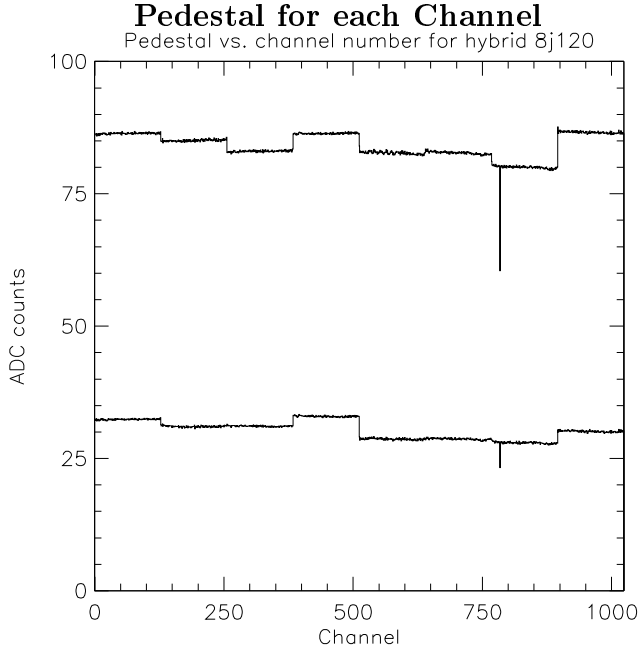
Pedestal for each Channel

The following plot shows the pedestals vs. channel number with and without charge injection:

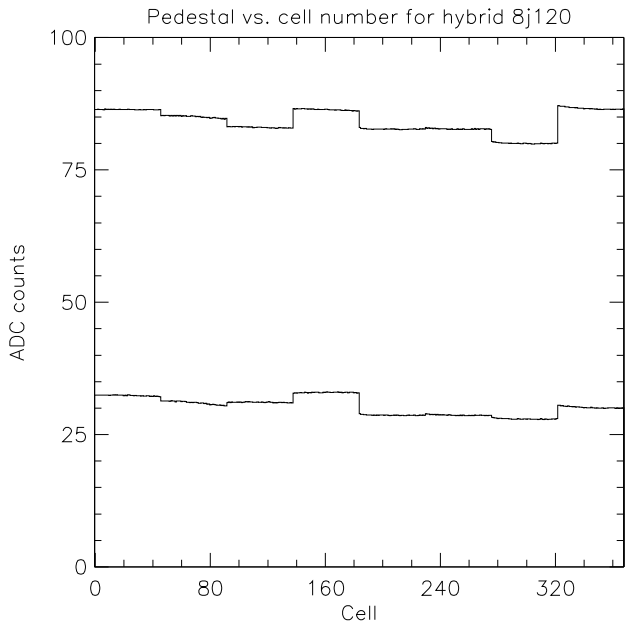
Pedestal vs. Pipeline Cell ID

The following plot shows the average pedestal vs. pipeline cell ID with and without charge injection. The x-axis is cell ID offset by 46 for each chip. Thus cell ID 5 for chip 1 is at x=5, chip 2 at x=51, chip 3 at x=97, etc.

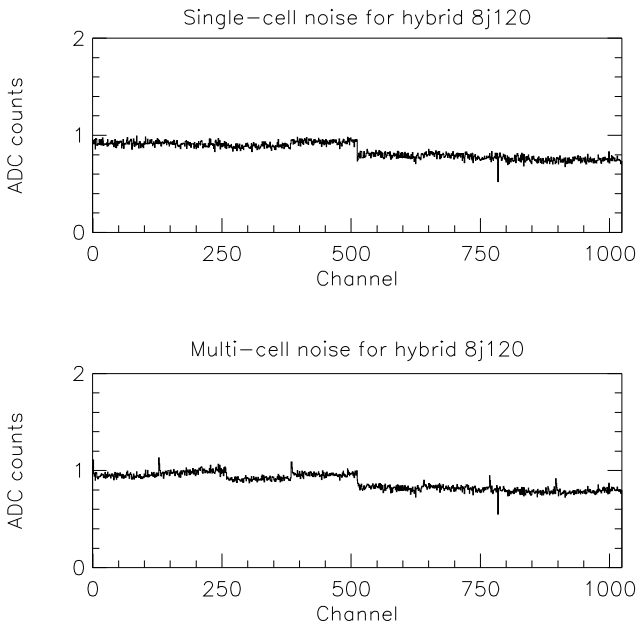
RMS Noise

The following plots show the single-cell and multi-cell RMS noise:

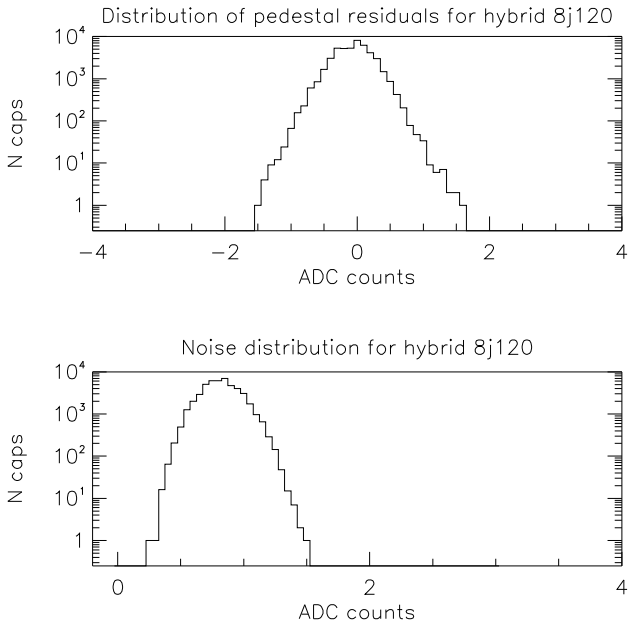
Distribution of Pedestals and Noise

The following are histograms of the pedestal of each pipeline capacitor relative to the chip average (top); and the RMS noise of each capacitor (bottom):

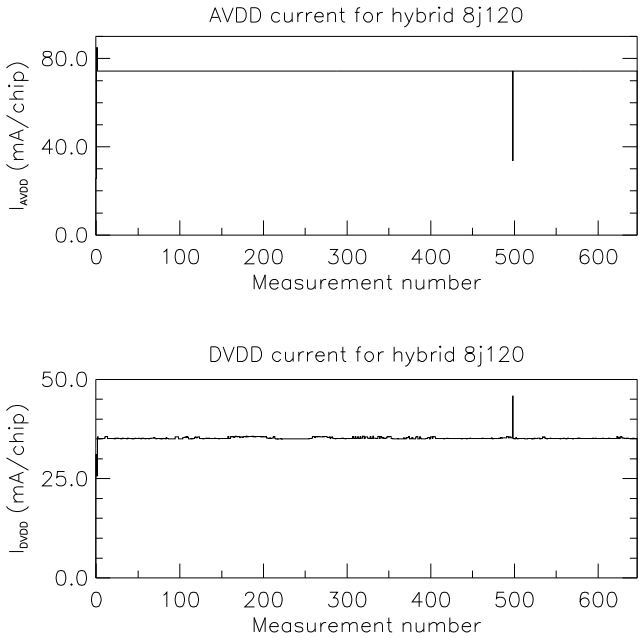
Supply Currents During Burn-in

The following plots show the supply currents per chip as a function of measurment number. Currents are measured approximately every 10 minutes:
