Hybrid 8j123 Traveler

December 8, 1999

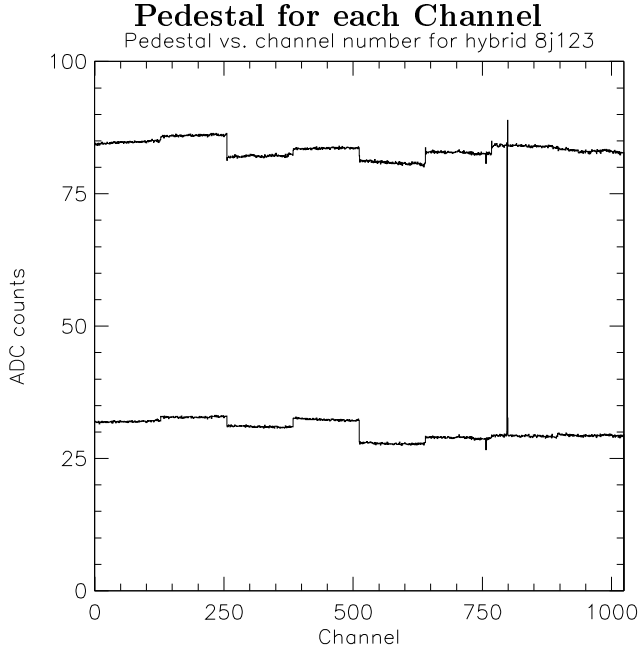
Pedestal for each Channel

The following plot shows the pedestals vs. channel number with and without charge injection:

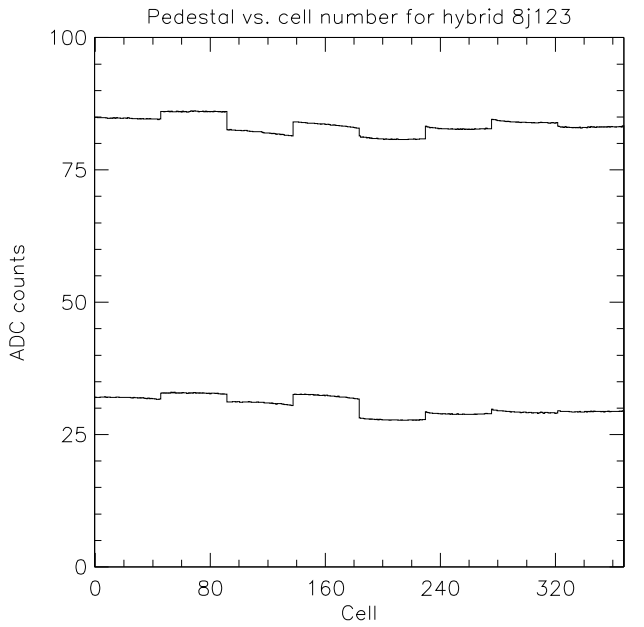
Pedestal vs. Pipeline Cell ID

The following plot shows the average pedestal vs. pipeline cell ID with and without charge injection. The x-axis is cell ID offset by 46 for each chip. Thus cell ID 5 for chip 1 is at x=5, chip 2 at x=51, chip 3 at x=97, etc.

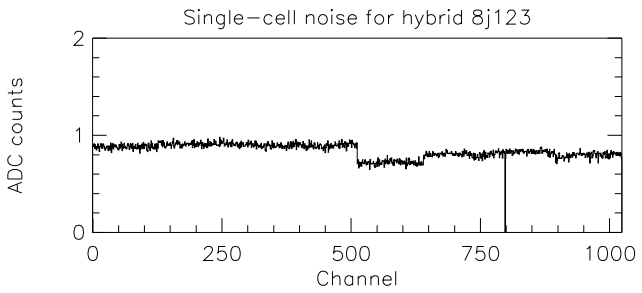
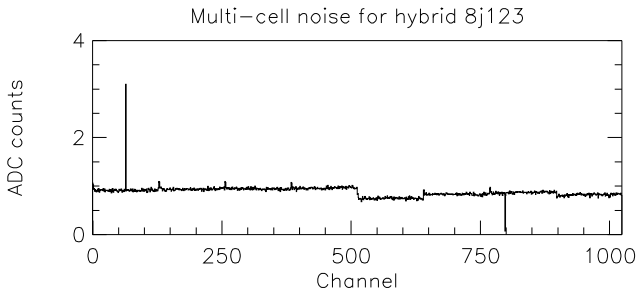
RMS Noise

The following plots show the single-cell and multi-cell RMS noise:

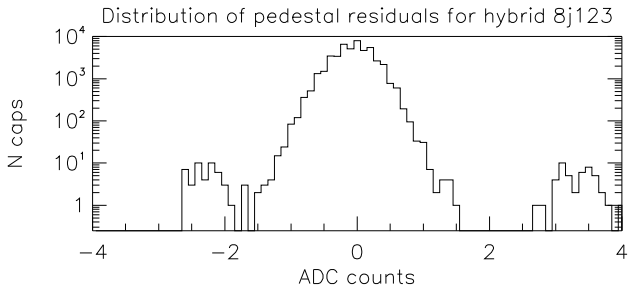
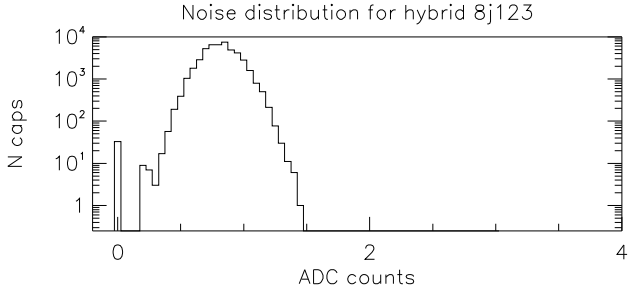
Distribution of Pedestals and Noise

The following are histograms of the pedestal of each pipeline capacitor relative to the chip average (top); and the RMS noise of each capacitor (bottom):

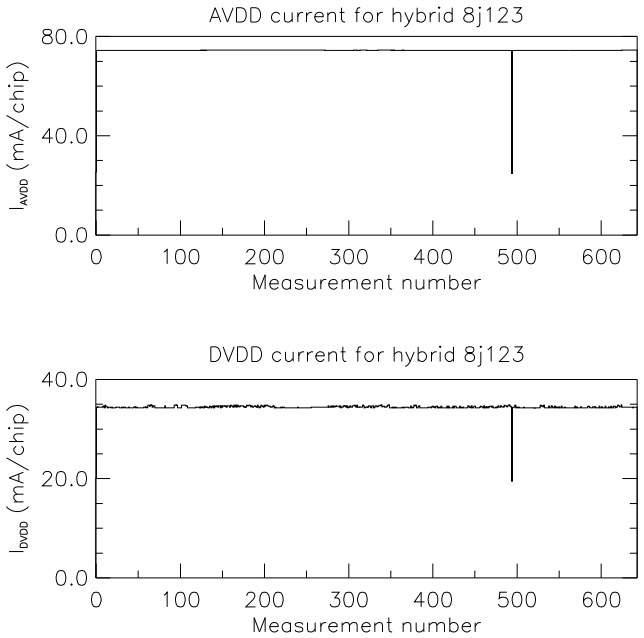
Supply Currents During Burn-in

The following plots show the supply currents per chip as a function of measurment number. Currents are measured approximately every 10 minutes:
