Hybrid 8j136 Traveler

December 16, 1999

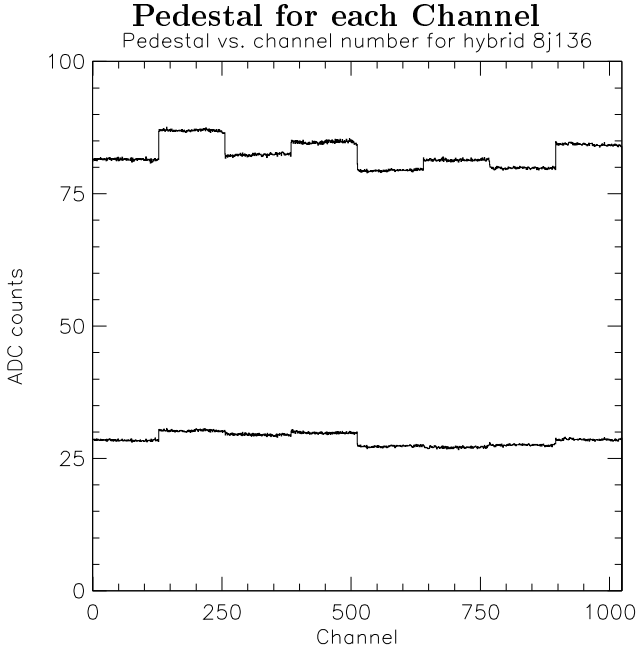
Pedestal for each Channel

The following plot shows the pedestals vs. channel number with and without charge injection:

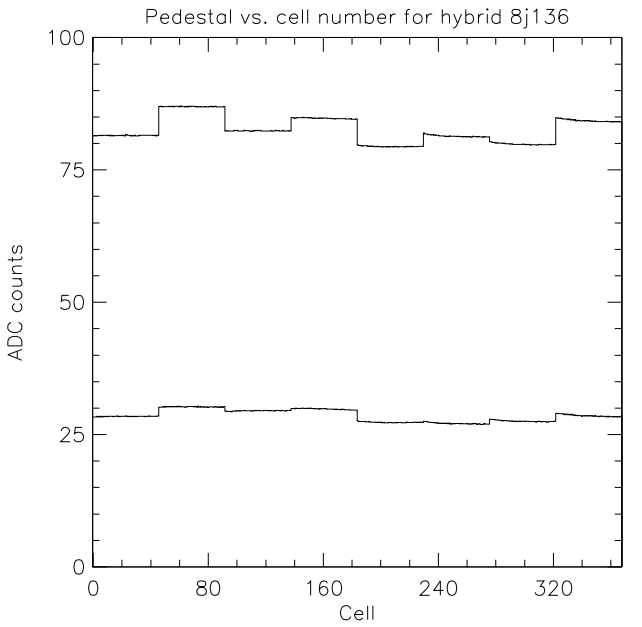
Pedestal vs. Pipeline Cell ID

The following plot shows the average pedestal vs. pipeline cell ID with and without charge injection. The x-axis is cell ID offset by 46 for each chip. Thus cell ID 5 for chip 1 is at x=5, chip 2 at x=51, chip 3 at x=97, etc.

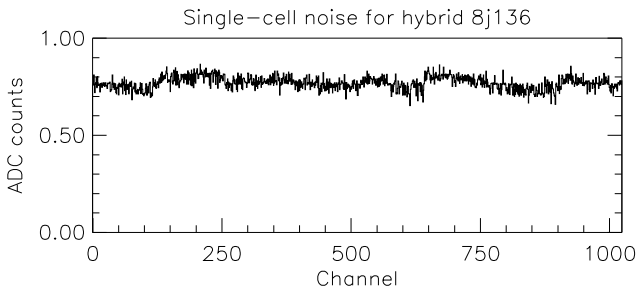
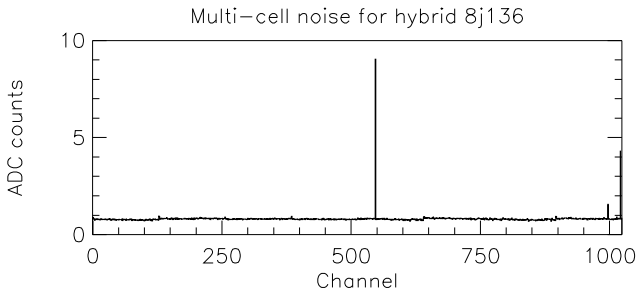
RMS Noise

The following plots show the single-cell and multi-cell RMS noise:

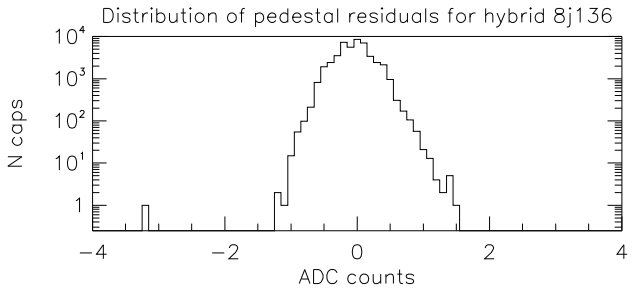
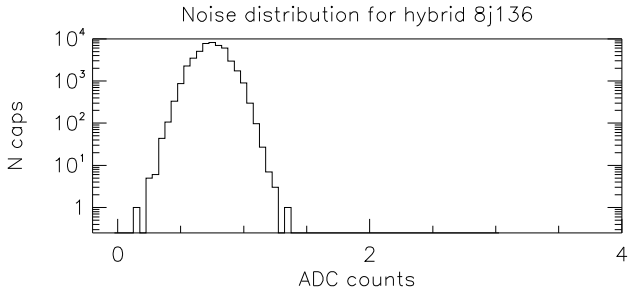
Distribution of Pedestals and Noise

The following are histograms of the pedestal of each pipeline capacitor relative to the chip average (top); and the RMS noise of each capacitor (bottom):

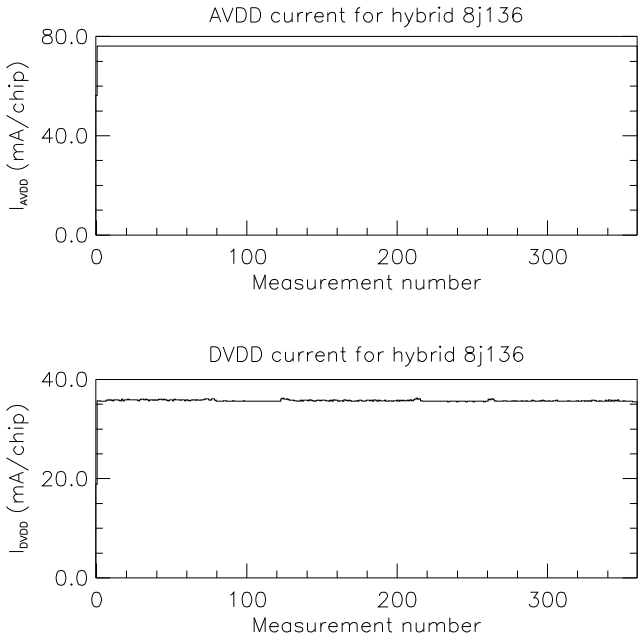
Supply Currents During Burn-in

The following plots show the supply currents per chip as a function of measurment number. Currents are measured approximately every 10 minutes:
