Hybrid 8j137 Traveler

December 20, 1999

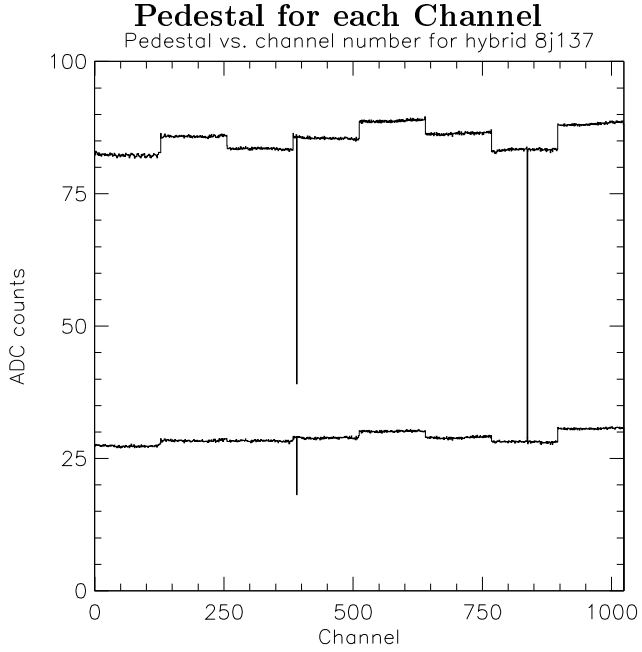
Pedestal for each Channel

The following plot shows the pedestals vs. channel number with and without charge injection:

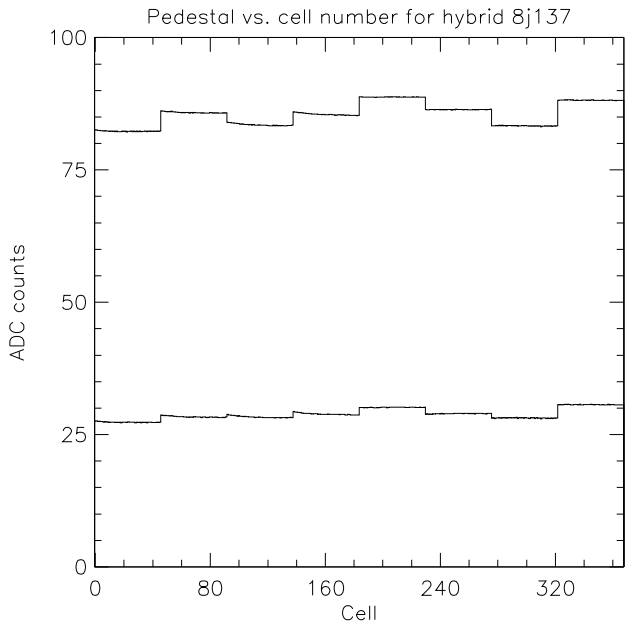
Pedestal vs. Pipeline Cell ID

The following plot shows the average pedestal vs. pipeline cell ID with and without charge injection. The x-axis is cell ID offset by 46 for each chip. Thus cell ID 5 for chip 1 is at x=5, chip 2 at x=51, chip 3 at x=97, etc.

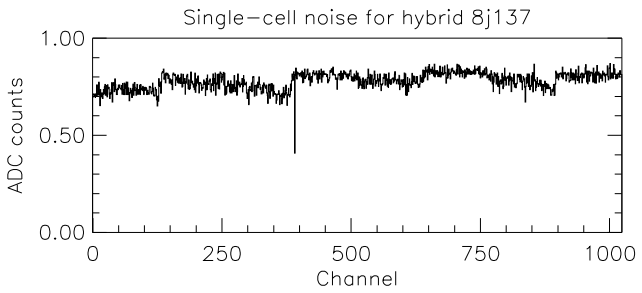
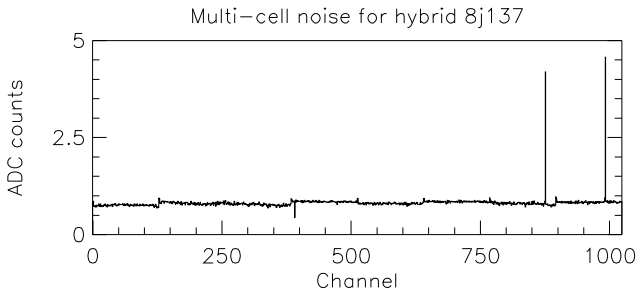
RMS Noise

The following plots show the single-cell and multi-cell RMS noise:

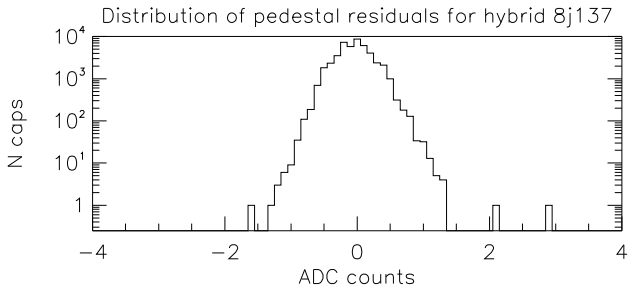
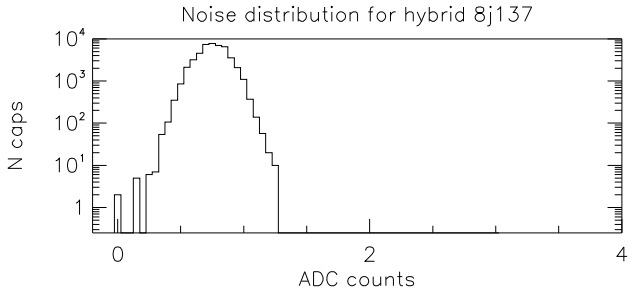
Distribution of Pedestals and Noise

The following are histograms of the pedestal of each pipeline capacitor relative to the chip average (top); and the RMS noise of each capacitor (bottom):

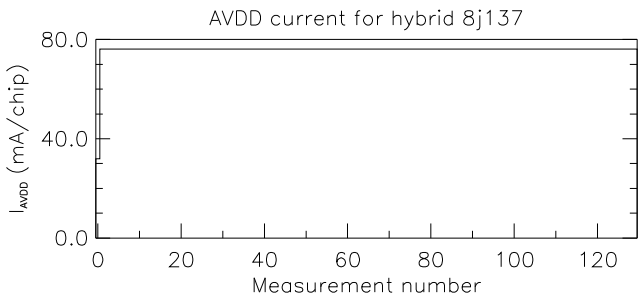
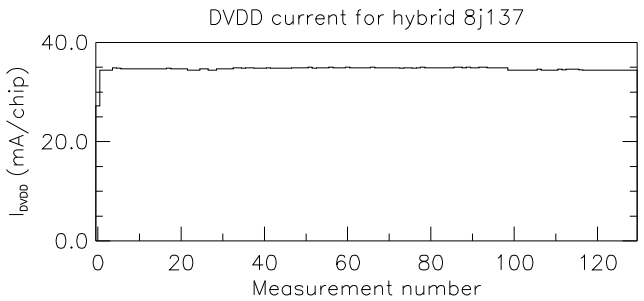
Supply Currents During Burn-in

The following plots show the supply currents per chip as a function of measurment number. Currents are measured approximately every 10 minutes:
