Hybrid 8j148 Traveler

January 11, 2000

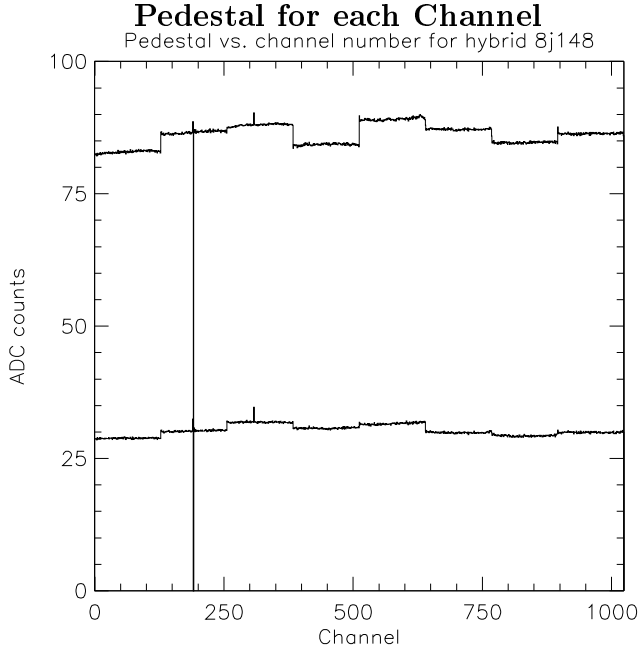
Pedestal for each Channel

The following plot shows the pedestals vs. channel number with and without charge injection:

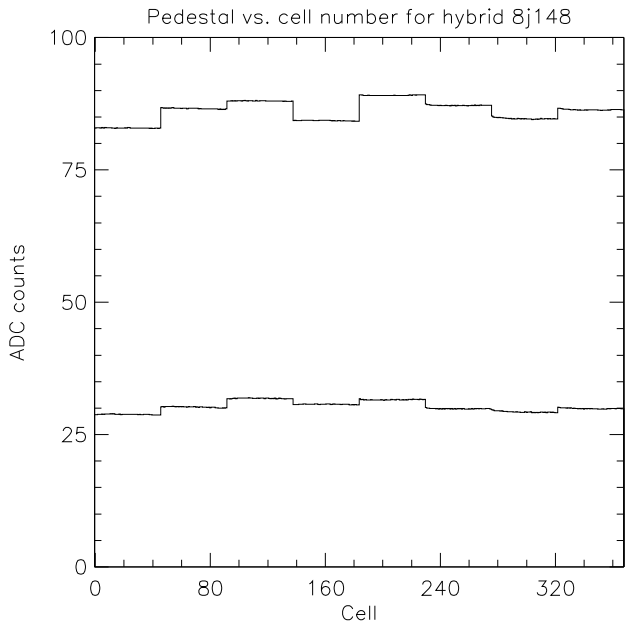
Pedestal vs. Pipeline Cell ID

The following plot shows the average pedestal vs. pipeline cell ID with and without charge injection. The x-axis is cell ID offset by 46 for each chip. Thus cell ID 5 for chip 1 is at x=5, chip 2 at x=51, chip 3 at x=97, etc.

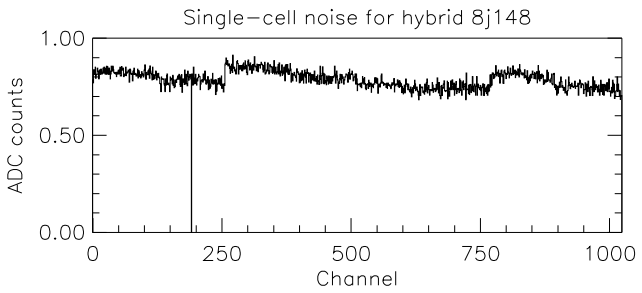
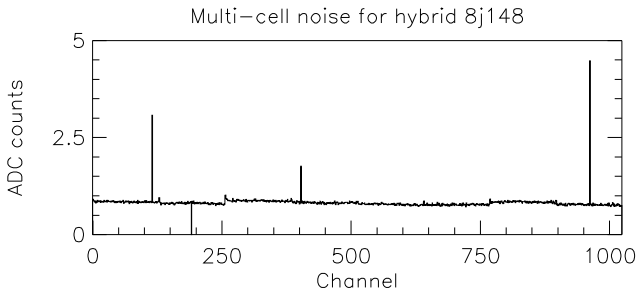
RMS Noise

The following plots show the single-cell and multi-cell RMS noise:

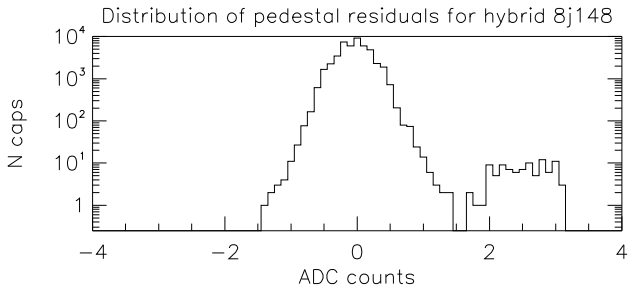
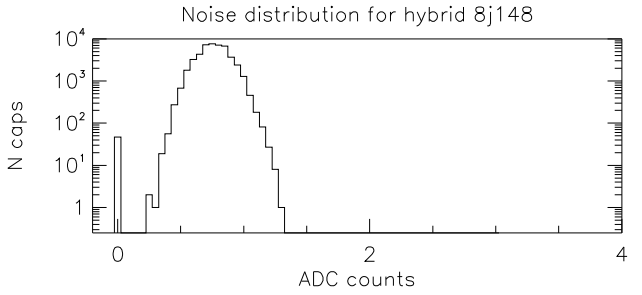
Distribution of Pedestals and Noise

The following are histograms of the pedestal of each pipeline capacitor relative to the chip average (top); and the RMS noise of each capacitor (bottom):

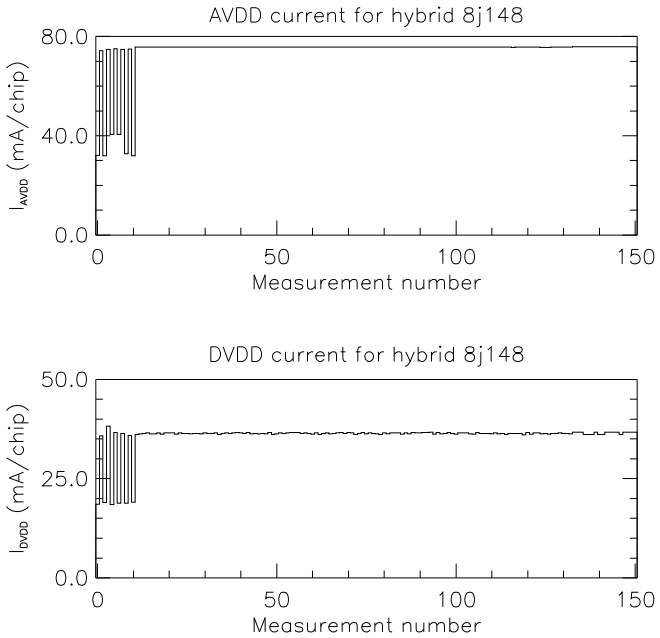
Supply Currents During Burn-in

The following plots show the supply currents per chip as a function of measurment number. Currents are measured approximately every 10 minutes:
