Hybrid 8j172 Traveler

January 27, 2000

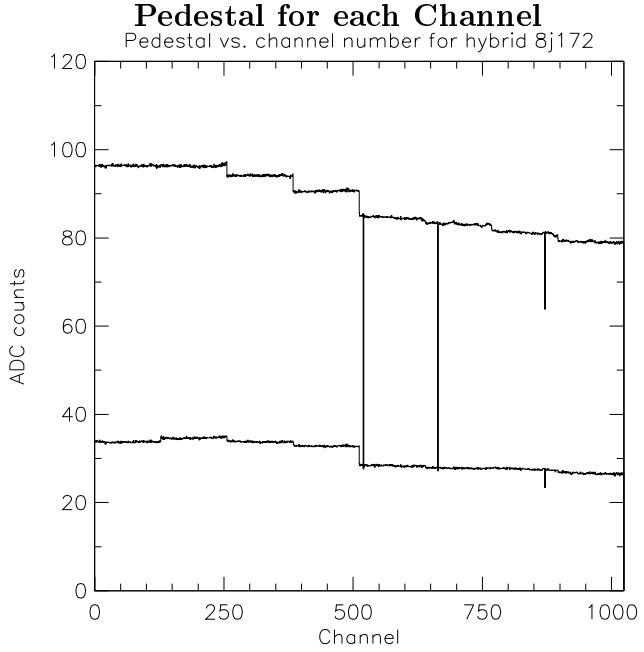
Pedestal for each Channel

The following plot shows the pedestals vs. channel number with and without charge injection:

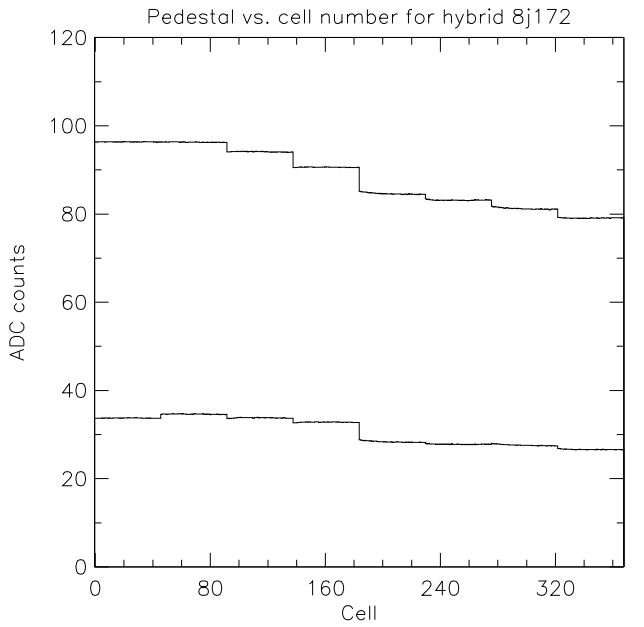
Pedestal vs. Pipeline Cell ID

The following plot shows the average pedestal vs. pipeline cell ID with and without charge injection. The x-axis is cell ID offset by 46 for each chip. Thus cell ID 5 for chip 1 is at x=5, chip 2 at x=51, chip 3 at x=97, etc.

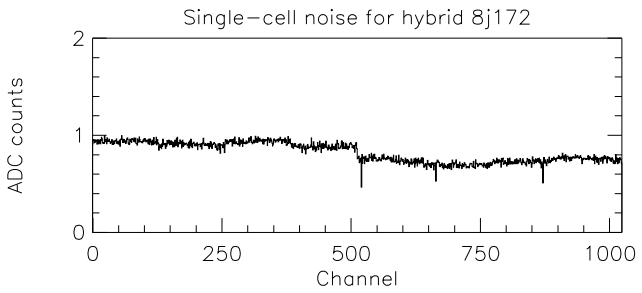
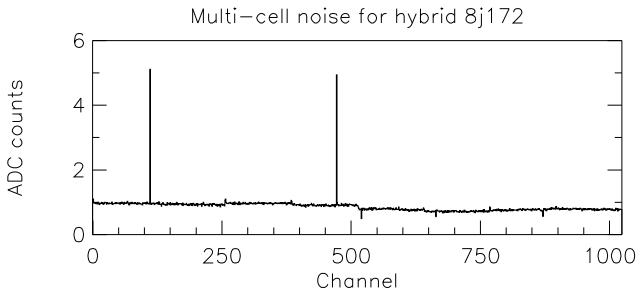
RMS Noise

The following plots show the single-cell and multi-cell RMS noise:

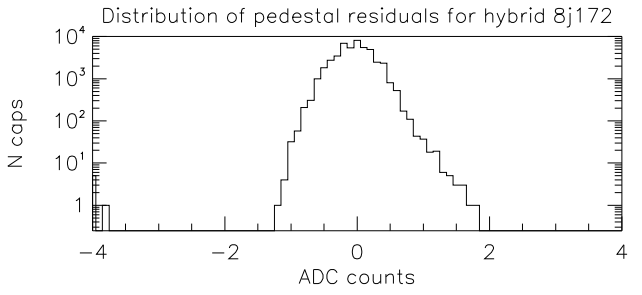
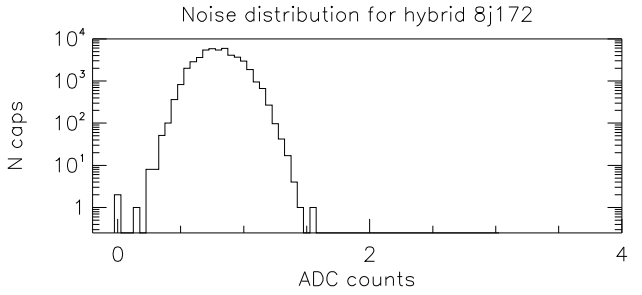
Distribution of Pedestals and Noise

The following are histograms of the pedestal of each pipeline capacitor relative to the chip average (top); and the RMS noise of each capacitor (bottom):

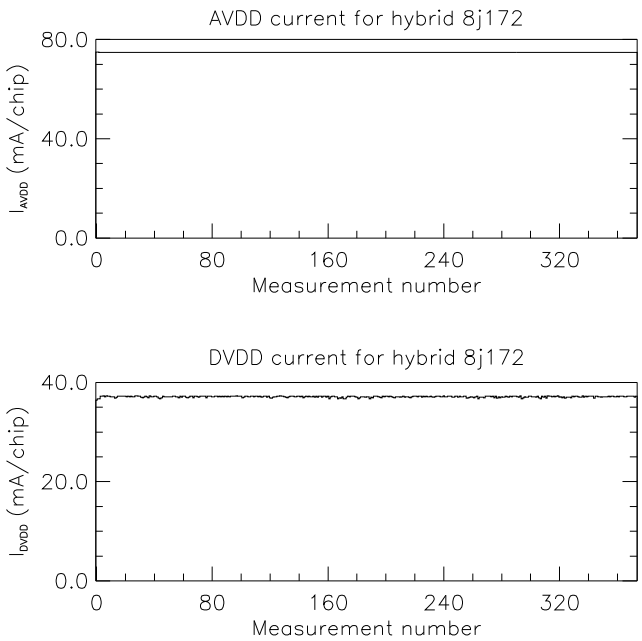
Supply Currents During Burn-in

The following plots show the supply currents per chip as a function of measurment number. Currents are measured approximately every 10 minutes:
