Hybrid 8j175 Traveler

June 9, 2000

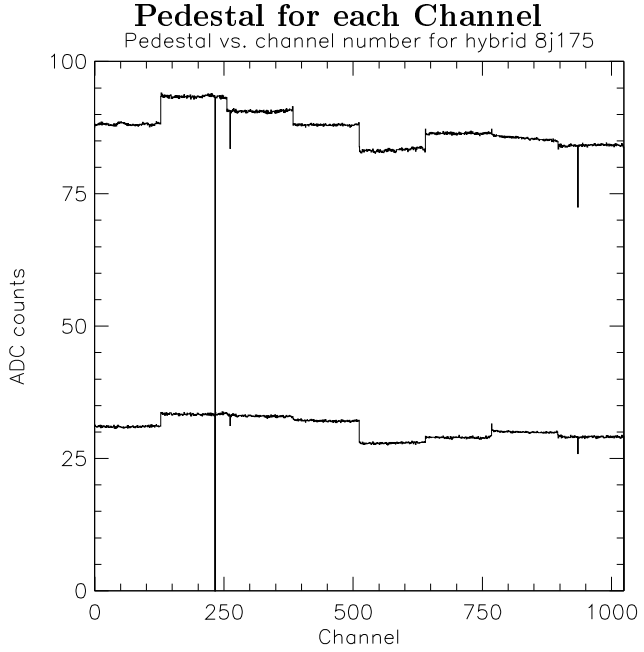
Pedestal for each Channel

The following plot shows the pedestals vs. channel number with and without charge injection:

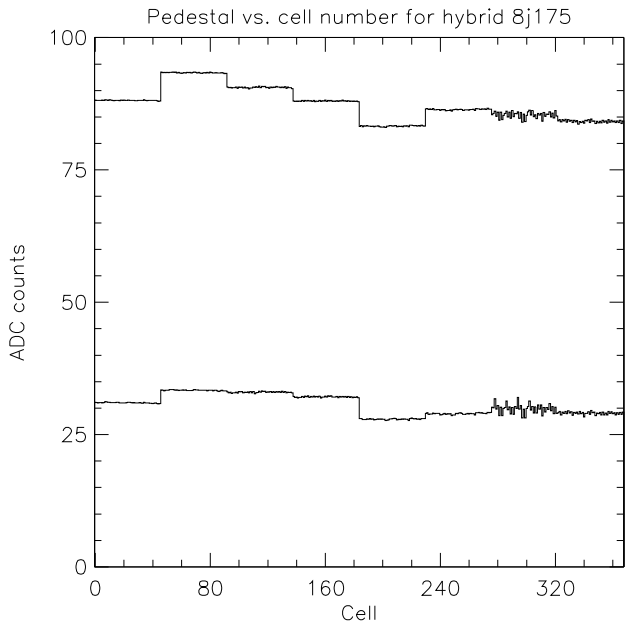
Pedestal vs. Pipeline Cell ID

The following plot shows the average pedestal vs. pipeline cell ID with and without charge injection. The x-axis is cell ID offset by 46 for each chip. Thus cell ID 5 for chip 1 is at x=5, chip 2 at x=51, chip 3 at x=97, etc.

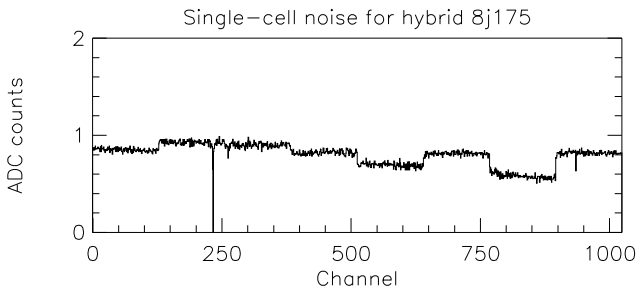
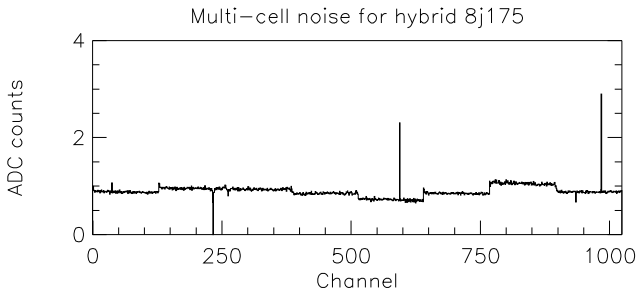
RMS Noise

The following plots show the single-cell and multi-cell RMS noise:

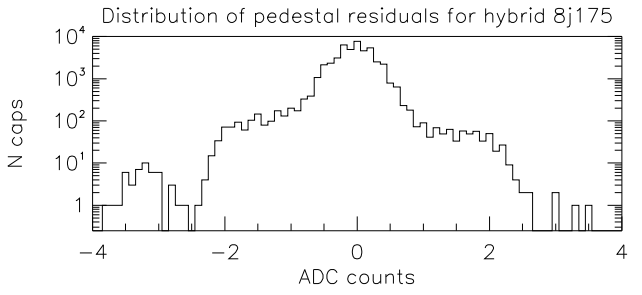
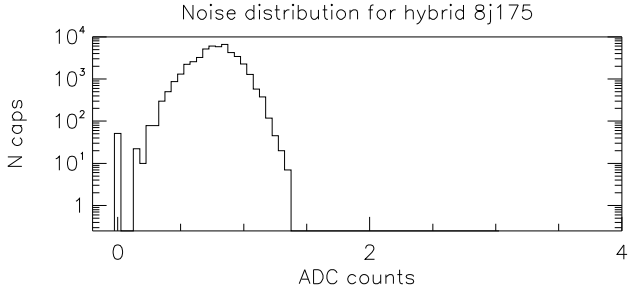
Distribution of Pedestals and Noise

The following are histograms of the pedestal of each pipeline capacitor relative to the chip average (top); and the RMS noise of each capacitor (bottom):

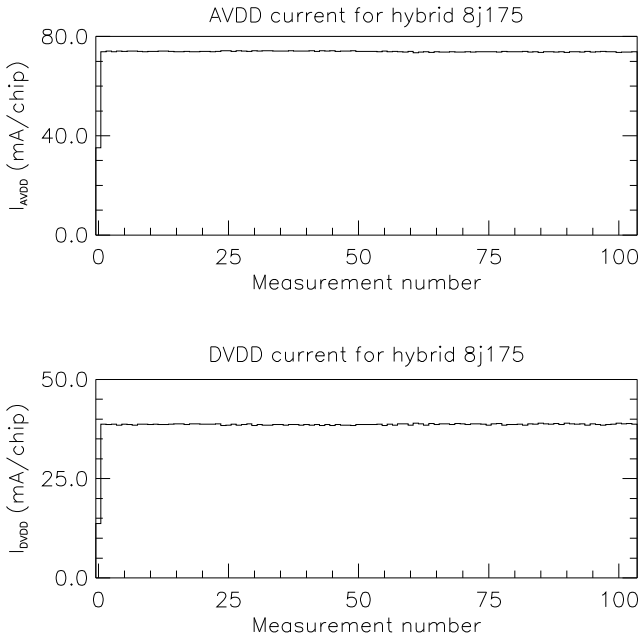
Supply Currents During Burn-in

The following plots show the supply currents per chip as a function of measurment number. Currents are measured approximately every 10 minutes:
