Hybrid 8j181 Traveler

March 6, 2000

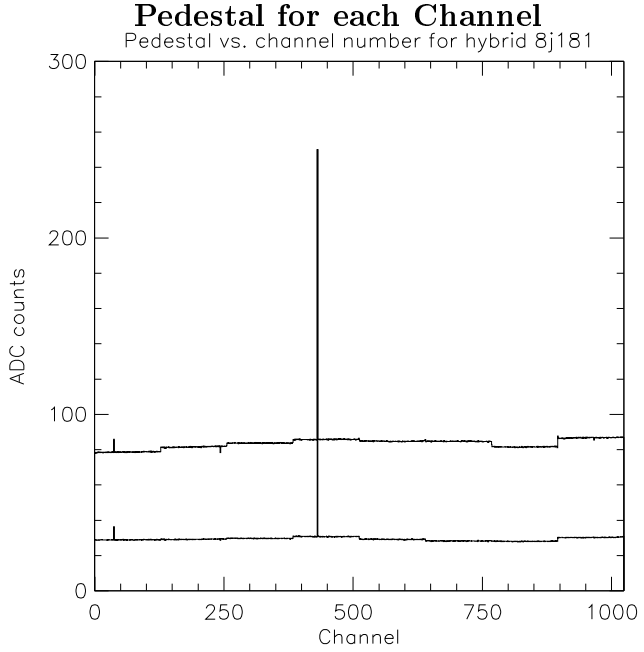
Pedestal for each Channel

The following plot shows the pedestals vs. channel number with and without charge injection:

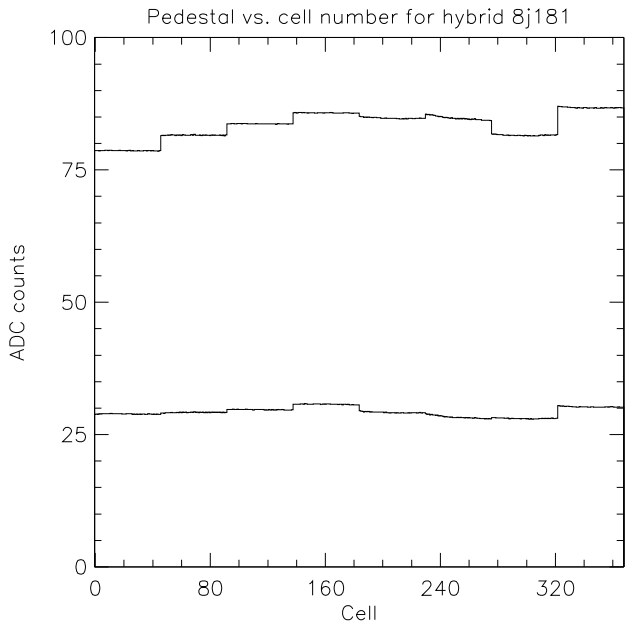
Pedestal vs. Pipeline Cell ID

The following plot shows the average pedestal vs. pipeline cell ID with and without charge injection. The x-axis is cell ID offset by 46 for each chip. Thus cell ID 5 for chip 1 is at x=5, chip 2 at x=51, chip 3 at x=97, etc.

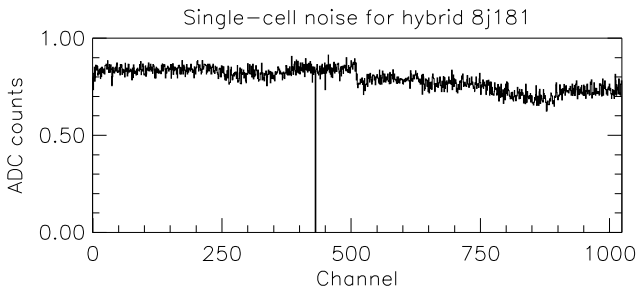
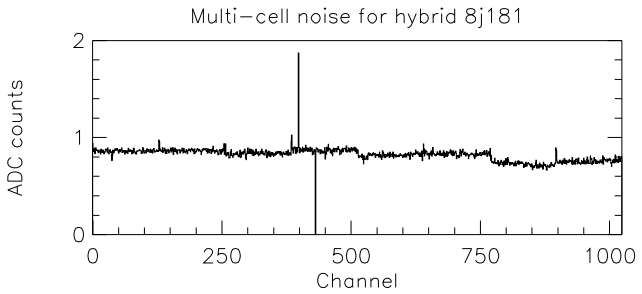
RMS Noise

The following plots show the single-cell and multi-cell RMS noise:

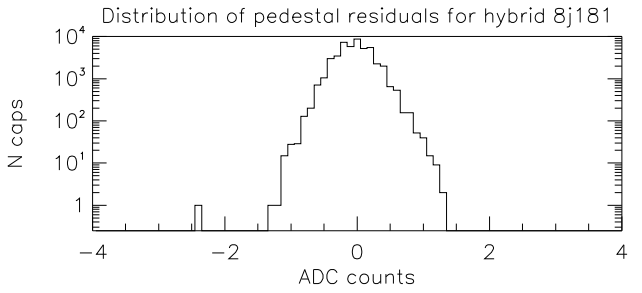
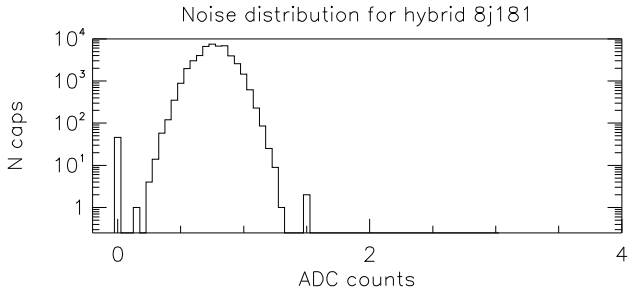
Distribution of Pedestals and Noise

The following are histograms of the pedestal of each pipeline capacitor relative to the chip average (top); and the RMS noise of each capacitor (bottom):

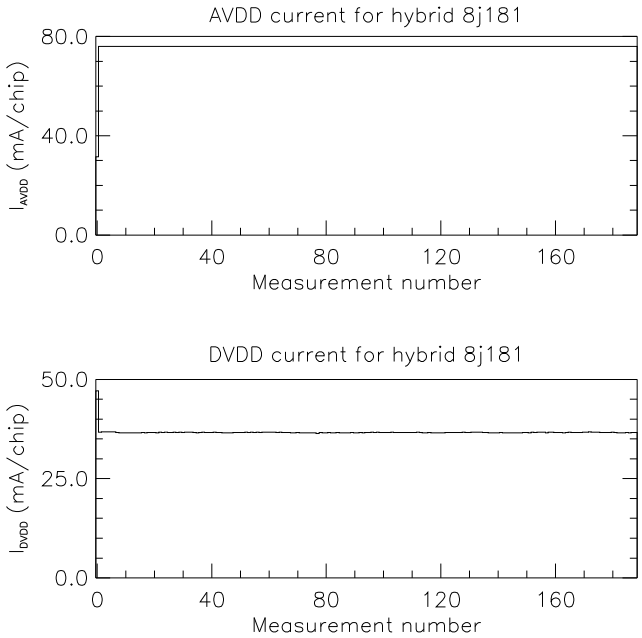
Supply Currents During Burn-in

The following plots show the supply currents per chip as a function of measurment number. Currents are measured approximately every 10 minutes:
