Hybrid 8j246 Traveler

March 1, 2000

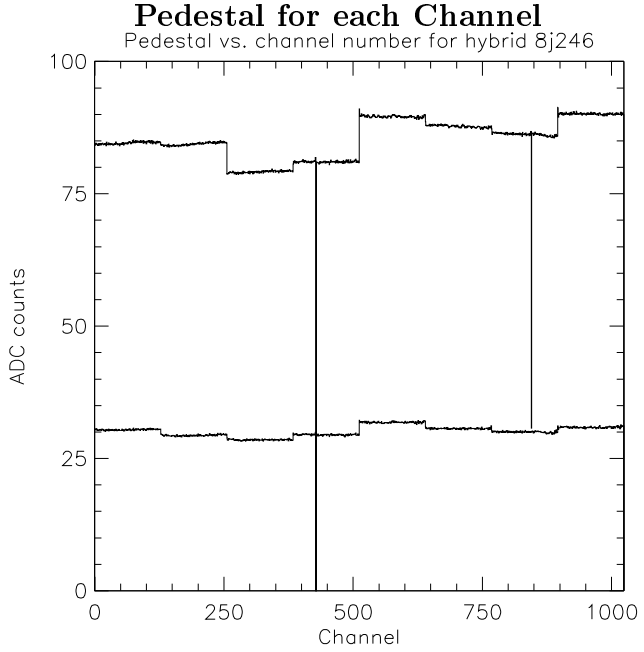
Pedestal for each Channel

The following plot shows the pedestals vs. channel number with and without charge injection:

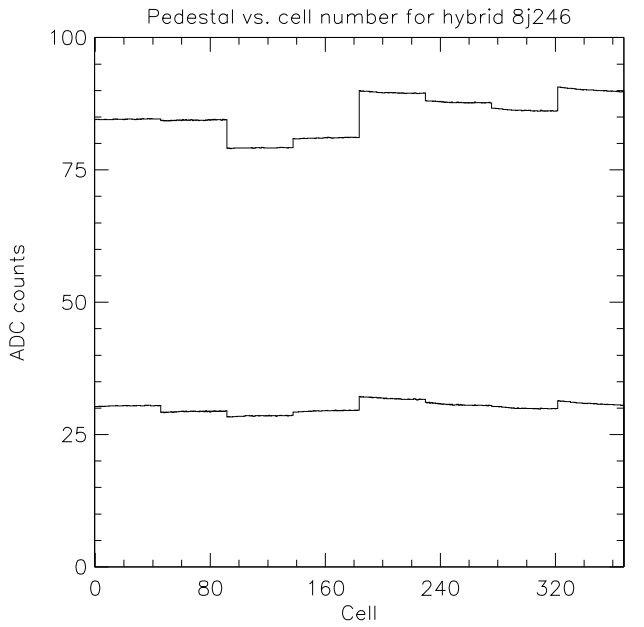
Pedestal vs. Pipeline Cell ID

The following plot shows the average pedestal vs. pipeline cell ID with and without charge injection. The x-axis is cell ID offset by 46 for each chip. Thus cell ID 5 for chip 1 is at x=5, chip 2 at x=51, chip 3 at x=97, etc.

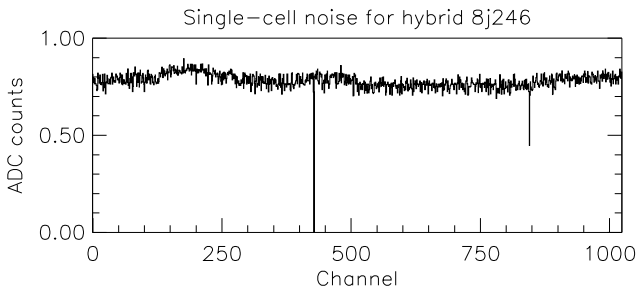
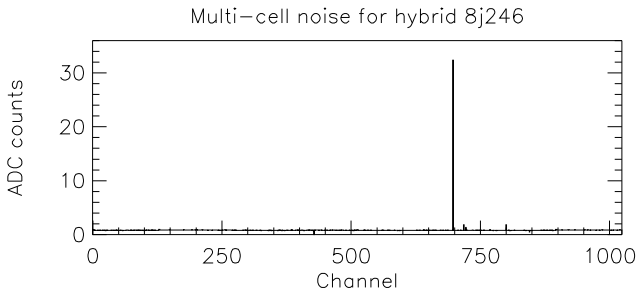
RMS Noise

The following plots show the single-cell and multi-cell RMS noise:

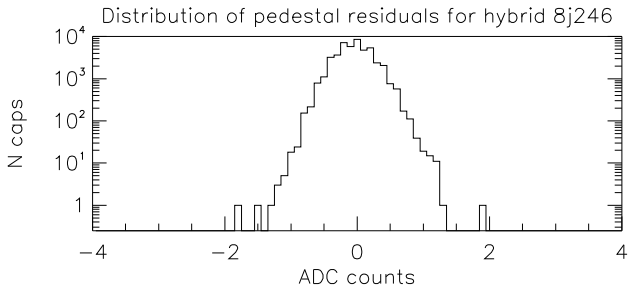
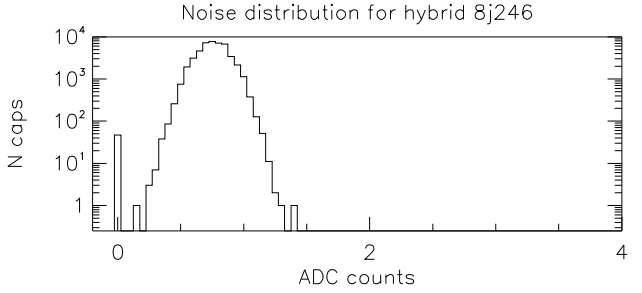
Distribution of Pedestals and Noise

The following are histograms of the pedestal of each pipeline capacitor relative to the chip average (top); and the RMS noise of each capacitor (bottom):

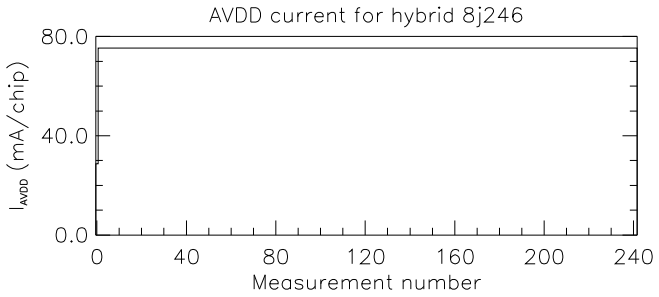
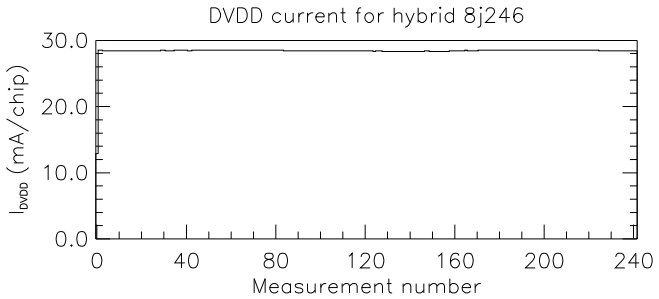
Supply Currents During Burn-in

The following plots show the supply currents per chip as a function of measurment number. Currents are measured approximately every 10 minutes:
