Hybrid 8j248 Traveler

February 23, 2000

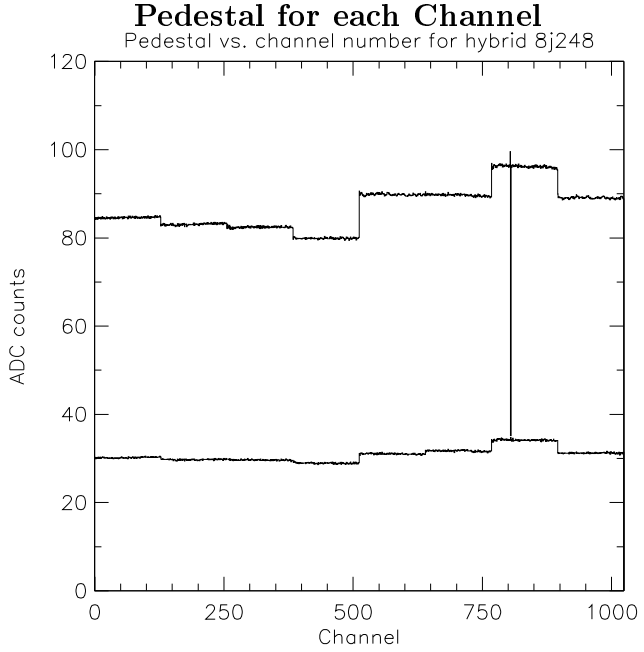
Pedestal for each Channel

Hybrid 8j248 quality: fair
Chip classification: good good good good good fair fair good
Bad channels (chip-channel): 5-112 6-37
Bad cells: none
Random bad capacitors (chip-cell-channel): 5-34-107 5-42-111
Channels at pedestal needed for DCMS: 31.3 30.7 29.7 31.6 34.7 34.6 32.6 32.6
```

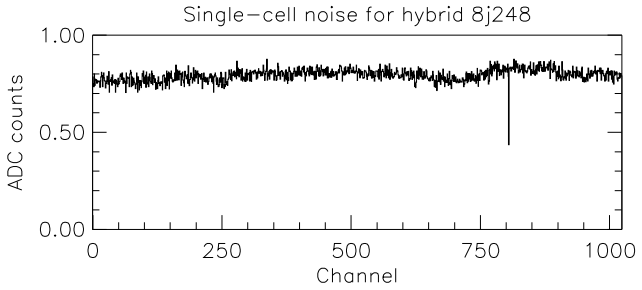
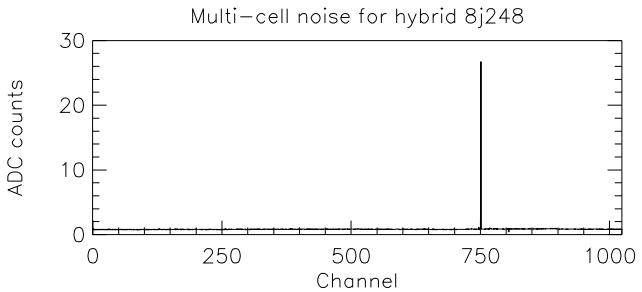
RMS Noise

The following plots show the single-cell and multi-cell RMS noise:

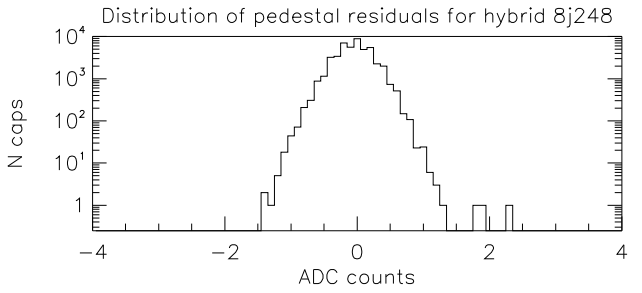
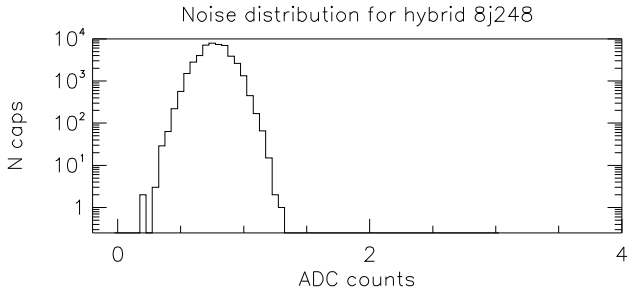
Distribution of Pedestals and Noise

The following are histograms of the pedestal of each pipeline capacitor relative to the chip average (top); and the RMS noise of each capacitor (bottom):
