Hybrid 8j259 Traveler

February 22, 2000

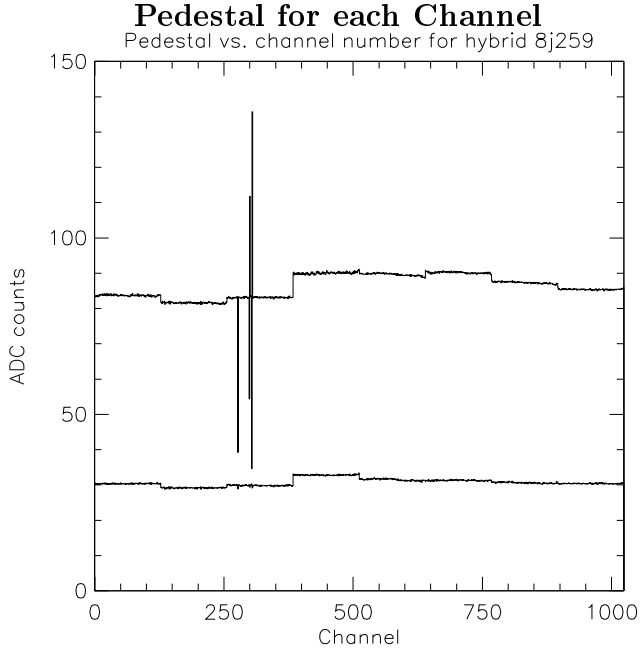
Pedestal for each Channel

The following plot shows the pedestals vs. channel number with and without charge injection:

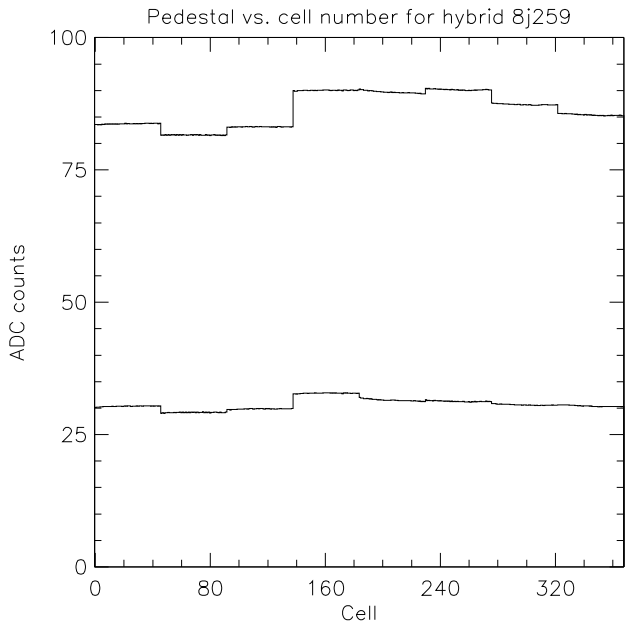
Pedestal vs. Pipeline Cell ID

The following plot shows the average pedestal vs. pipeline cell ID with and without charge injection. The x-axis is cell ID offset by 46 for each chip. Thus cell ID 5 for chip 1 is at x=5, chip 2 at x=51, chip 3 at x=97, etc.

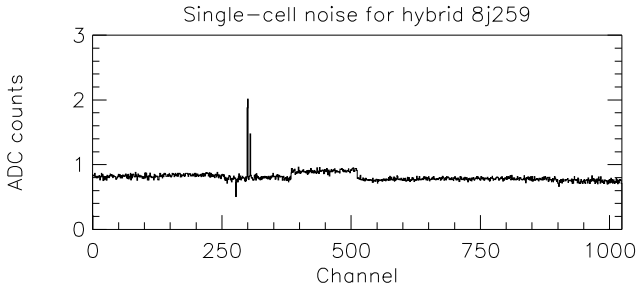
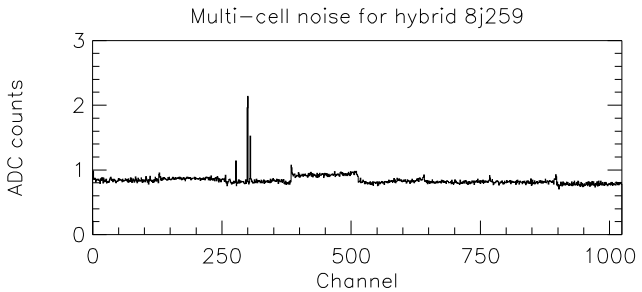
RMS Noise

The following plots show the single-cell and multi-cell RMS noise:

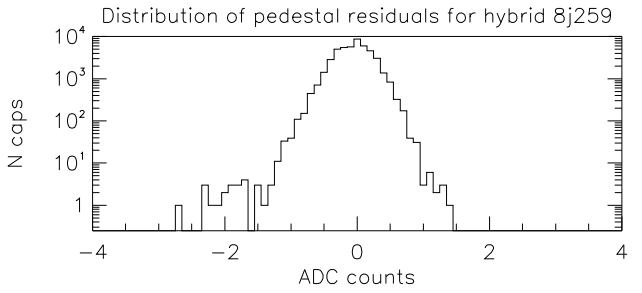
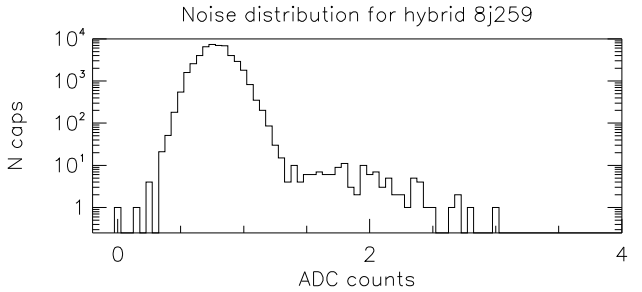
Distribution of Pedestals and Noise

The following are histograms of the pedestal of each pipeline capacitor relative to the chip average (top); and the RMS noise of each capacitor (bottom):

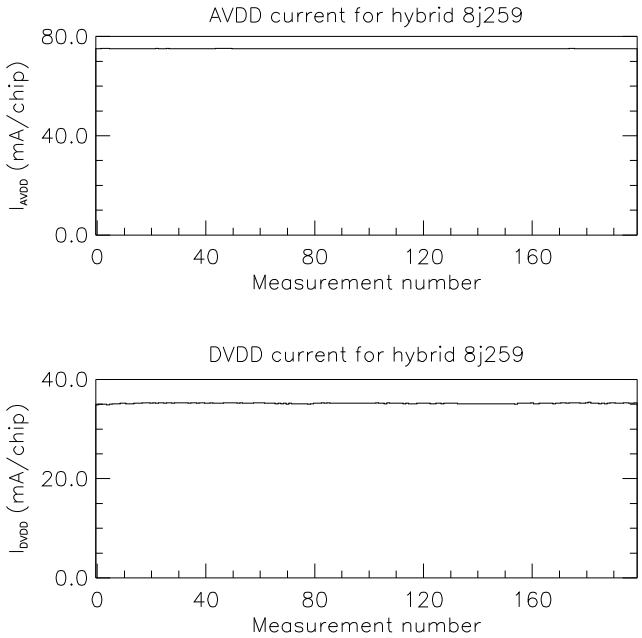
Supply Currents During Burn-in

The following plots show the supply currents per chip as a function of measurment number. Currents are measured approximately every 10 minutes:
