Hybrid 8j26 Traveler

October 26, 1999

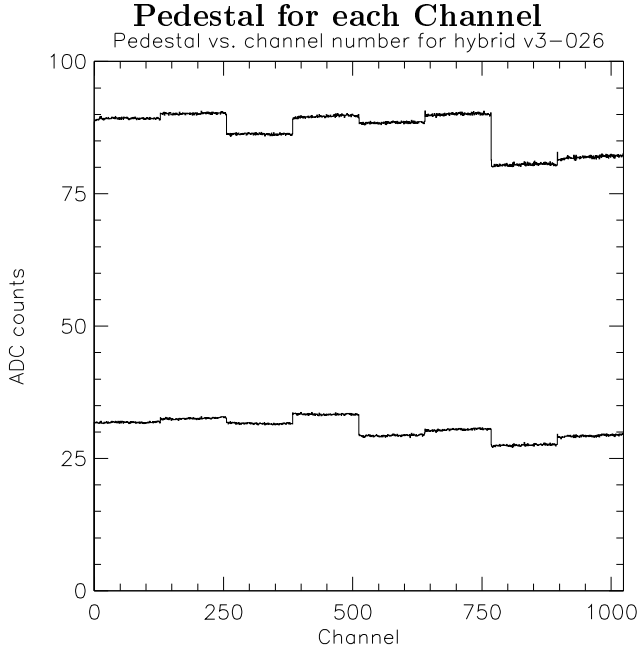
Pedestal for each Channel

The following plot shows the pedestals vs. channel number with and without charge injection:

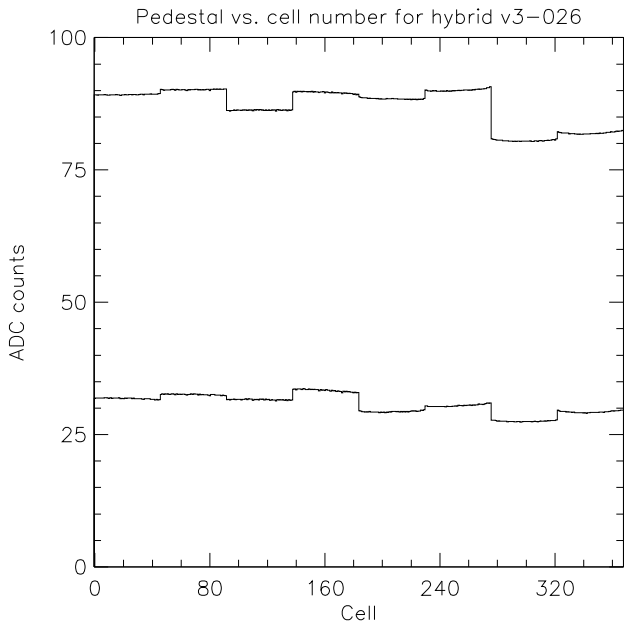
Pedestal vs. Pipeline Cell ID

The following plot shows the average pedestal vs. pipeline cell ID with and without charge injection. The x-axis is cell ID offset by 46 for each chip. Thus cell ID 5 for chip 1 is at x=5, chip 2 at x=51, chip 3 at x=97, etc.

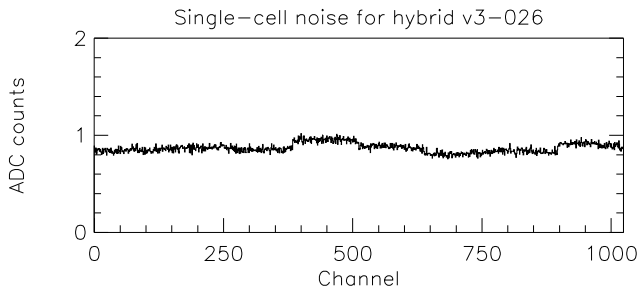
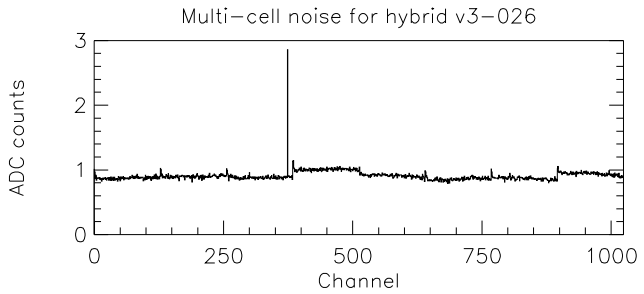
RMS Noise

The following plots show the single-cell and multi-cell RMS noise:

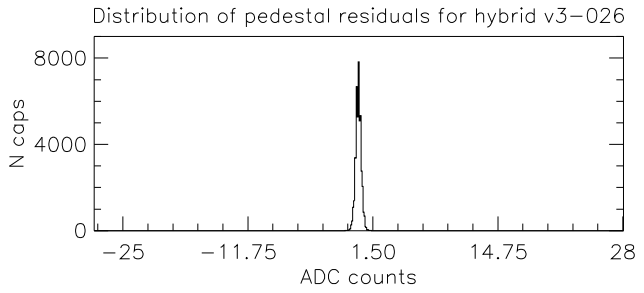
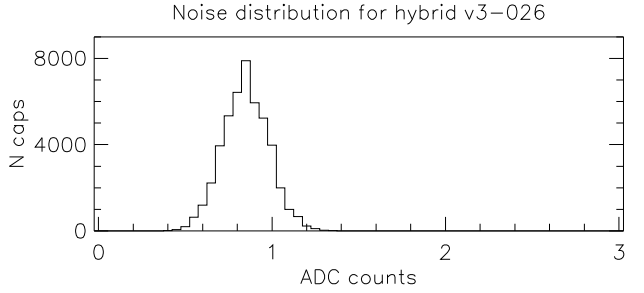
Distribution of Pedestals and Noise

The following are histograms of the pedestal of each pipeline capacitor relative to the chip average (top); and the RMS noise of each capacitor (bottom):

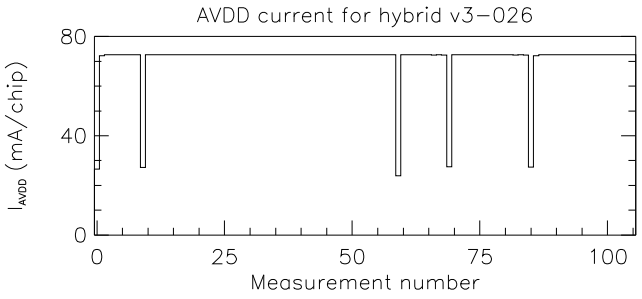
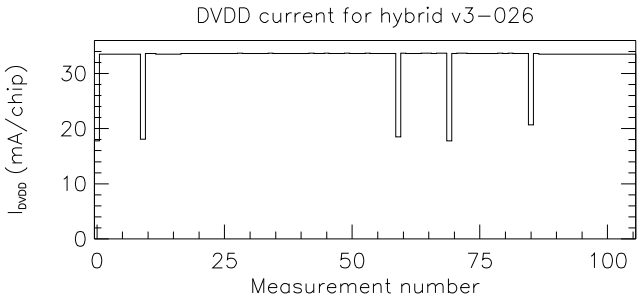
Supply Currents During Burn-in

The following plots show the supply currents per chip as a function of measurment number. Currents are measured approximately every 10 minutes:
