Hybrid 8j275 Traveler

March 3, 2000

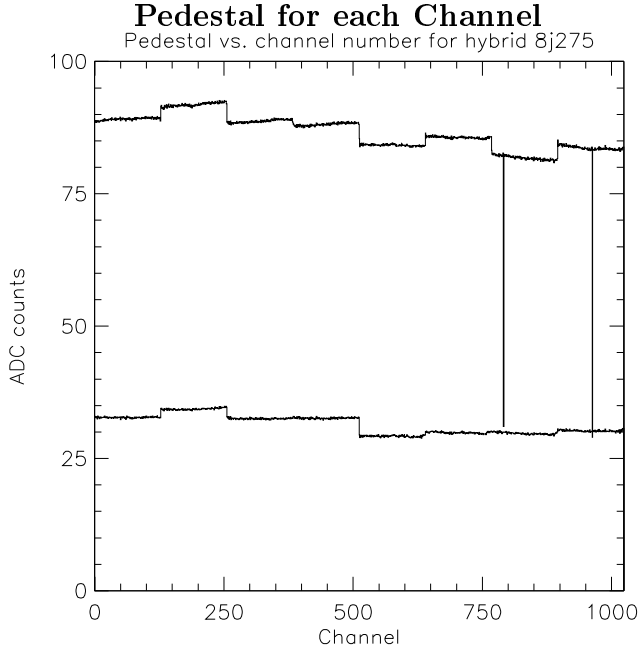
Pedestal for each Channel

The following plot shows the pedestals vs. channel number with and without charge injection:

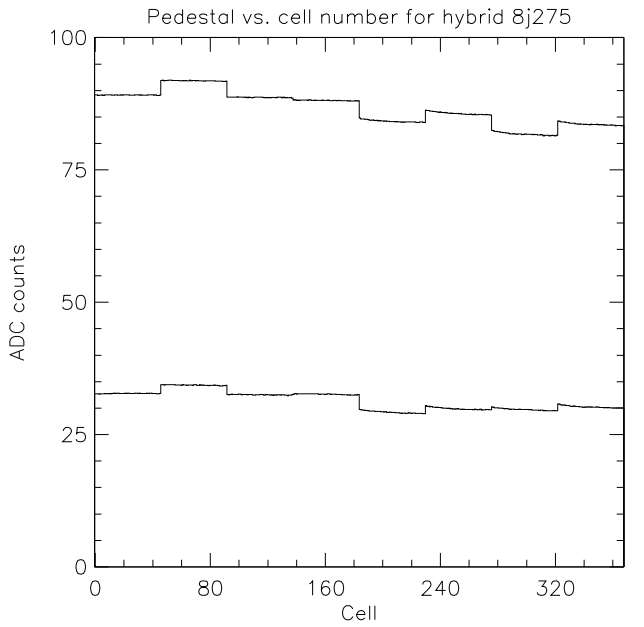
Pedestal vs. Pipeline Cell ID

The following plot shows the average pedestal vs. pipeline cell ID with and without charge injection. The x-axis is cell ID offset by 46 for each chip. Thus cell ID 5 for chip 1 is at x=5, chip 2 at x=51, chip 3 at x=97, etc.

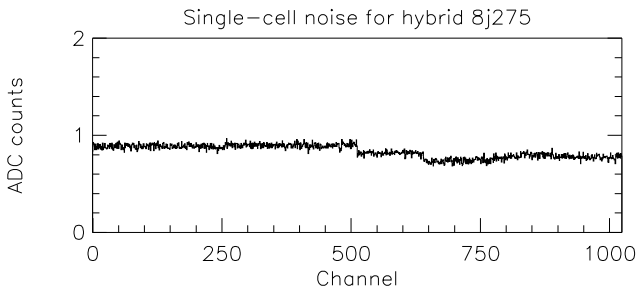
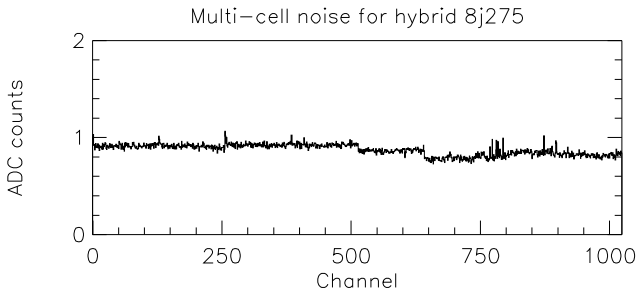
RMS Noise

The following plots show the single-cell and multi-cell RMS noise:

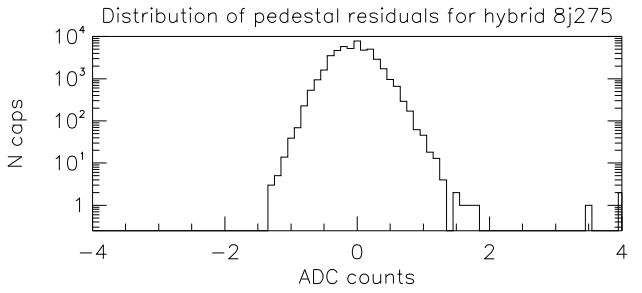
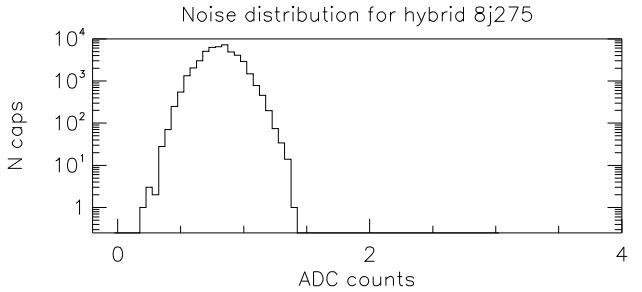
Distribution of Pedestals and Noise

The following are histograms of the pedestal of each pipeline capacitor relative to the chip average (top); and the RMS noise of each capacitor (bottom):

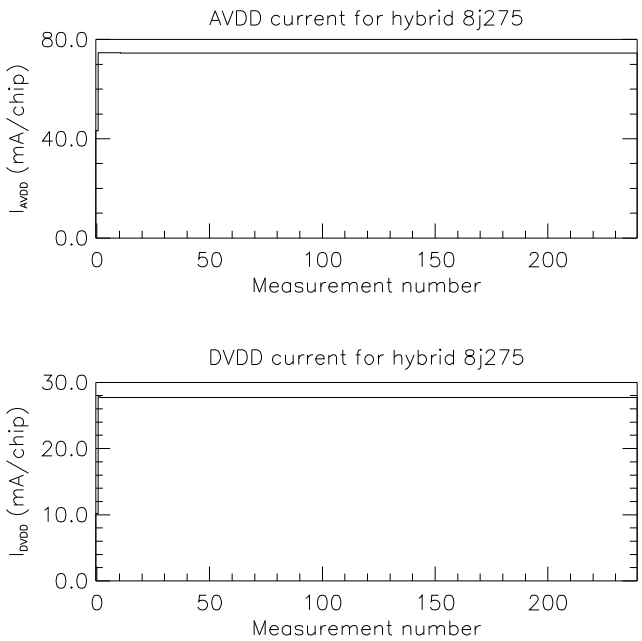
Supply Currents During Burn-in

The following plots show the supply currents per chip as a function of measurment number. Currents are measured approximately every 10 minutes:
