Hybrid 8j282 Traveler

March 8, 2000

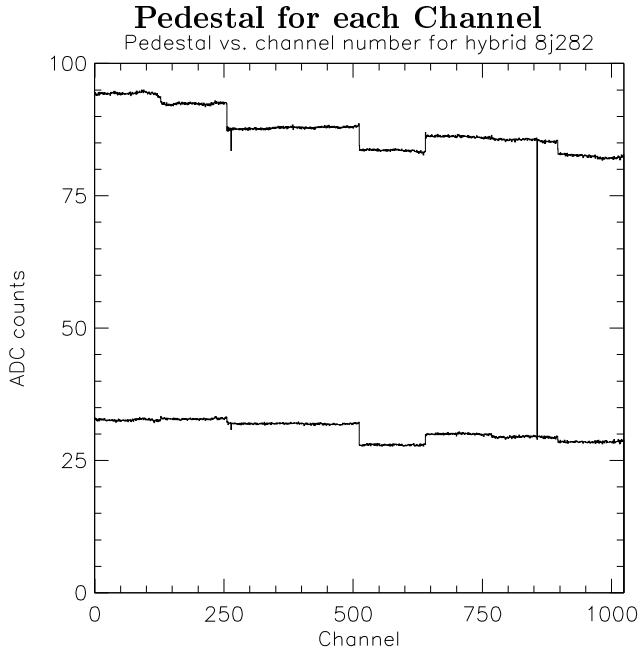
The following plot shows the pedestals vs. channel number with and without charge injection:

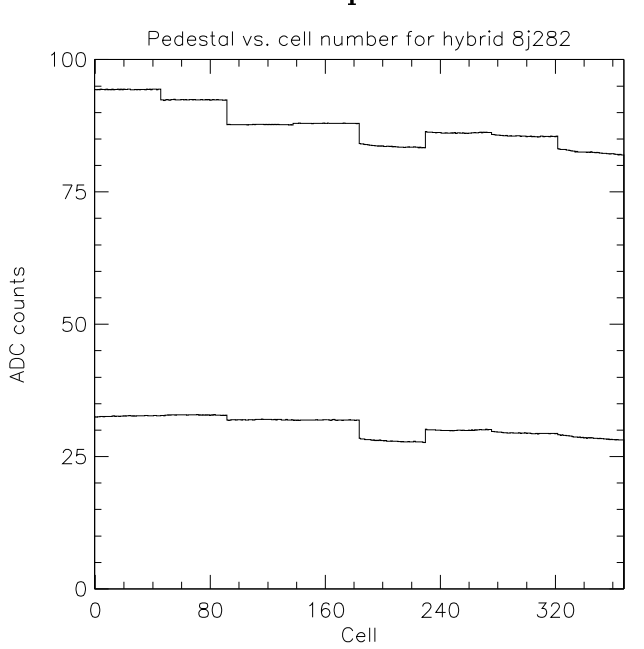
The following plot shows the average pedestal vs. pipeline cell ID with and without charge injection. The x-axis is cell ID offset by 46 for each chip. Thus cell ID 5 for chip 1 is at x=5, chip 2 at x=51, chip 3 at x=97, etc.

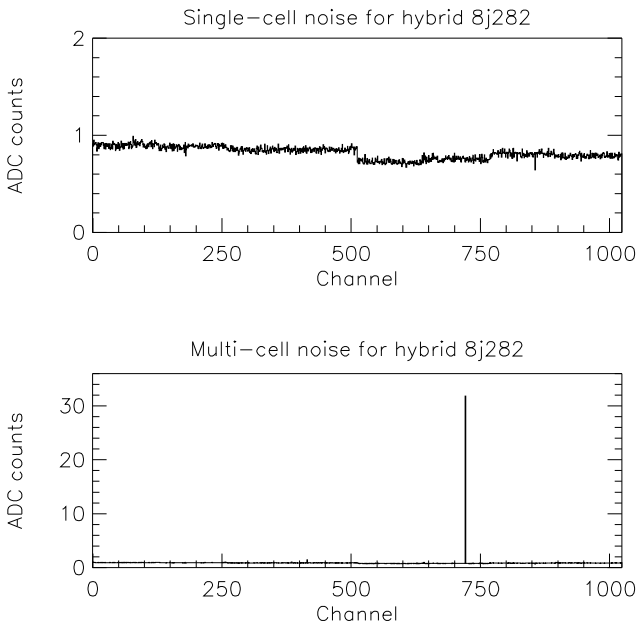
RMS Noise

The following plots show the single-cell and multi-cell RMS noise:

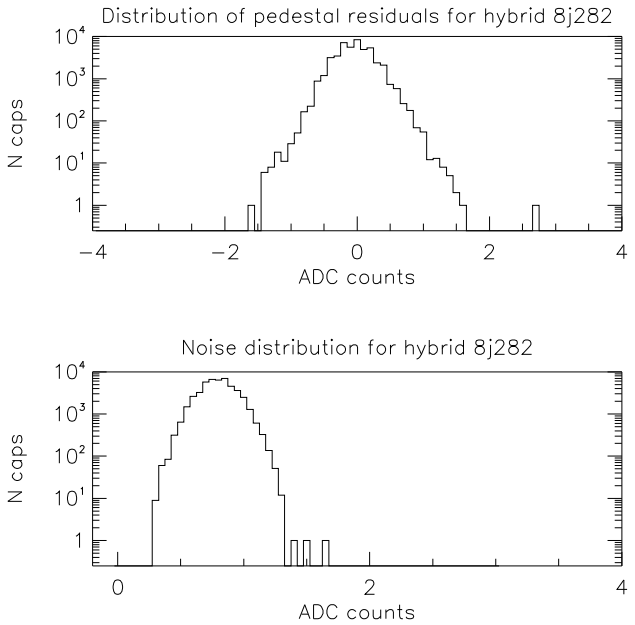
Distribution of Pedestals and Noise

The following are histograms of the pedestal of each pipeline capacitor relative to the chip average (top); and the RMS noise of each capacitor (bottom):

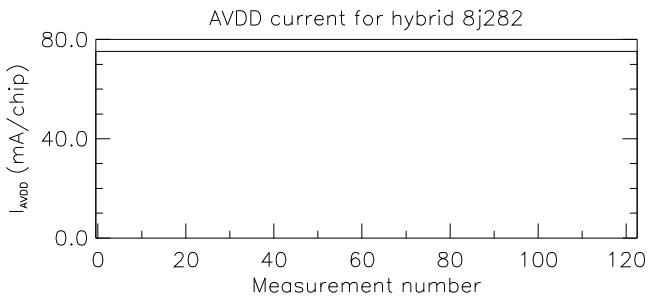
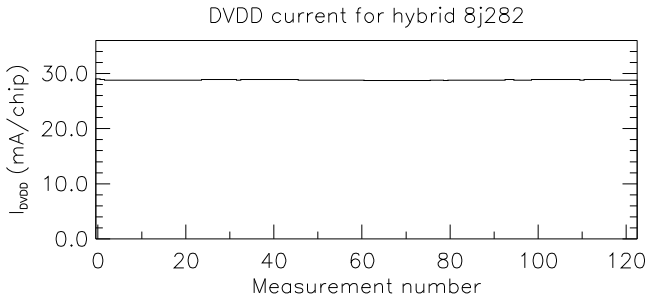
Supply Currents During Burn-in

The following plots show the supply currents per chip as a function of measurment number. Currents are measured approximately every 10 minutes:
