Hybrid 8j318 Traveler

June 19, 2000

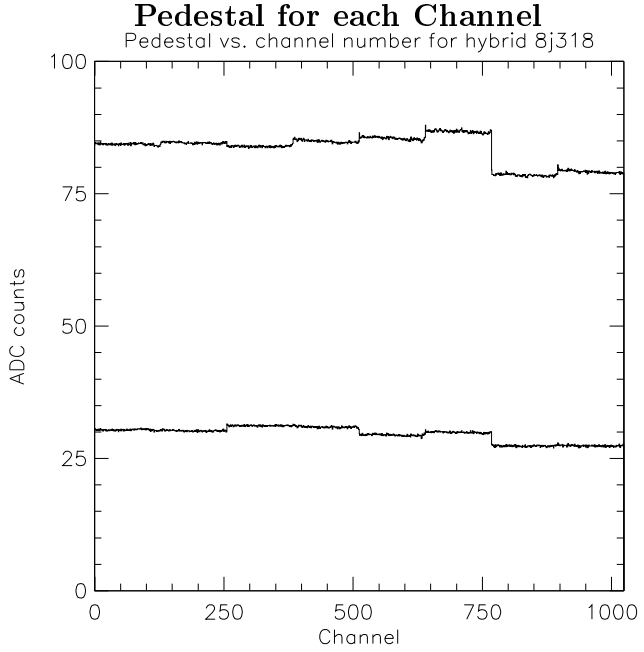
Pedestal for each Channel

The following plot shows the pedestals vs. channel number with and without charge injection:

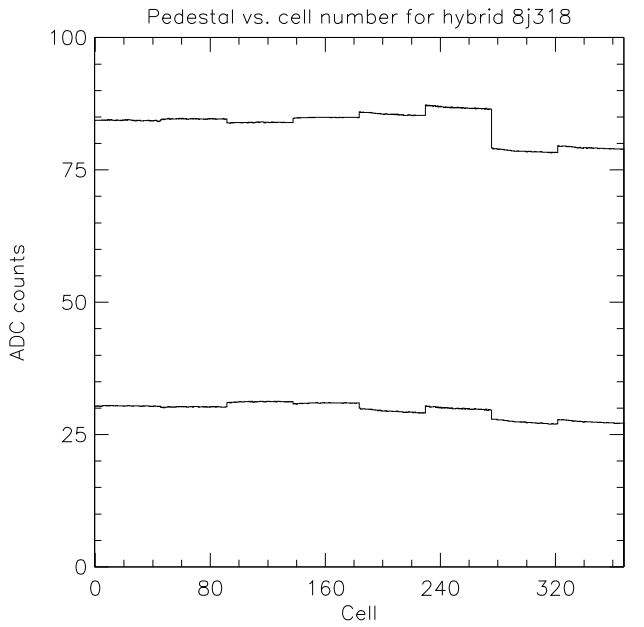
Pedestal vs. Pipeline Cell ID

The following plot shows the average pedestal vs. pipeline cell ID with and without charge injection. The x-axis is cell ID offset by 46 for each chip. Thus cell ID 5 for chip 1 is at x=5, chip 2 at x=51, chip 3 at x=97, etc.

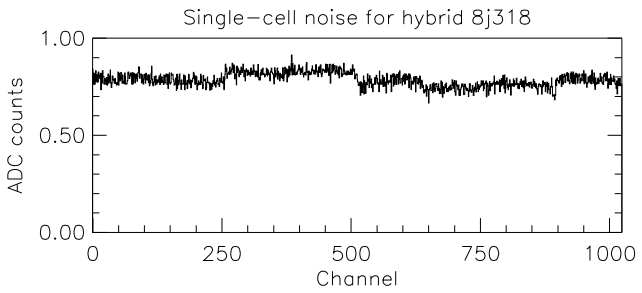
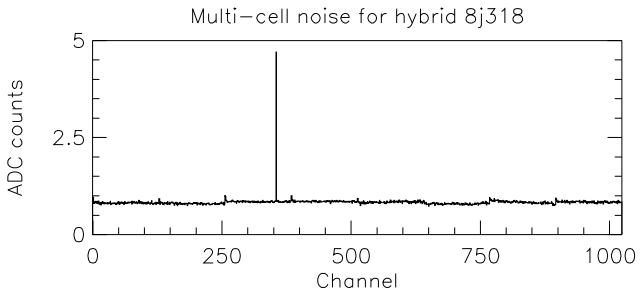
RMS Noise

The following plots show the single-cell and multi-cell RMS noise:

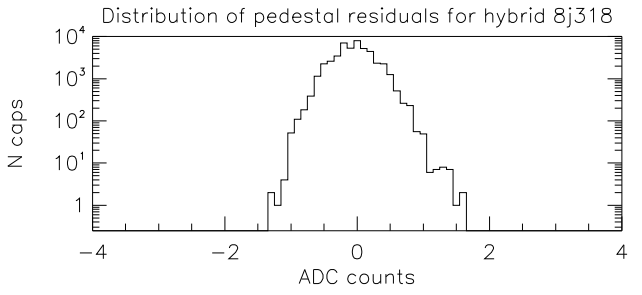
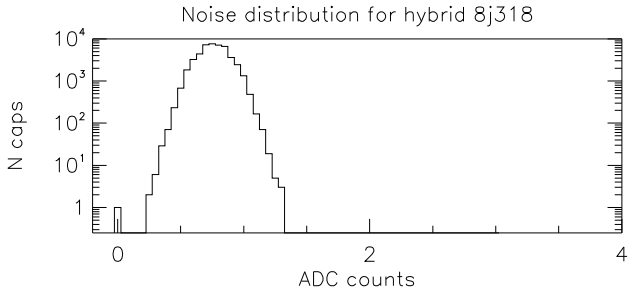
Distribution of Pedestals and Noise

The following are histograms of the pedestal of each pipeline capacitor relative to the chip average (top); and the RMS noise of each capacitor (bottom):

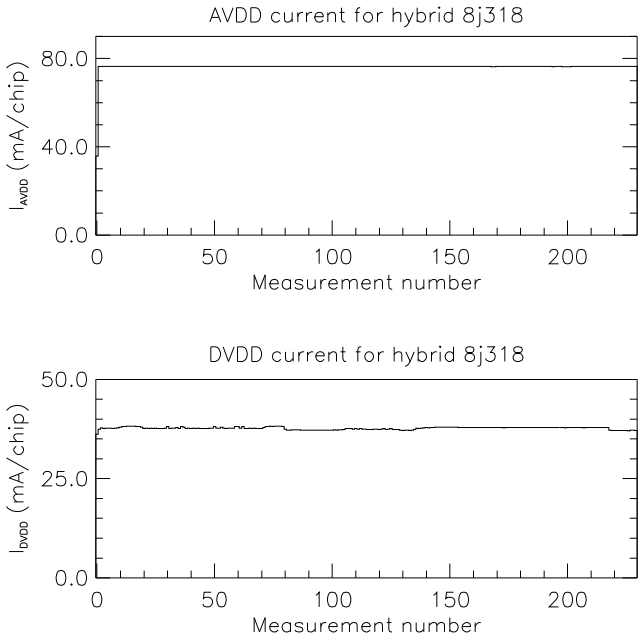
Supply Currents During Burn-in

The following plots show the supply currents per chip as a function of measurment number. Currents are measured approximately every 10 minutes:
