Hybrid 8j343 Traveler

May 11, 2000

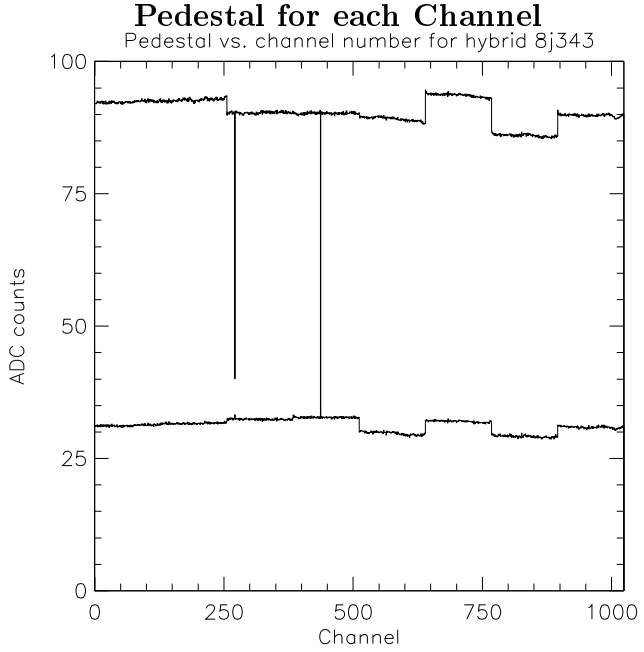
Pedestal for each Channel

The following plot shows the pedestals vs. channel number with and without charge injection:

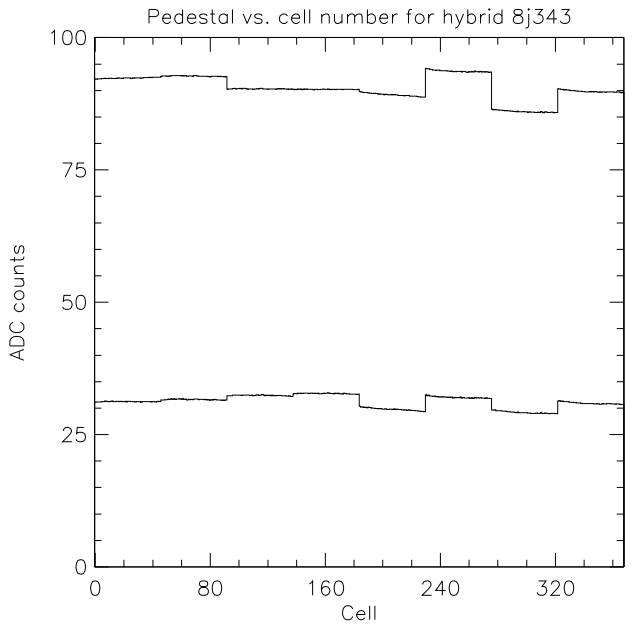
Pedestal vs. Pipeline Cell ID

The following plot shows the average pedestal vs. pipeline cell ID with and without charge injection. The x-axis is cell ID offset by 46 for each chip. Thus cell ID 5 for chip 1 is at x=5, chip 2 at x=51, chip 3 at x=97, etc.

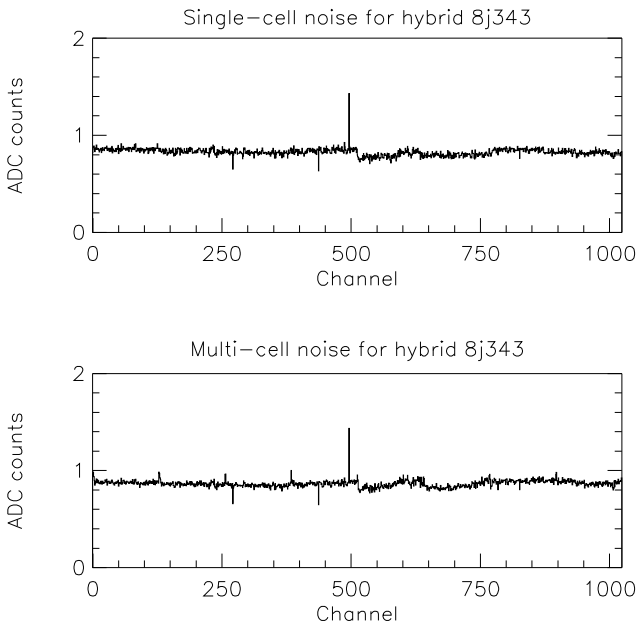
RMS Noise

The following plots show the single-cell and multi-cell RMS noise:

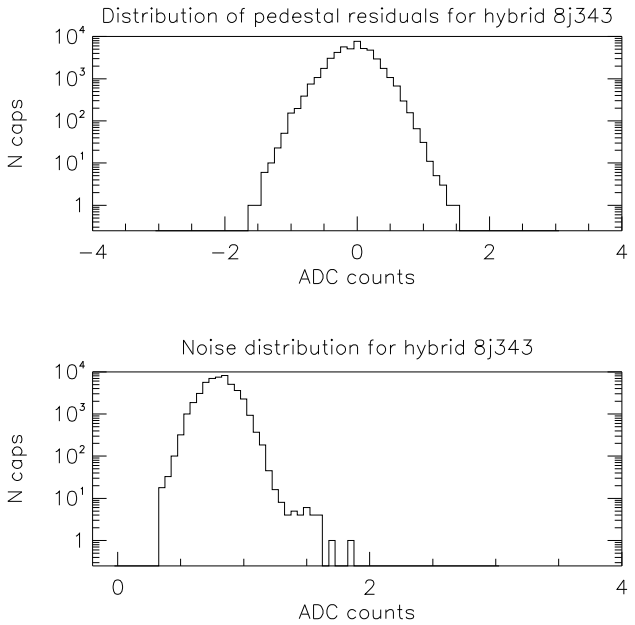
Distribution of Pedestals and Noise

The following are histograms of the pedestal of each pipeline capacitor relative to the chip average (top); and the RMS noise of each capacitor (bottom):

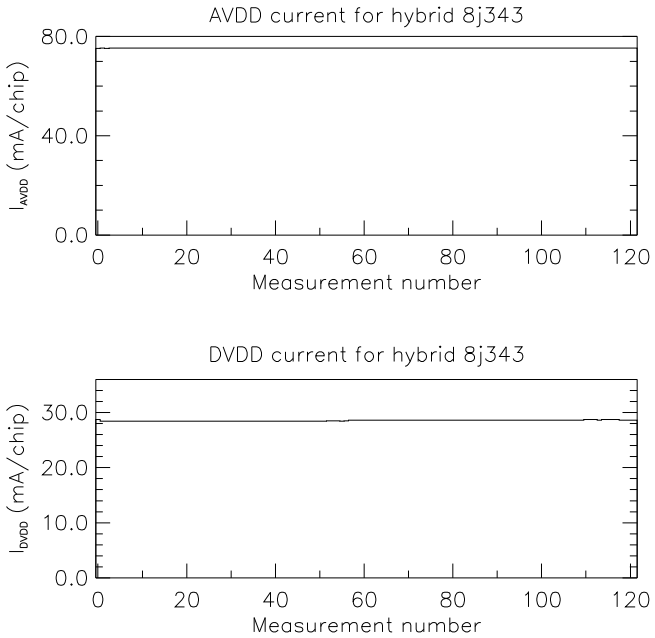
Supply Currents During Burn-in

The following plots show the supply currents per chip as a function of measurment number. Currents are measured approximately every 10 minutes:
